04th December 2023

Bat Building Inspection: County Hall, Fishergate, Preston, Lancashire PR1 8RL

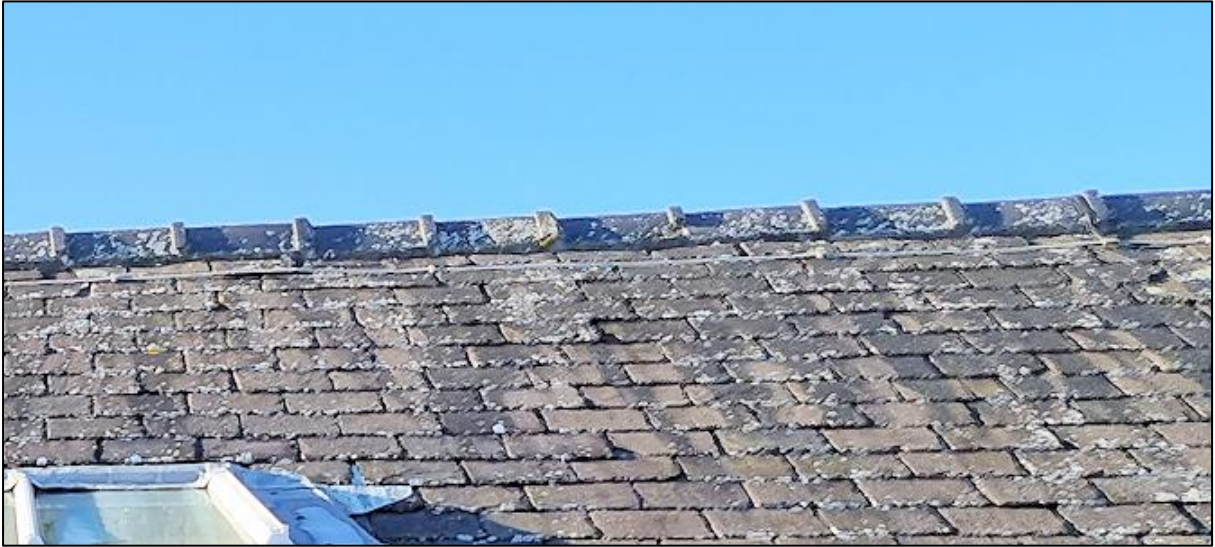
The roof pitches around the dormers were found to be in generally satisfactory condition with no significant gaps under the ridge or the slate tiles (see Plate 1).

Plate 1: The ridges and roof pitches were intact with no PRFs.

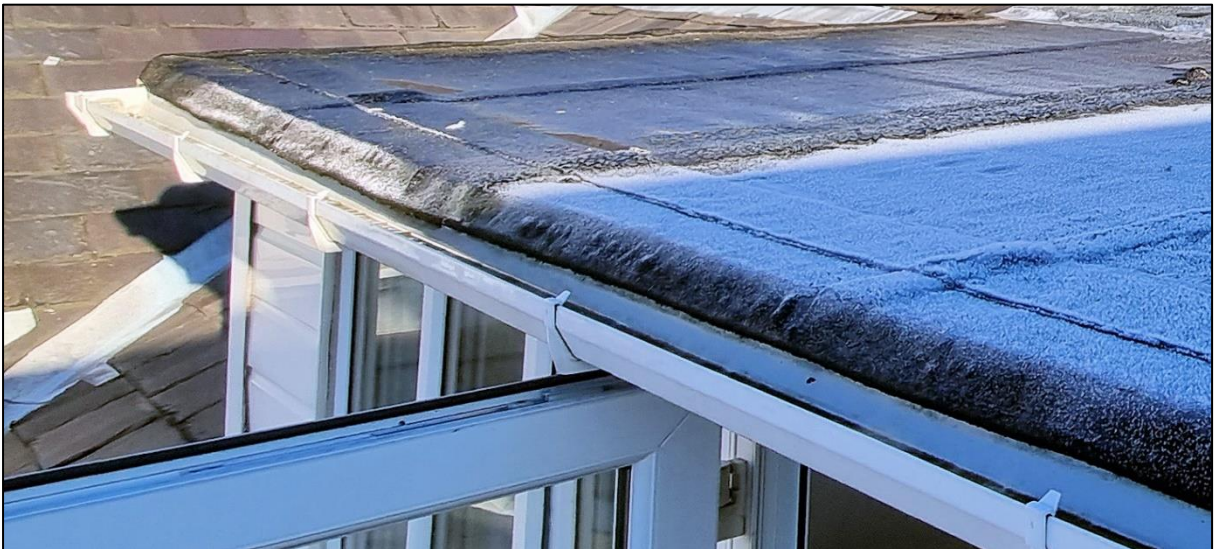
The roofing felts on the dormers were found to be intact (see Plate 2) with no Potential Roost Features (PRFs) and no potential access to the internal spaces for bats. Elsewhere, outside of the proposed works areas, the dormers had glazed roofs, but again these had no gaps or potential access to the internal spaces for bats.

Plate 2: The roofing felts were intact with no gaps suitable for bats.

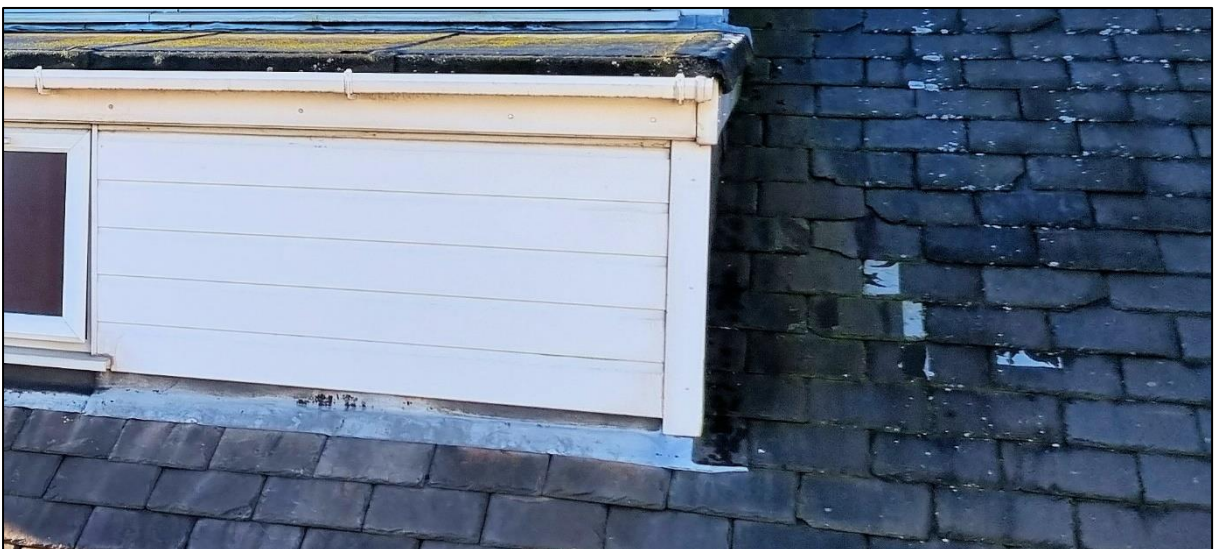
Where the dormers were clad in timber, the cladding was intact with no gaps or holes suitable for roosting bats (see Plate 3).

Plate 3: The cladding of the dormers had no gaps and no potential for bats.

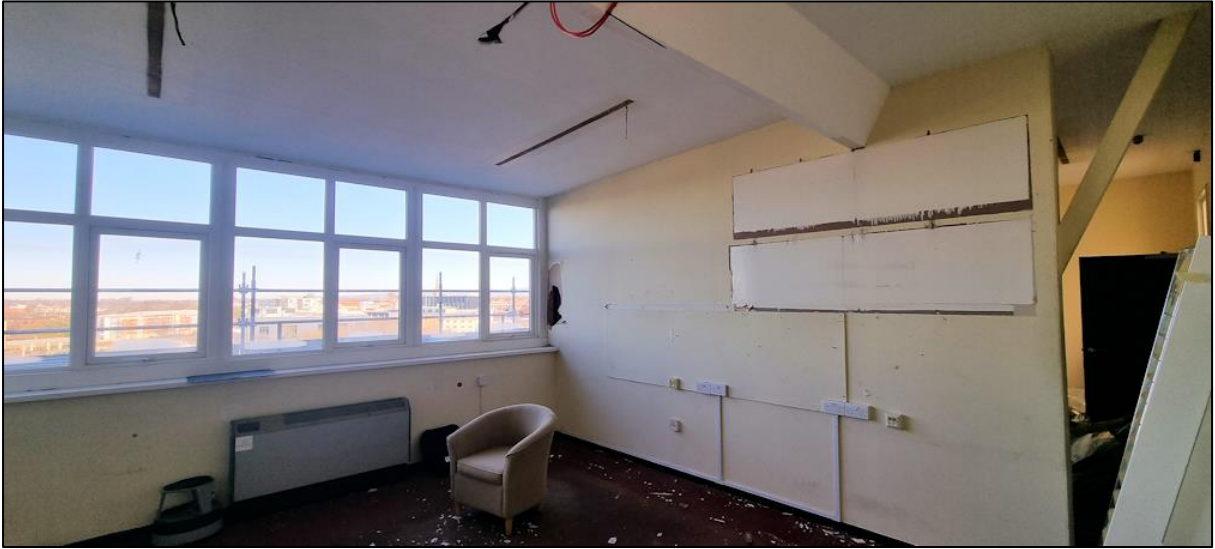
In the offices of Zone A, the ceiling of the dormers were found to be generally intact with no access to the internal space from outside (see Plate 4). In some areas, the dormers were in poor condition, and the previous ingress of water had resulted in areas of rot (see Plate 5) and water damage to the plaster board. Where the plasterboard had been removed, the exposed cavities were found to have no roosting potential and there was no evidence of bat activity.

Plate 4: The offices in Zone A were open to the plaster board on the underside of the dormer roof.

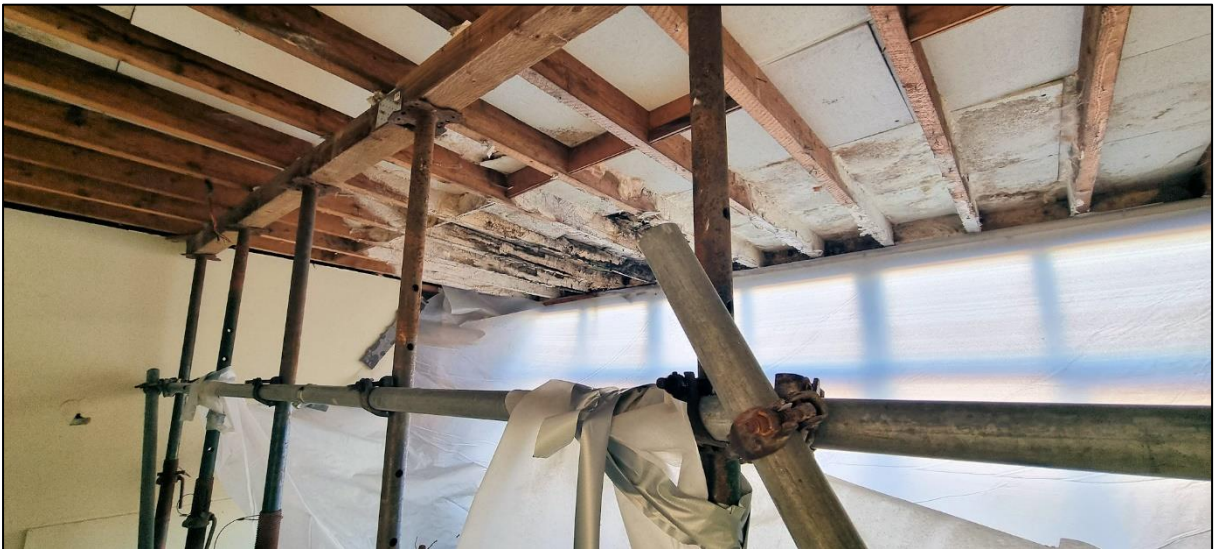
Plate 5: Where the plaster boarding had been removed the water damage to the timbers was apparent – there were no bat roosting opportunities here.

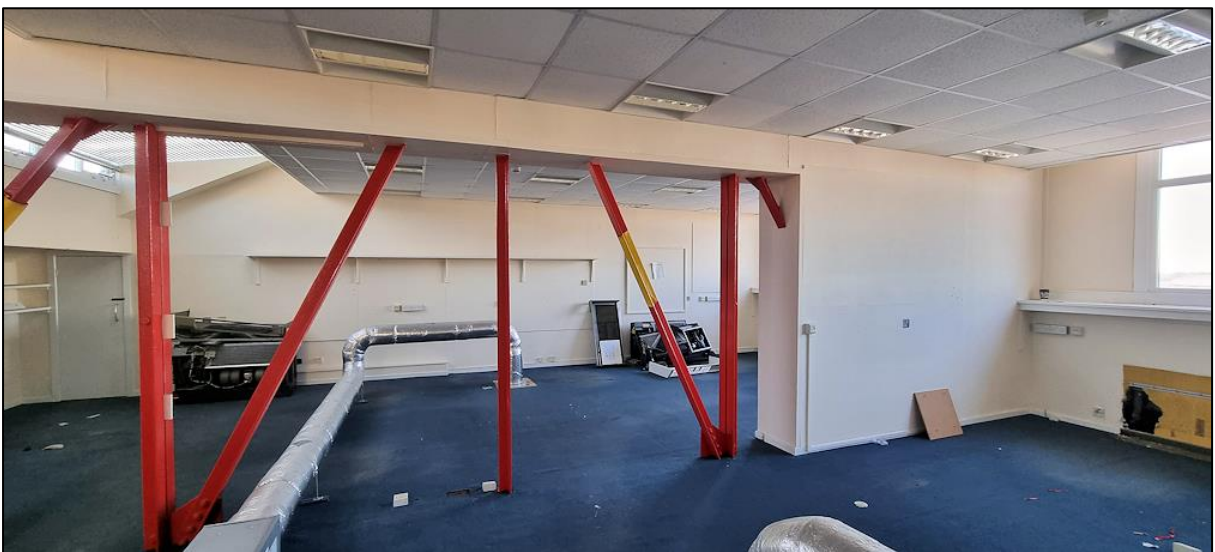
In Zone B, the roof was partially boarded out and had a suspended ceiling preventing direct access to, or inspection of, the underside of the roof above these offices (see Plate 6 and Plate 7).

Plate 6: The internal spaces in Zone B Site was open to the suspended ceiling.

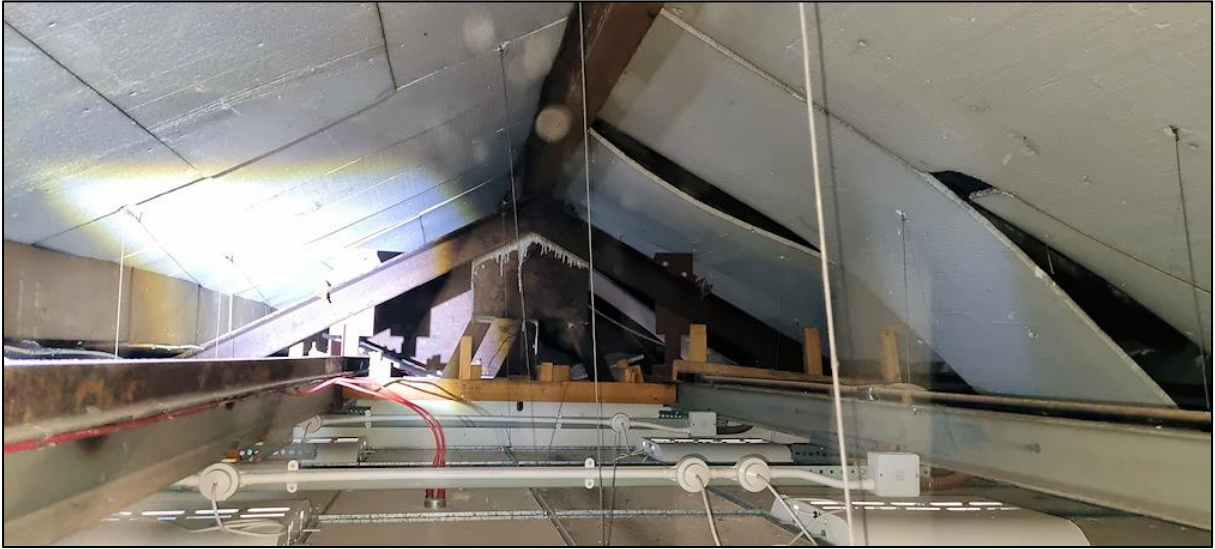
Plate 7: The void above the suspended ceiling in Zone B was partially boarded preventing inspection of the underside of the roof.

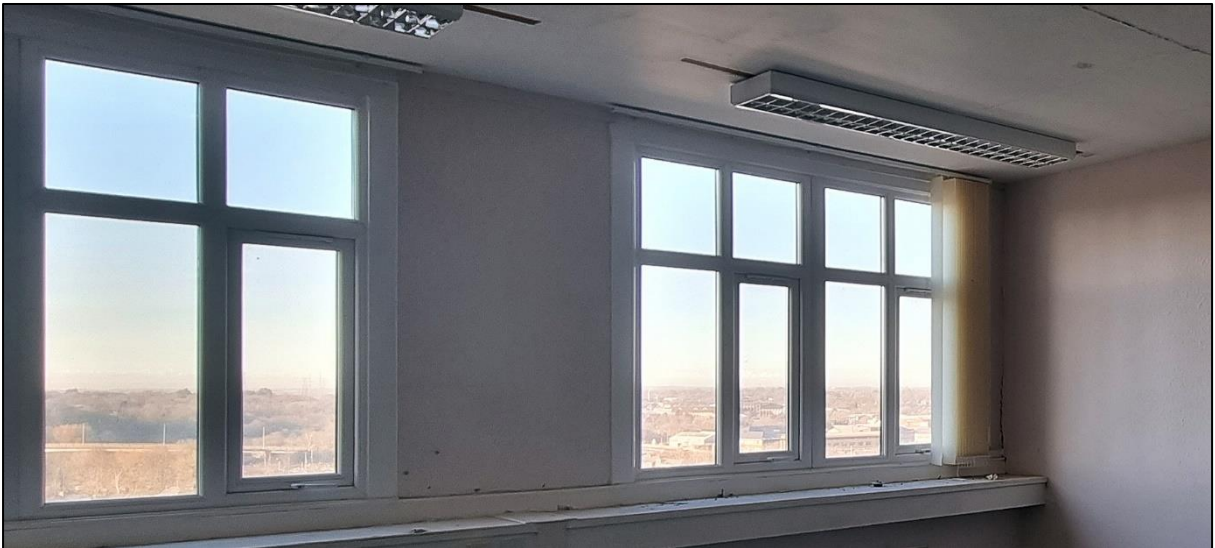
The windows within the dormers themselves were intact throughout and provided no access for bats from the outside (see Plate 8).

Plate 8: The windows of the dormers were intact with no potential access from the outside for bats.

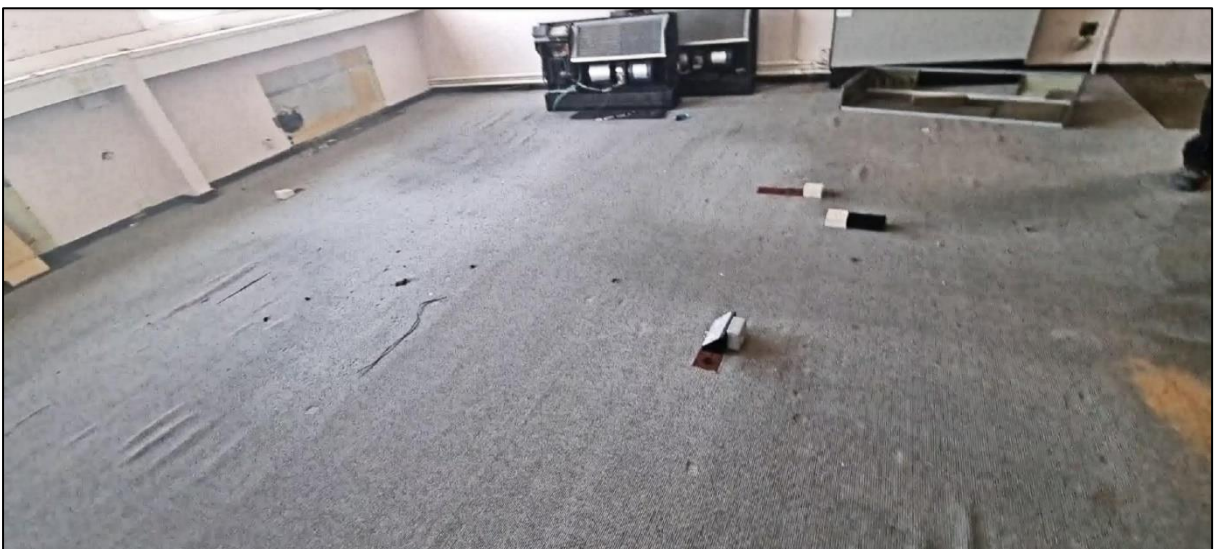
There was no evidence of bat activity on the walls or flat surfaces in these office spaces (see Plate 9).

Plate 9: The surfaces in the spaces served by the dormer windows had no evidence of bat activity.

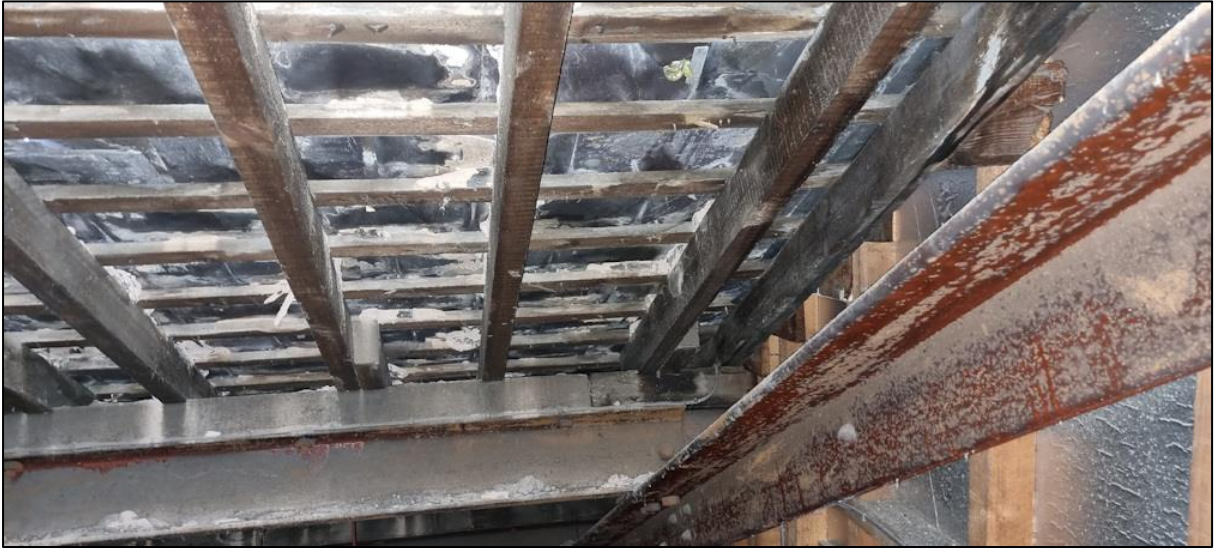
At each end of the roof there were voids adjacent to the dormer windows; these had no underfelt and were open to the exposed roof tiles, timber joists and steel beams (see Plate 10). Here the roof tiles were torched. Gaps apparent in the lime mortar that offered potential access to these voids (see Plate 11). However, the walls and flat surfaces within these voids had no evidence of bat activity (see Plate 12 and Plate 13). It was not considered that there was any reasonably foreseeable likelihood of bat access to this area or into the adjoining working area where impacts could arise.

Plate 10: In the voids at the end of each roof, the voids were open to the tiles, the timbers and steel joists.

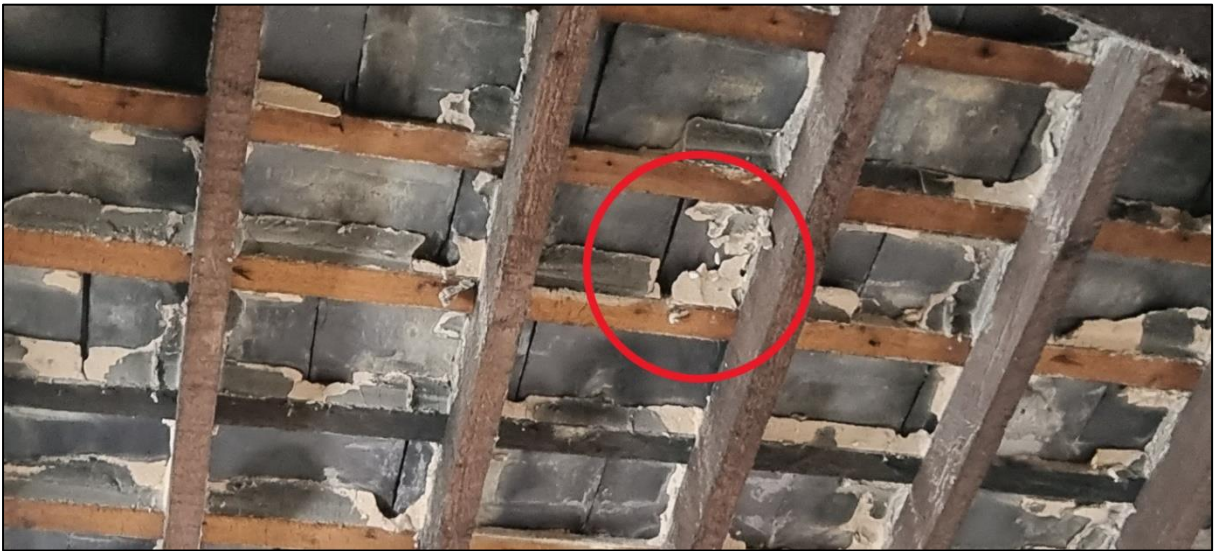
Plate 11: Where the mortar was missing there was potential access from outside the roof.

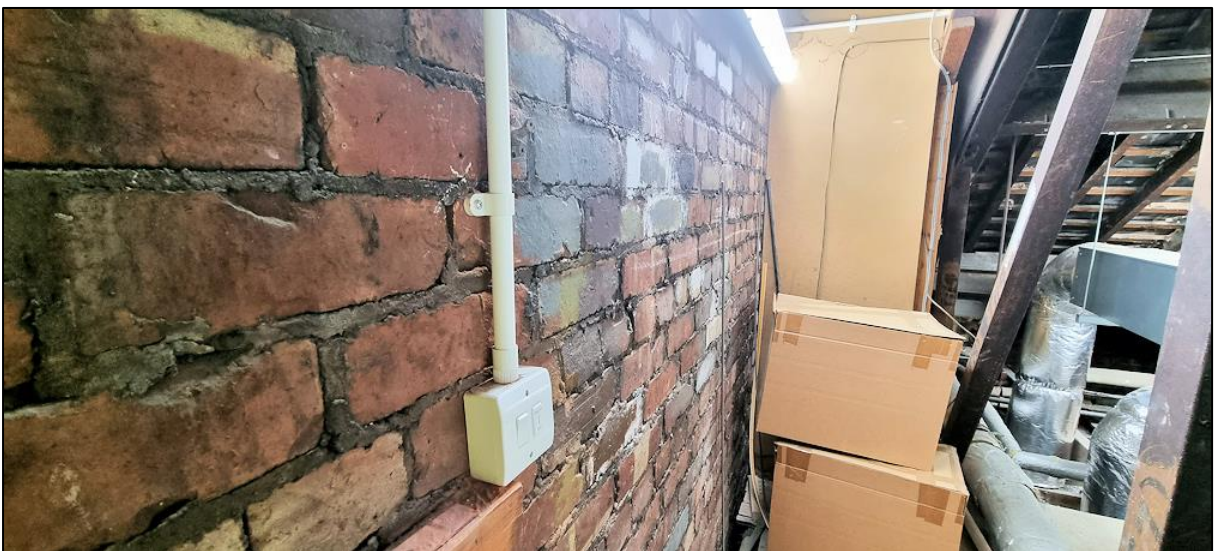
Plate 12: There were no gaps in the exposed brickwork of the adjacent roof voids and no roosting potential.

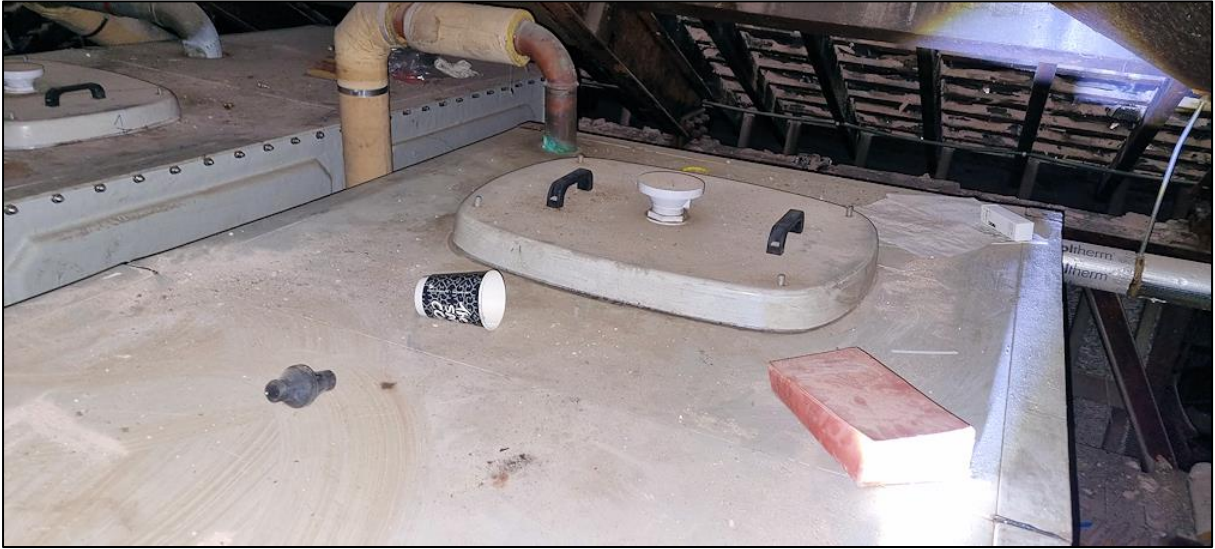
Plate 13: There was no evidence on the flat surfaces within the adjacent roof voids.
