B. Drainage Survey Details

Project Name: B5254 Lostock Hall 2021_12_06
Project Description: WinCan Import in Miraculix WRc4 Standard
Project Date: 07/12/2021
Inspection Standard: MSCC4 Sewers & Drainage GB (SRM4 Scoring)

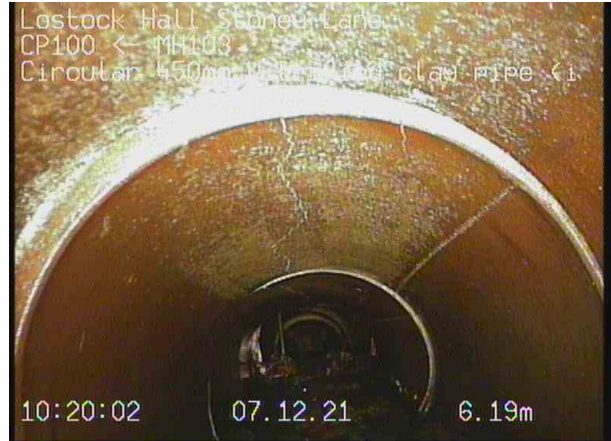
CP100X_81ea9923-0b11-4158-8616-5000123291da_20211207_092350_574.jpg, 00:01:00, 6.19 m
 Crack, longitudinal, in roof slab at 1 o'clock

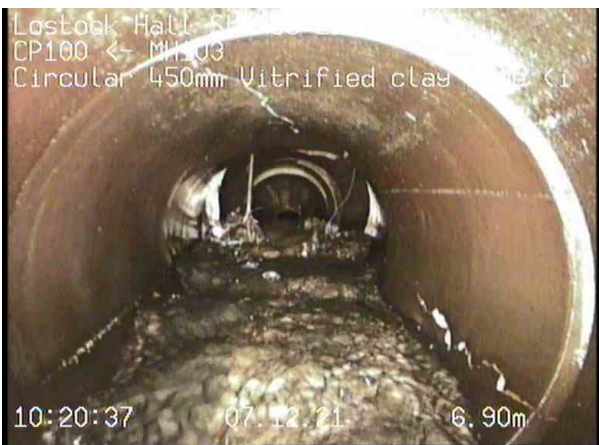
CP100X_a968e610-510b-4e61-b553-cfb58d9e4c08_20220105_074449_126.jpg, 00:01:18, 6.90 m
 Fracture, longitudinal at 4 o'clock

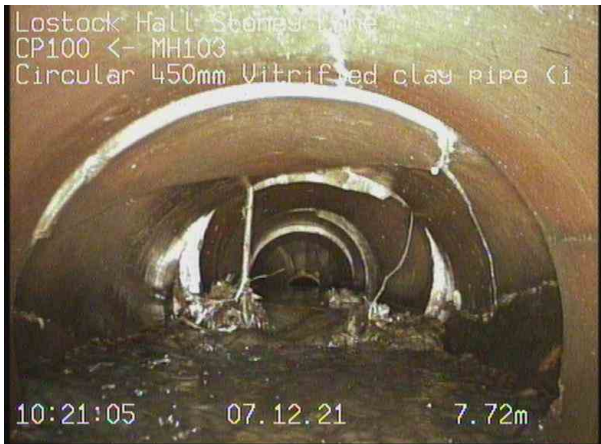
CP100X_f25e2b2b-5fe8-4ce4-9d80-9e239a8192aa_20211207_092453_375.jpg, 00:01:44, 7.72 m
Fracture, multiple at joint from 12 o'clock to 12 o'clock

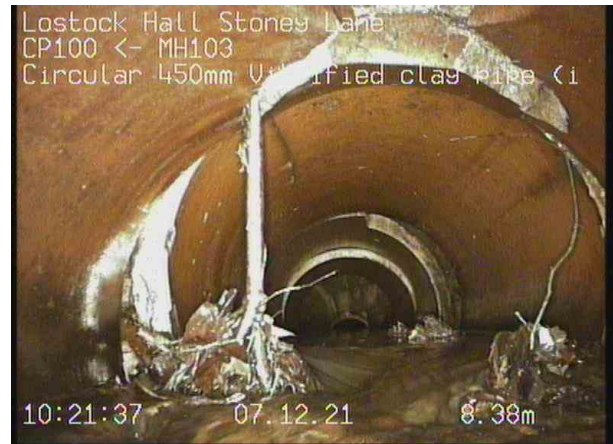
CP100X_70b78f9b-2b52-403e-a9fe-9ac17ee53f7c_20211207_092525_523.jpg, 00:02:12, 8.38 m
Roots, tap at joint

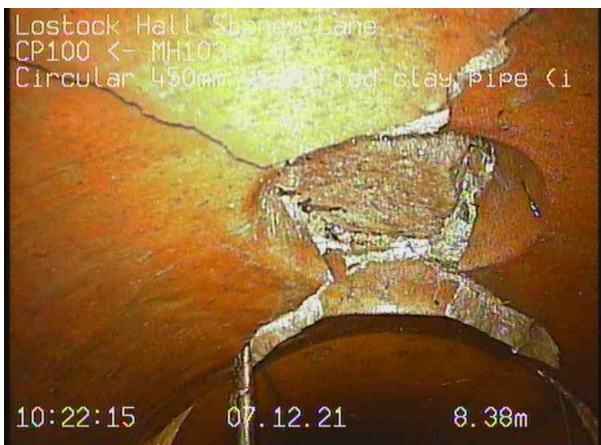
CP100X_c7afb641-09c1-4864-8684-5ba0da8ebdb5_20211207_092602_744.jpg, 00:02:17, 8.38 m
Connection defective, connecting pipe is damaged at 12 o'clock, diameter: 150mm, Blocked and no sign of gullies within this area.

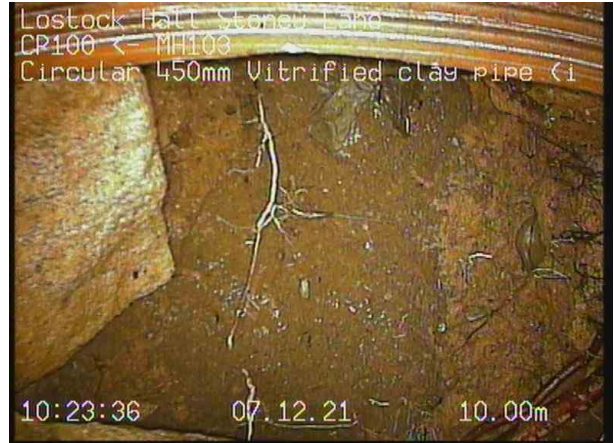
CP100X_0b6959cb-bf47-4b35-be67-4c037a8aafa6_20211207_092744_477.jpg, 00:03:38, 10.34 m
 Joint displaced, medium

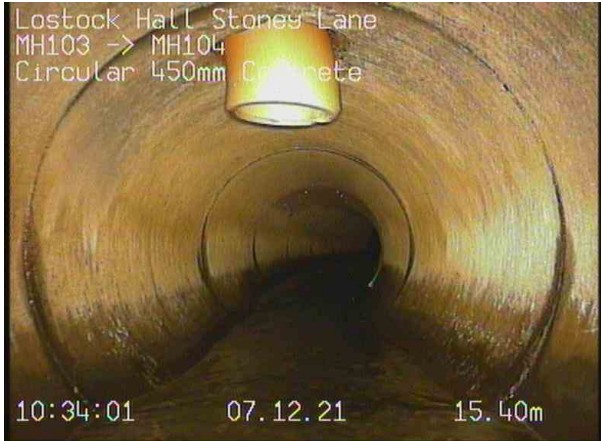
MH103X_14f17149-adf5-4275-b571-e659c8eb35b5_20211207_093749_231.jpg, 00:01:21, 15.40 m
Connection defective, connecting pipe is intruding at 12 o'clock, diameter: 150mm, intrusion: 10%, GY2

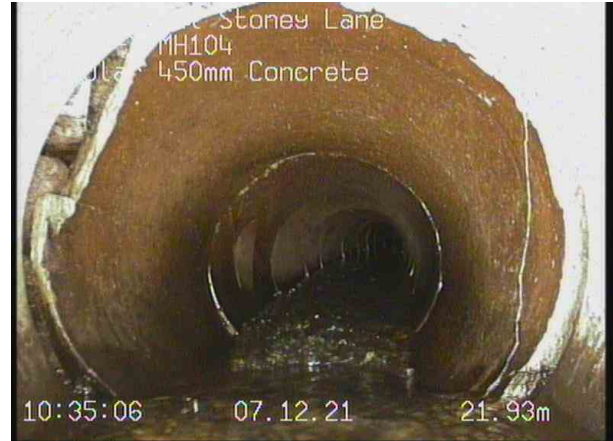
MH103X_3b172e0e-65d9-4f6a-8d7d-240340eeaa79_20211207_093854_396.jpg, 00:02:12, 21.93 m
Hole in drain or sewer at a joint from 9 o'clock to 11 o'clock

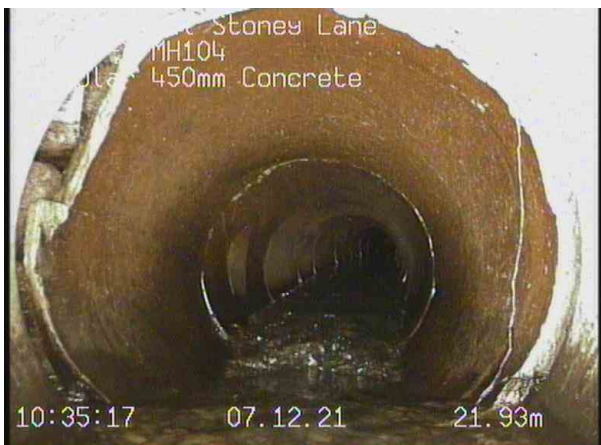
MH103X_13962f2c-f77b-473e-9097-880c88d8c147_20211207_093905_164.jpg, 00:02:15, 21.93 m
Crack, circumferential at joint from 2 o'clock to 5 o'clock

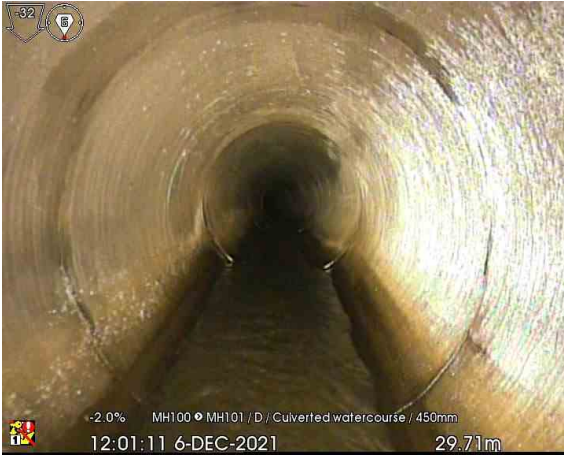
MH100X_29-71m_120111.jpg, 00:03:00, 29.71 m
 Crack, circumferential, at 12 o'clock

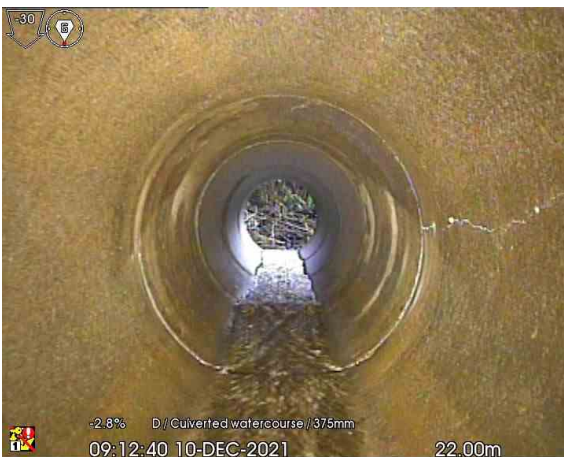
MH113X_22-00m_091240.jpg, 00:02:13, 22.00 m
 Crack, longitudinal at 3 o'clock

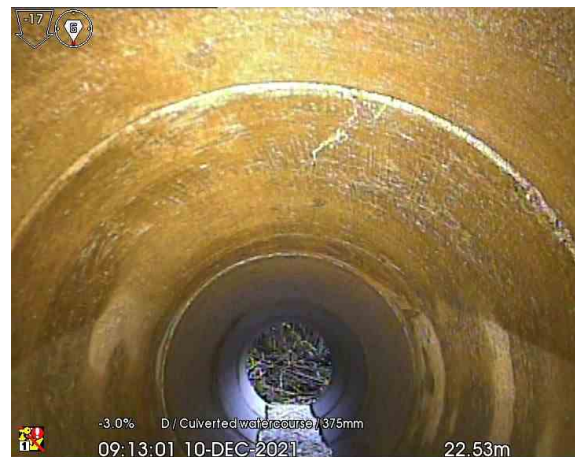
MH113X_22-53m_091301.jpg, 00:02:28, 22.53 m
 Crack, longitudinal at joint, at 12 o'clock

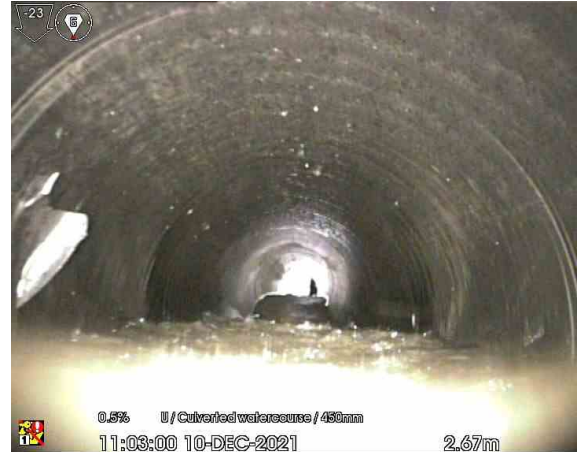
POND1X_2-67m_110300.jpg, 00:00:17, 2.67 m
 Surface damage, other from 9 o'clock to 10 o'clock, Surface damage, plastic has peeled.

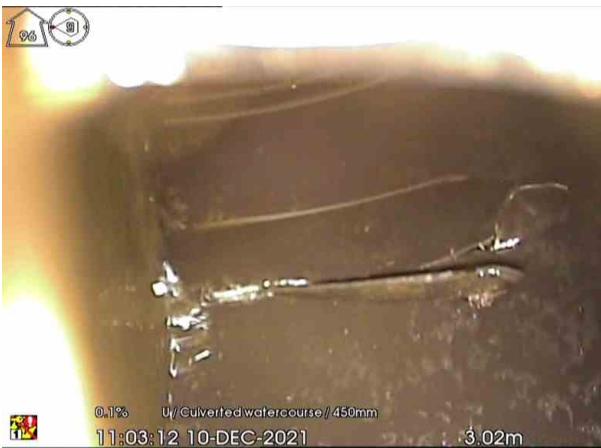
POND1X_95365508-cc5d-44a3-a42a-f720754d5abd_20220105_092539_965.jpg, 00:00:17, 2.67 m
 Surface damage, other from 9 o'clock to 10 o'clock, Surface damage, plastic has peeled.

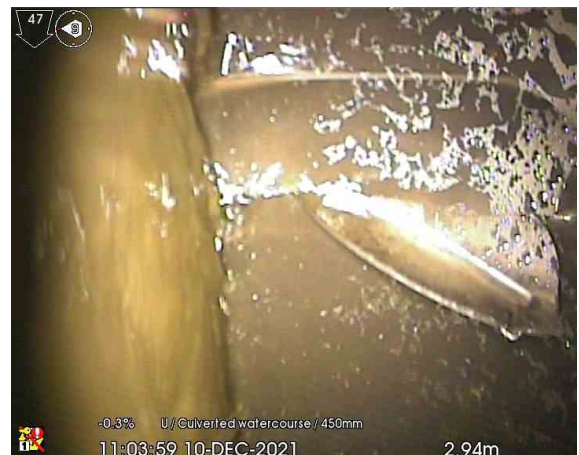
POND1X_2-94m_110359.jpg, 00:00:48, 2.94 m
 Infiltration, gushing, from 10 to 09 o'clock

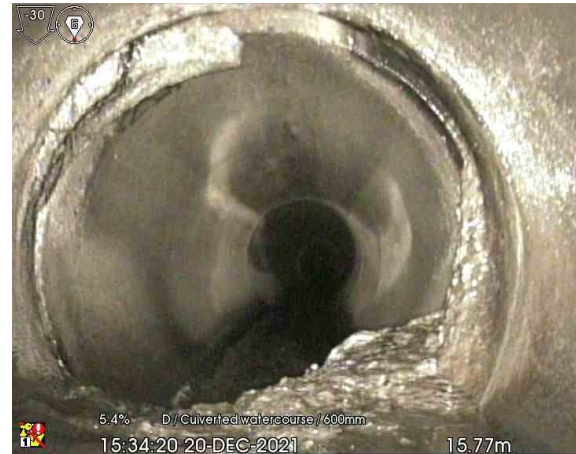
MH115X_15-77m_153420.jpg, 00:01:52, 15.77 m
 Fracture, circumferential at joint, from 09 to 12 o'clock

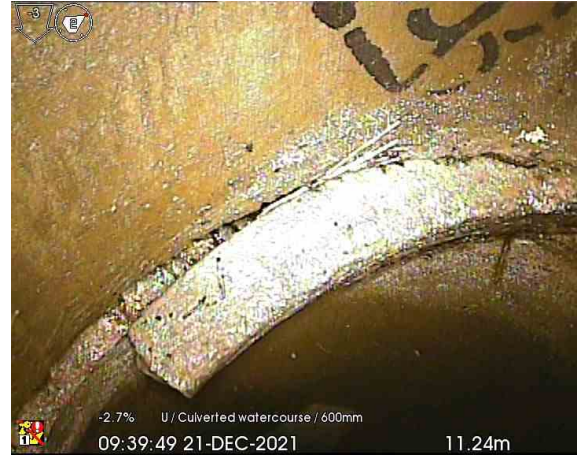
MH115X Overlap_11-24m_093949.jpg, 00:01:22, 9.75 m
 Fracture, circumferential at joint from 12 o'clock to 4 o'clock

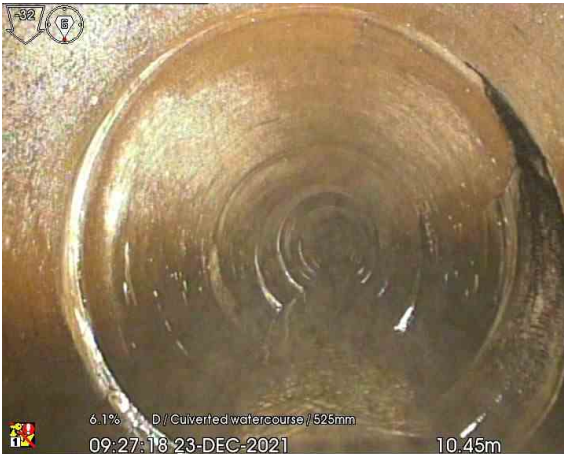
MH106X_10-45m_092718.jpg, 00:01:07, 10.45 m
 Crack, longitudinal at joint, at 03 o'clock

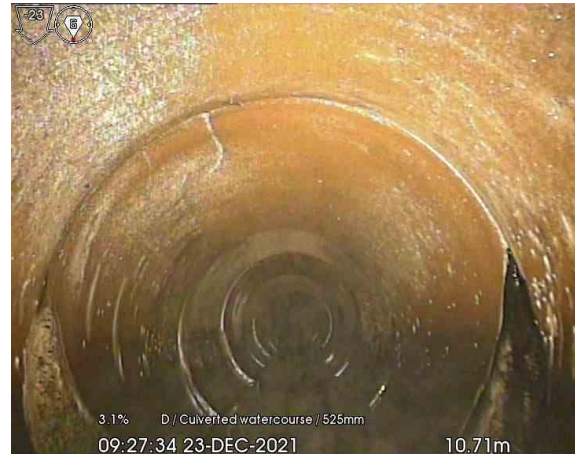
MH106X_10-71m_092734.jpg, 00:01:15, 10.71 m
 Crack, longitudinal at joint, at 11 o'clock

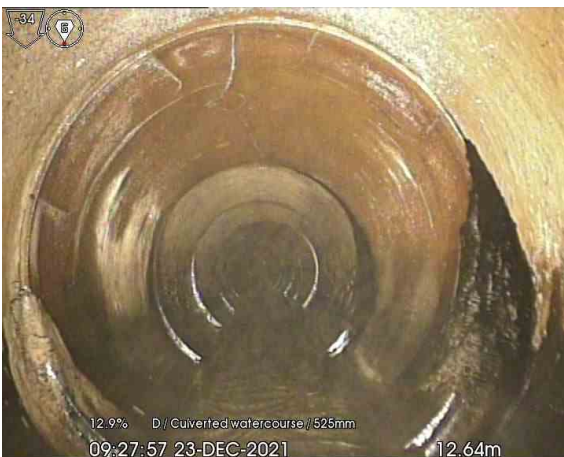
MH106X_12-64m_092757.jpg, 00:01:29, 12.64 m
 Cracks, multiple at joint, from 08 to 04 o'clock

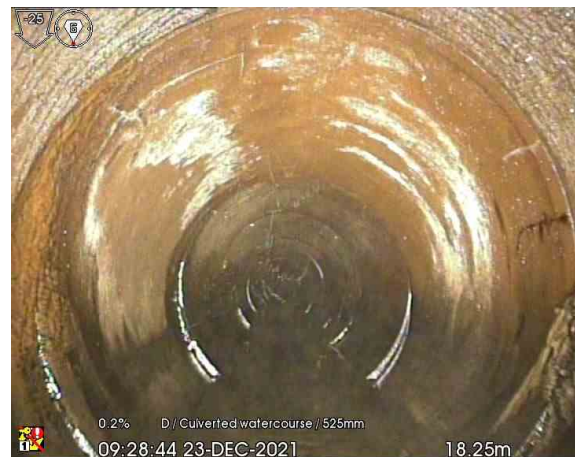
MH106X_18-25m_092844.jpg, 00:02:09, 18.25 m
 Crack, longitudinal at joint, at 03 o'clock

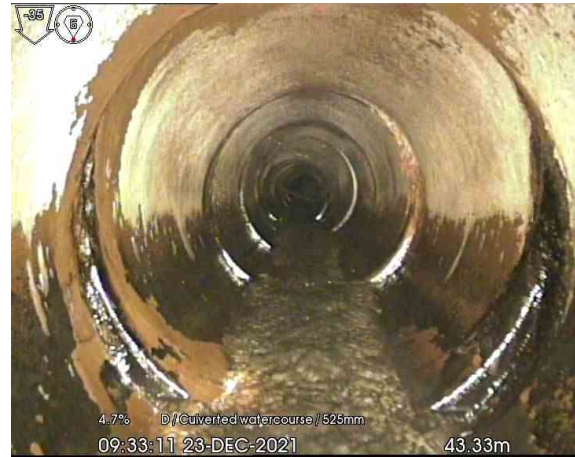
MH106X_43-33m_093311.jpg, 00:06:01, 43.33 m
 Infiltration, running at joint, from 11 to 05 o'clock

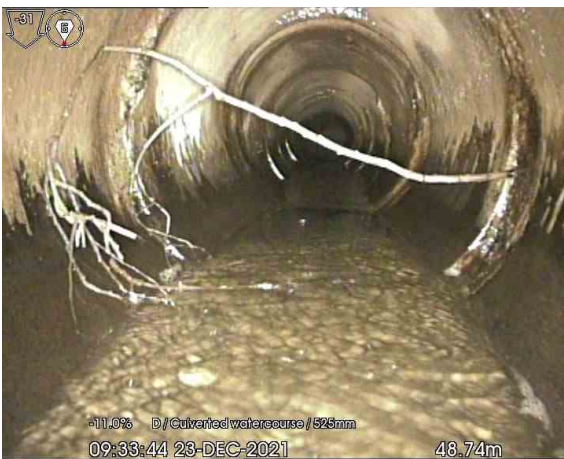
MH106X_48-74m_093344.jpg, 00:06:28, 48.74 m
 Roots, tap at joint

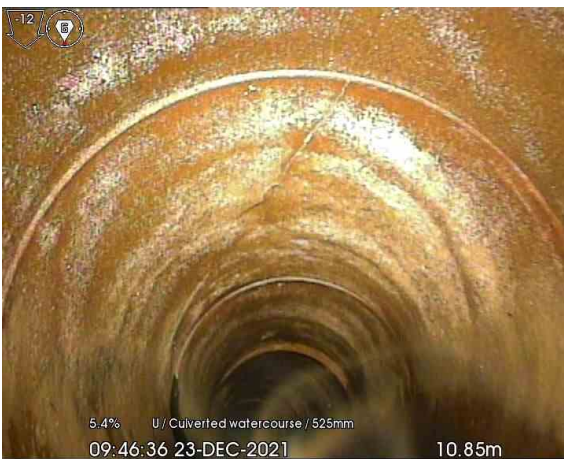
MH105X_10-85m_094636.jpg, 00:01:10, 10.85 m
 Crack, longitudinal at joint, at 12 o'clock

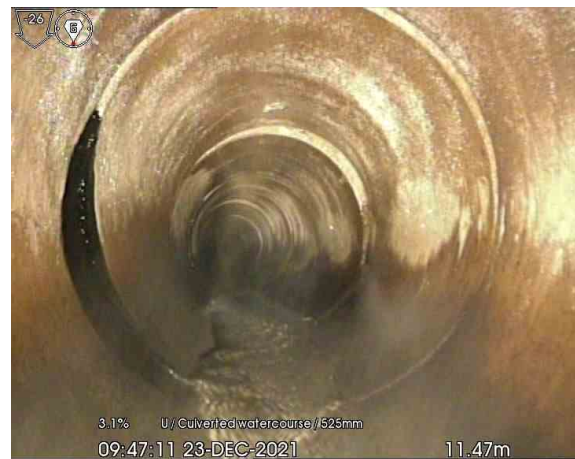
MH105X_11-47m_094711.jpg, 00:01:22, 11.47 m
 Infiltration, running at joint, from 11 to 04 o'clock

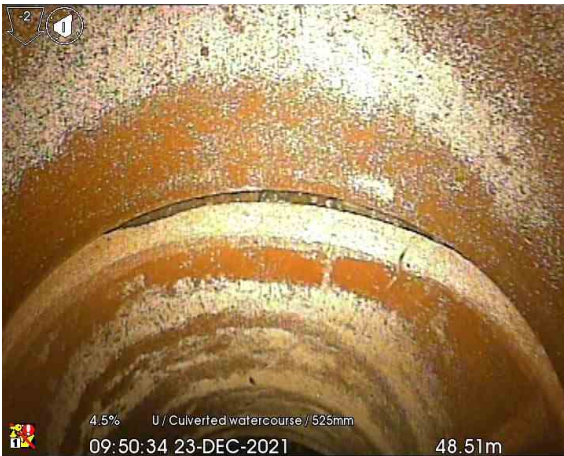
MH105X_48-51m_095034.jpg, 00:04:24, 48.51 m
 Soil visible beyond defect
