Project  
**LANCASHIRE CENTRAL, PRESTON**

Title  
**DRAINAGE SURVEY REQUIREMENTS**

Client  
**MAPLE GROVE DEVELOPMENTS**

WIE DR 92 0503-01 P02

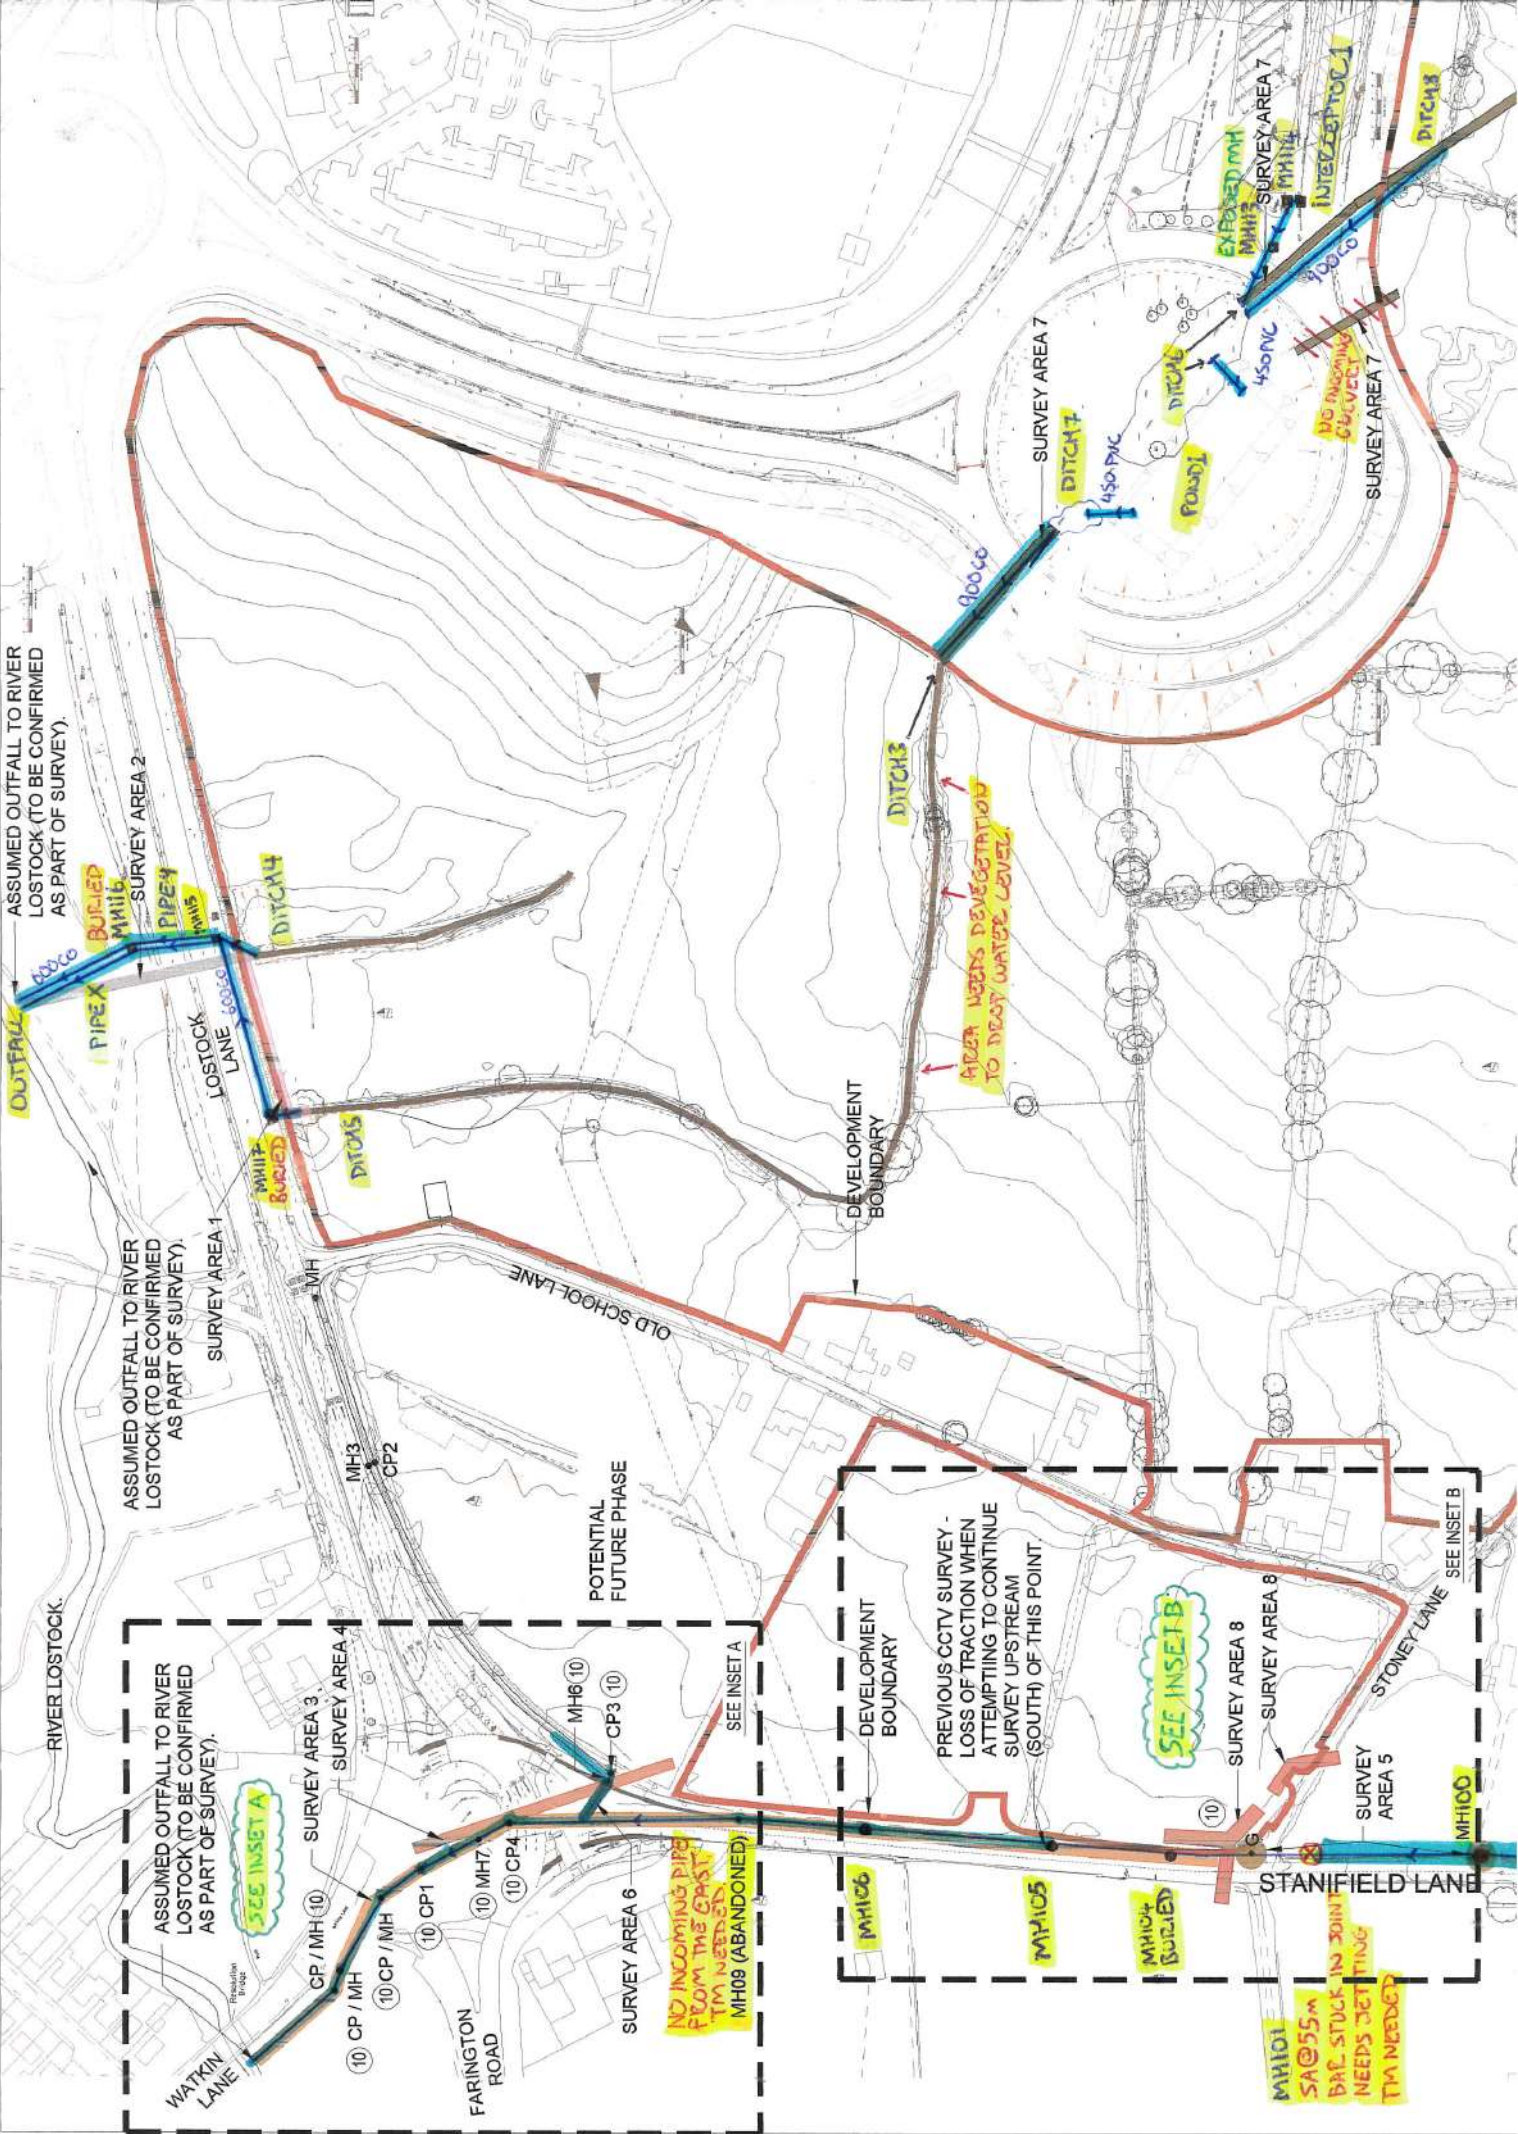
NO INCOMING PIPE  
FROM THE EAST  
TMA NEEDS  
MH08 (ABANDONED)

MH101  
SAG @ 55m  
BAR STUCK IN JOINT  
NEEDS DETTING  
TMA NEEDS

PREVIOUS CCTV SURVEY -  
LOSS OF TRACTION WHEN  
ATTEMPTING TO CONTINUE  
SURVEY UPSTREAM  
(SOUTH) OF THIS POINT

RIVER NEEDS DEVEGETATION  
TO DEEP WATER LEVEL

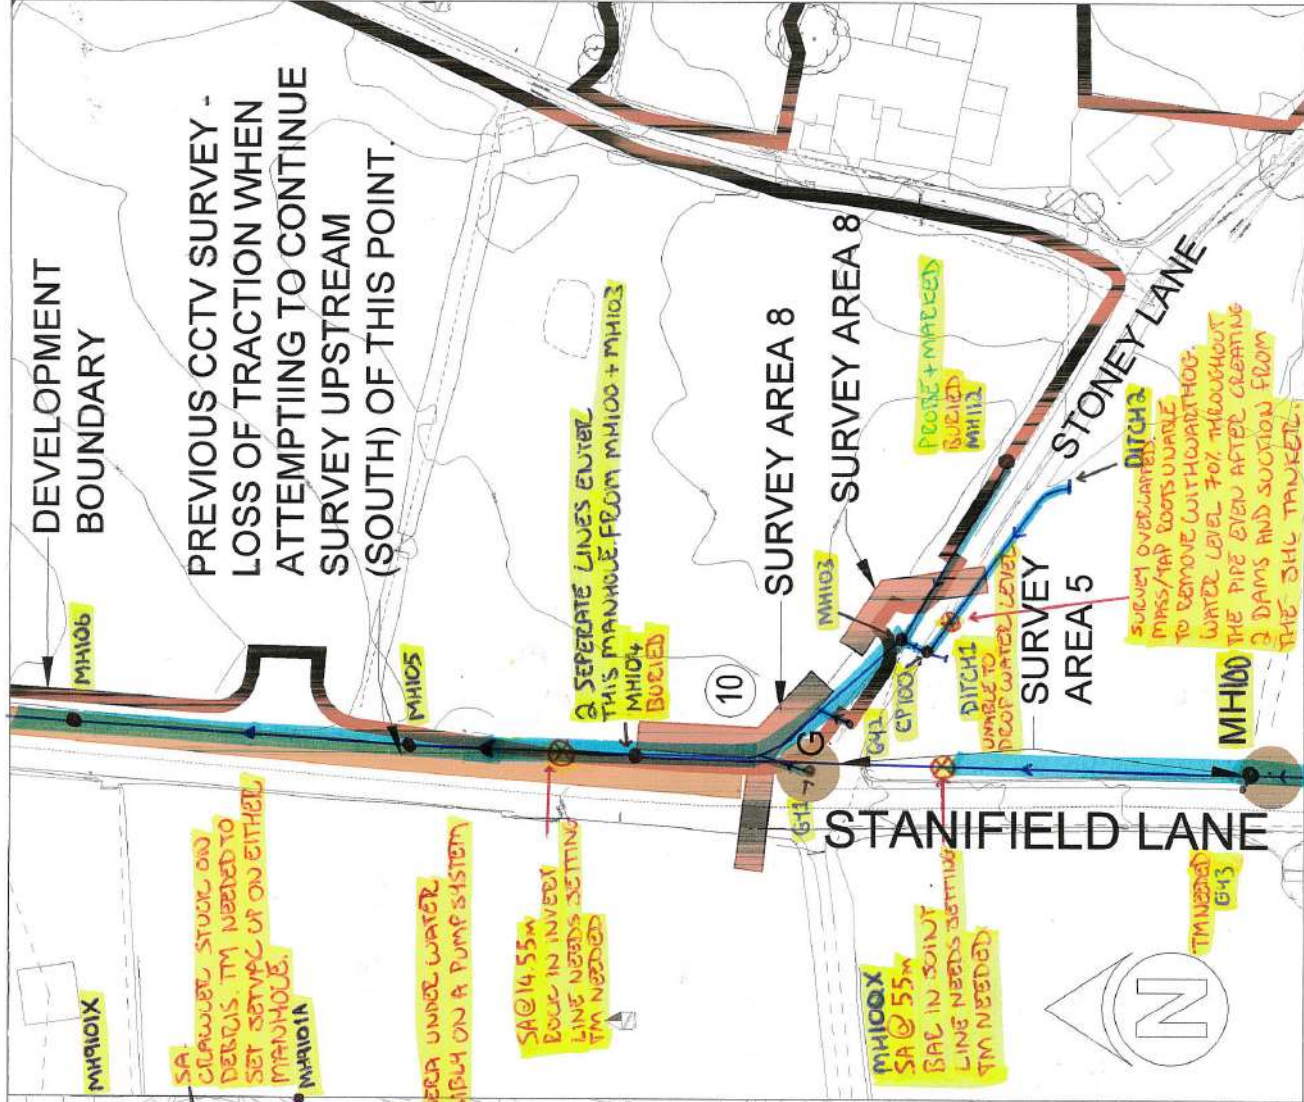
Survey Required  
 INSET B SCALE 1:1000@A1

SURVEY OF BOTH CULVERTS COMPLETE.

SURVEY COMPLETE. DISCHARGES INTO MH115.

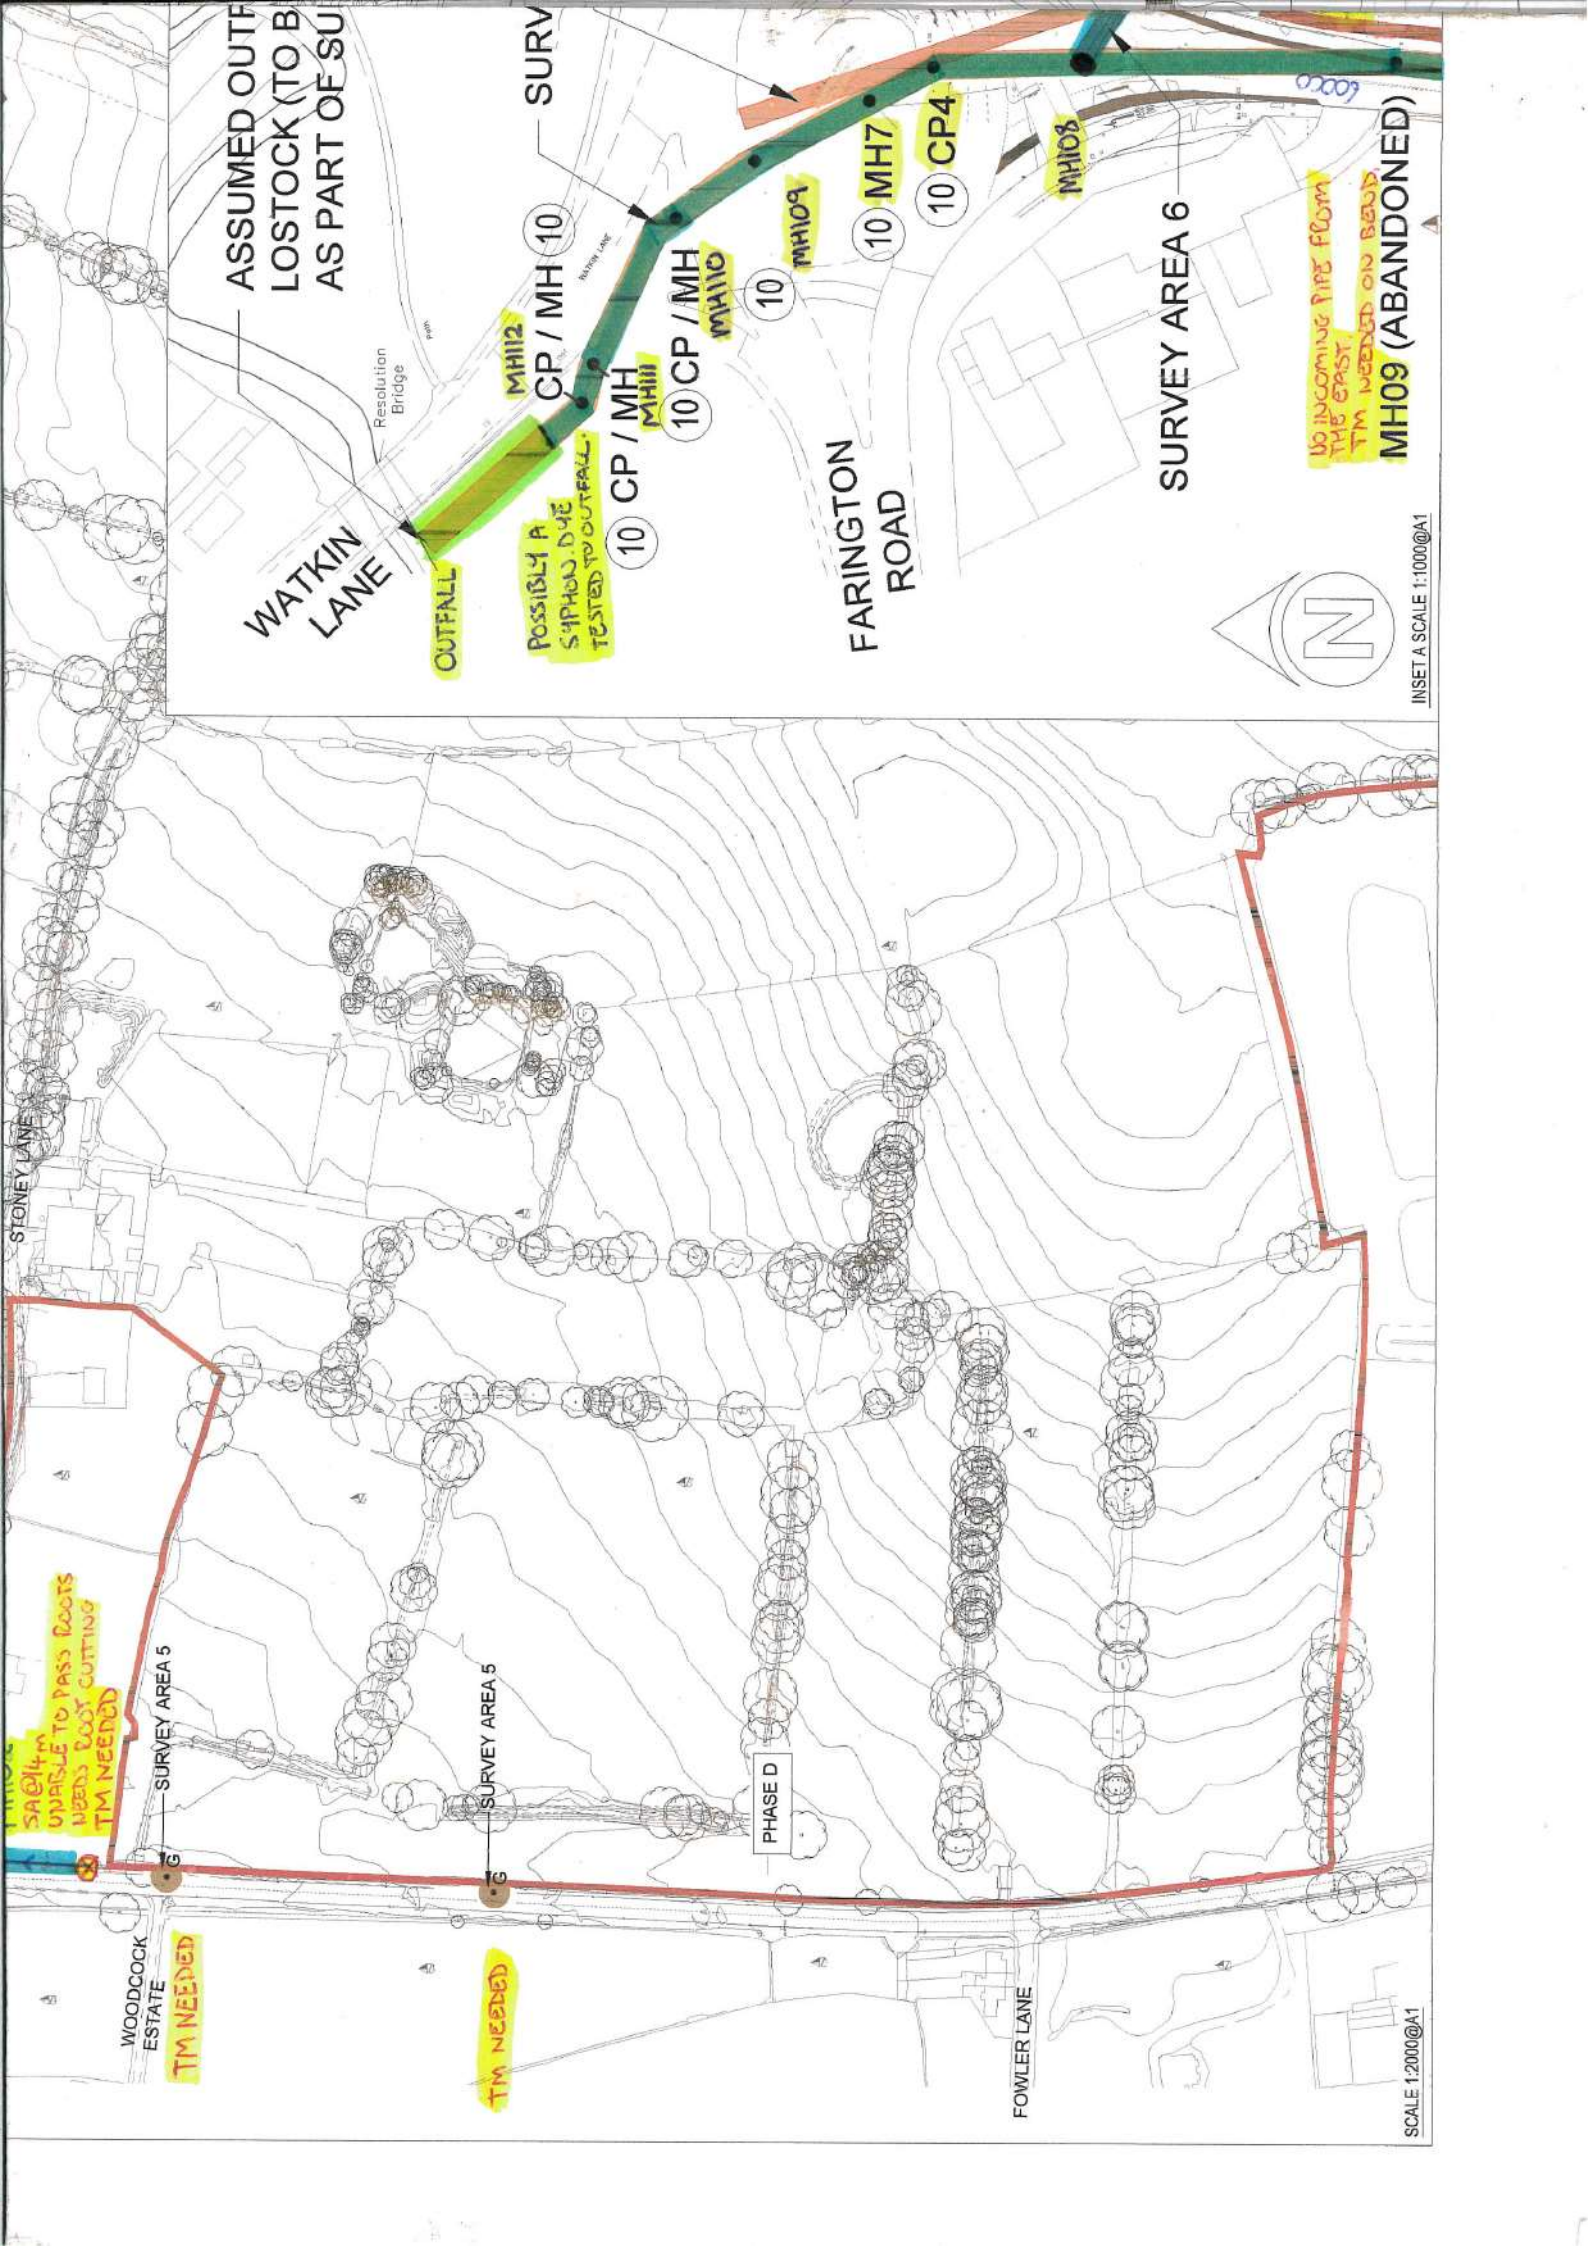
INSET A SCALE 1:1000@A1

POSSIBLY A  
 SYPHON DUE  
 TO OUT-FALL

NO INCOMING PIPE FLOW  
 THIS EAST  
 TM NEEDED ON BEHVS  
 MH09 (ABANDONED)

SA @ 14m  
 UNABLE TO PASS ROOTS  
 NEEDS ROOT CUTTING  
 TM NEEDED

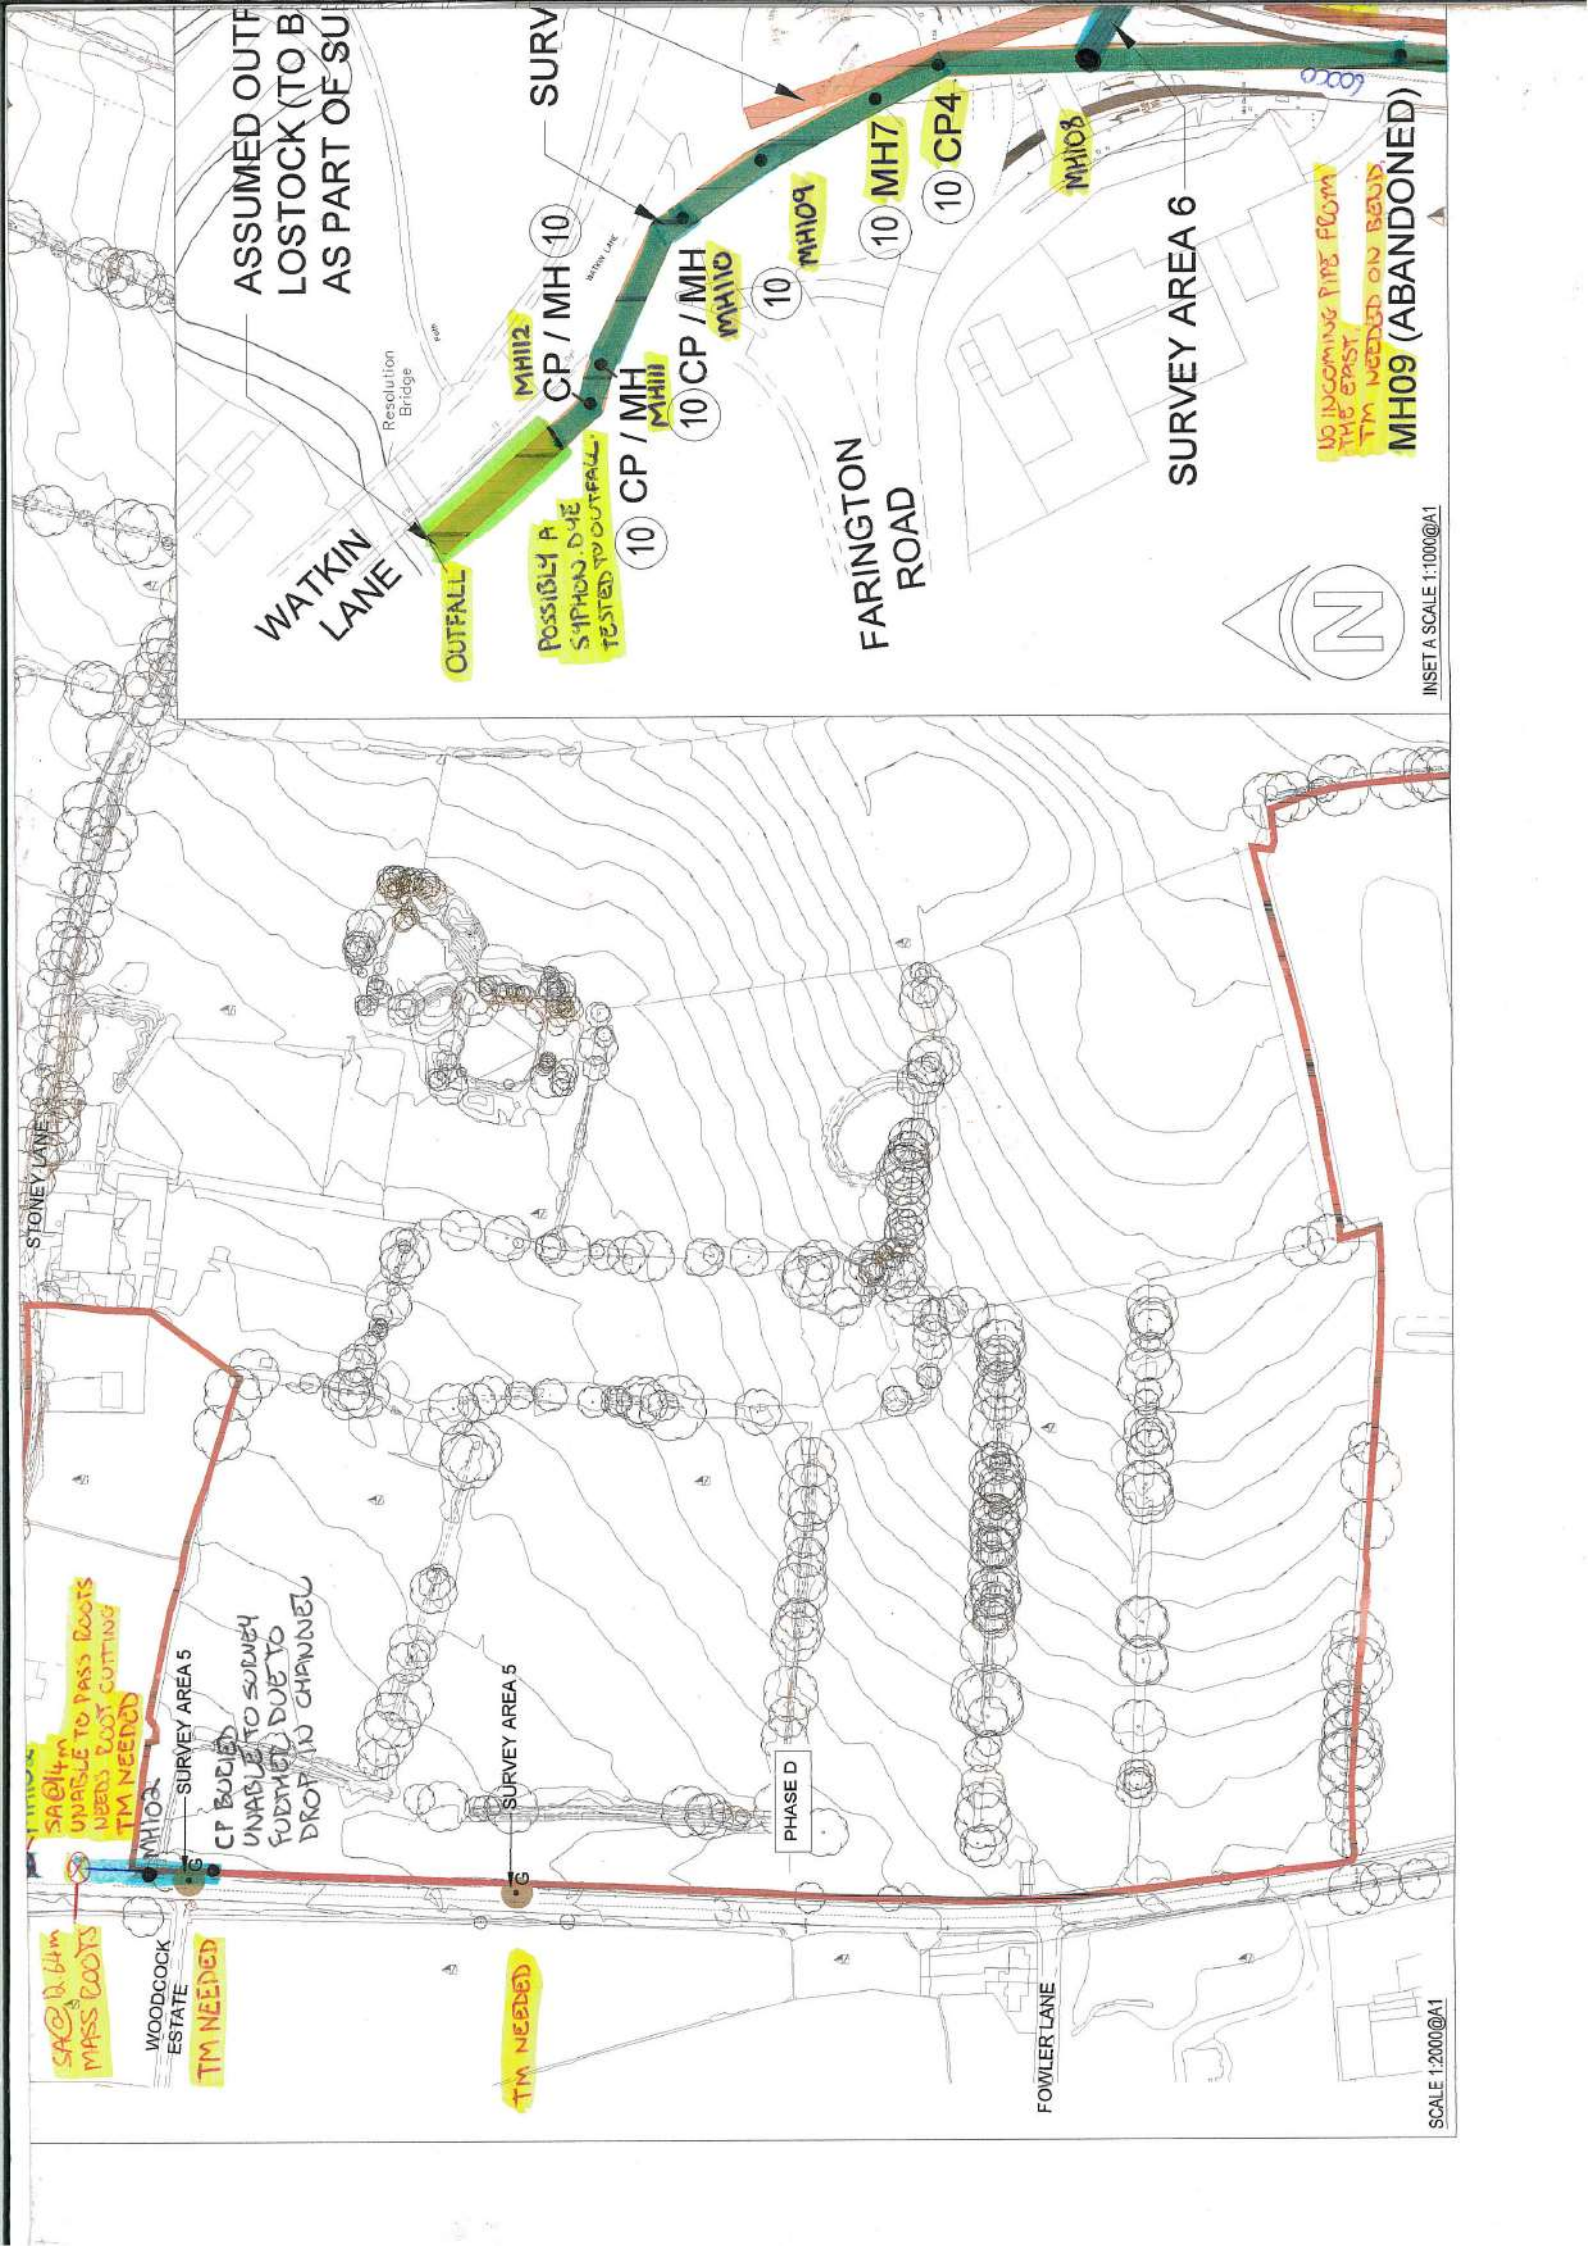
INSET A SCALE 1:1000@A1

POSSIBLY A  
 SIPHON. DUE  
 TESTED TO OUTFALL

NO INCOMING PIPE FROM  
 THE EAST.  
 TM NEEDED ON BEH  
 MH09 (ABANDONED)

CP BODIES  
 UNABLE TO SURVEY  
 FURTHER DUE TO  
 DROP IN CHANNEL

SAC 12.4m  
 UNABLE TO PASS ROOTS  
 NEEDS ROOT CUTTING  
 TM NEEDED
