Drainage Ditch Survey

Land Drainage Survey

Woodcock Estate

Doc No: LCCC-BDP-RPT-C-001

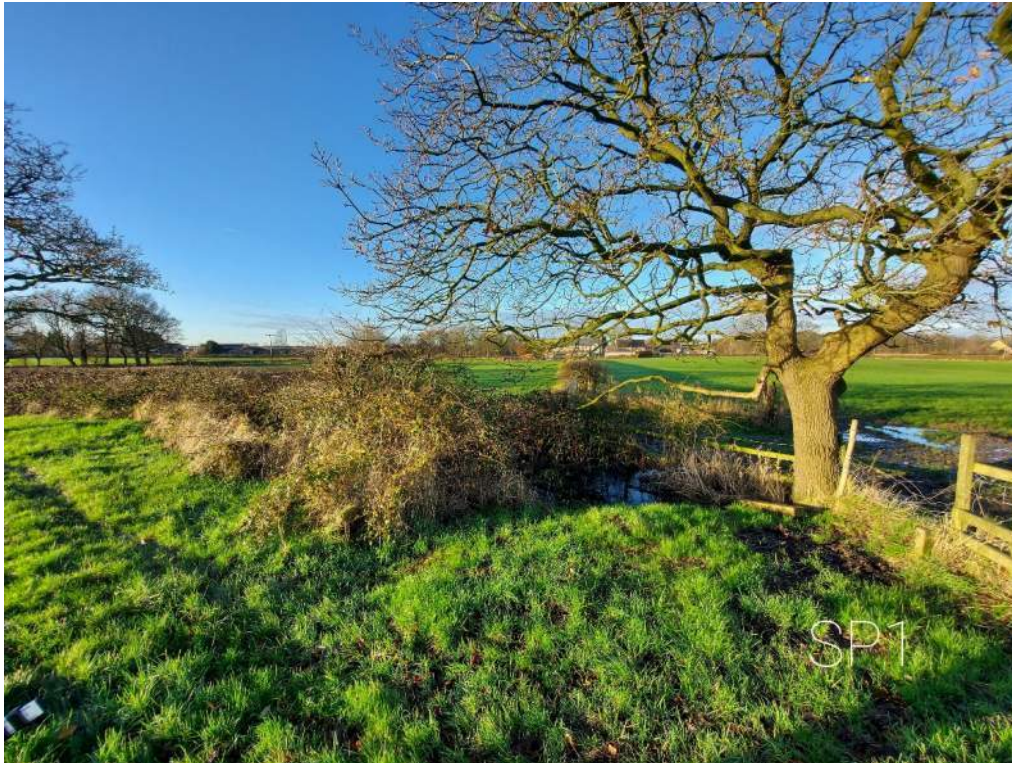
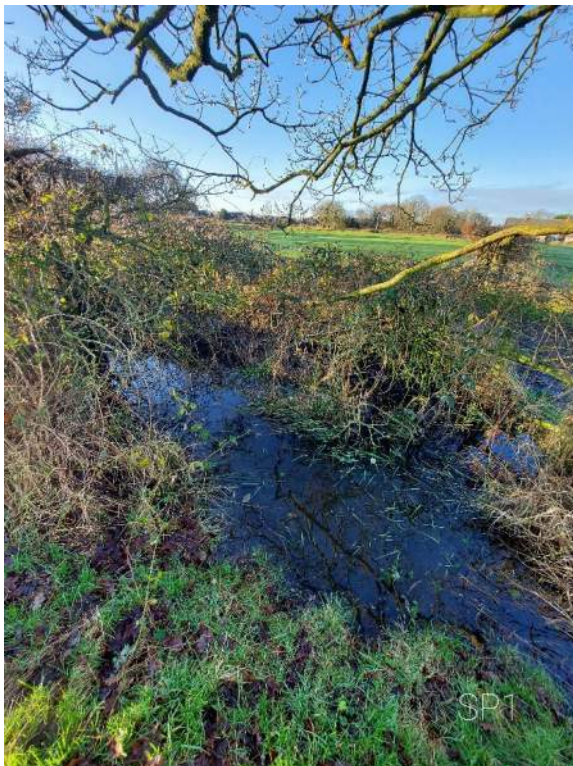
SURVEY POINT 1

Ponded water present – No flow.

WL = 0.25m

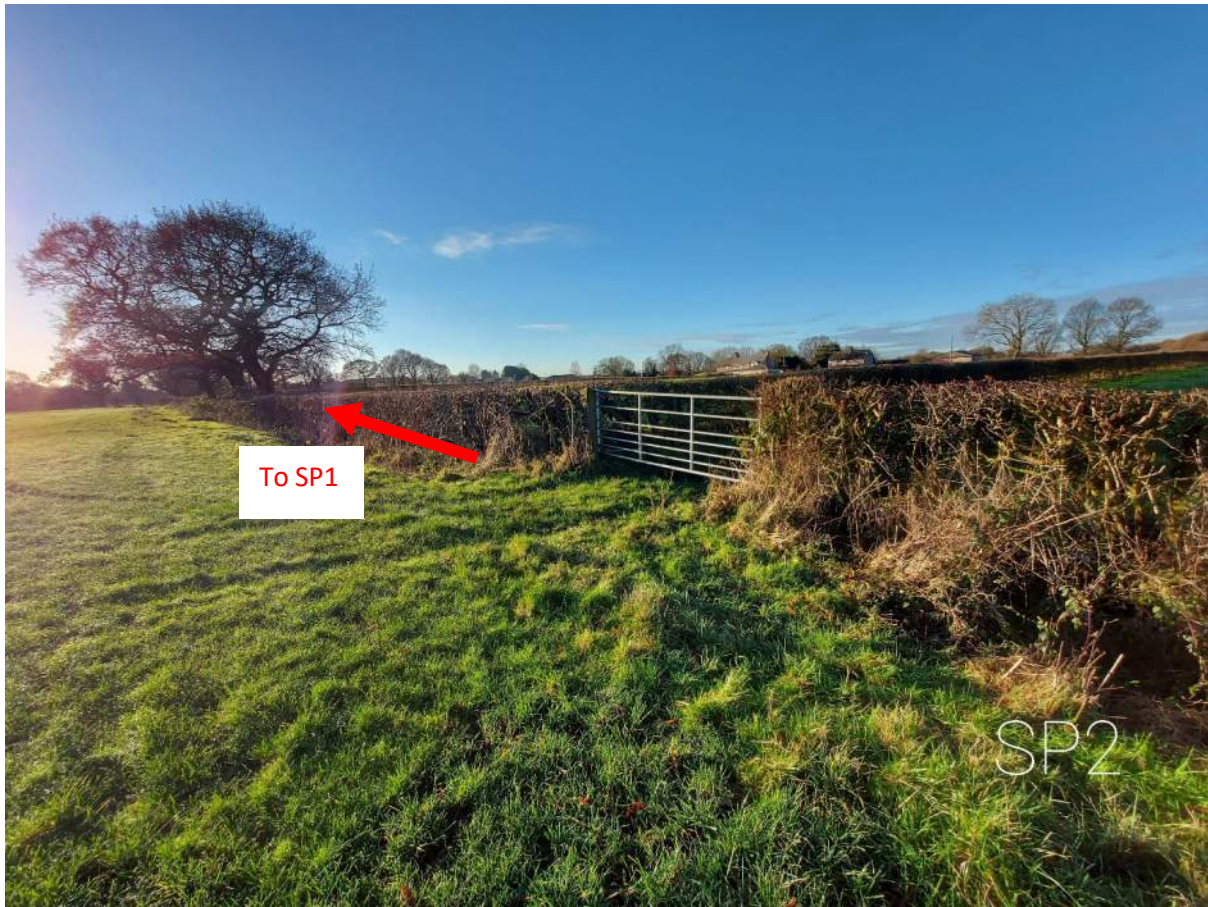
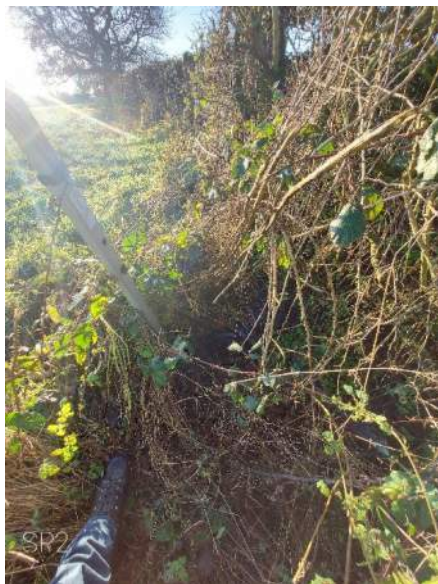
SURVEY POINT 2

No water present. Collapsed culvert under gate.

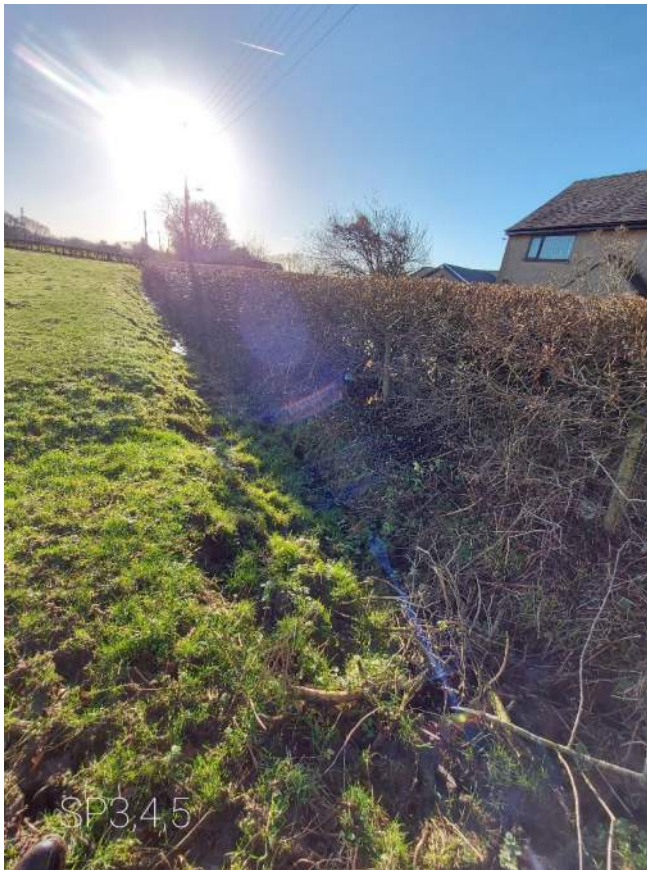
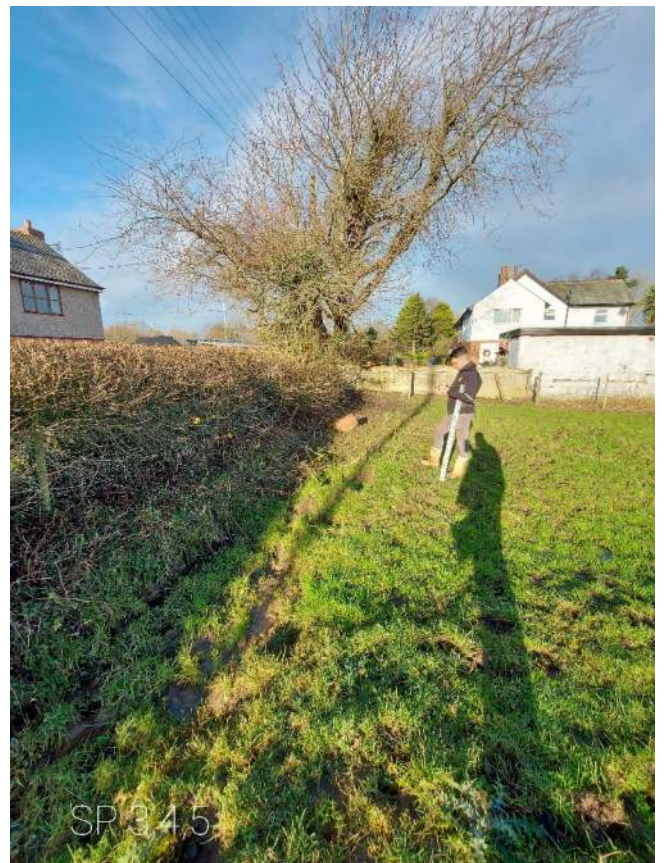
SURVEY POINT 3

The area of field to the rear of White Farm house is saturated. It appears to drain towards the ditch adjacent to the hedgerow and filter away. No flow present.

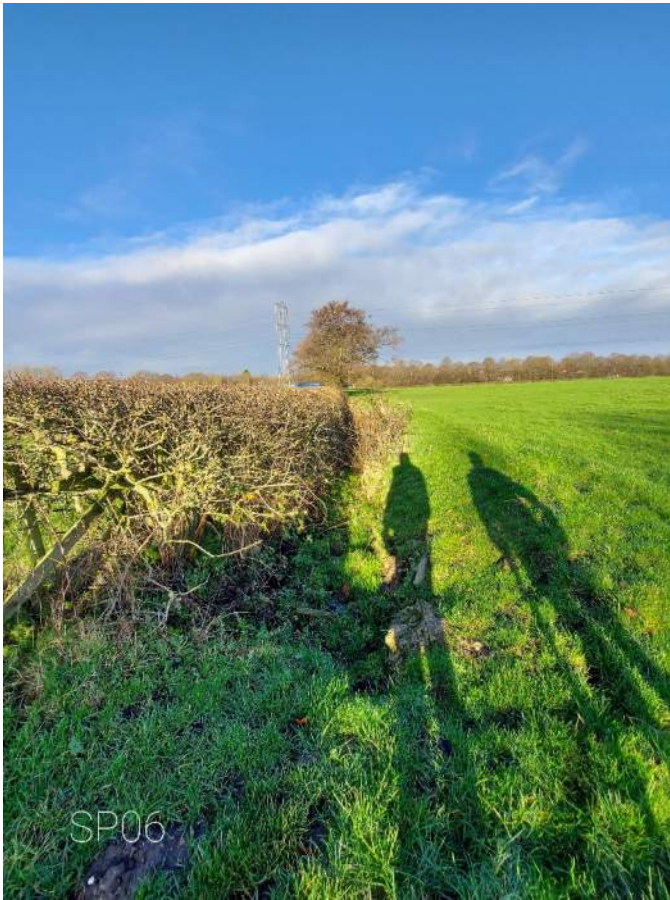
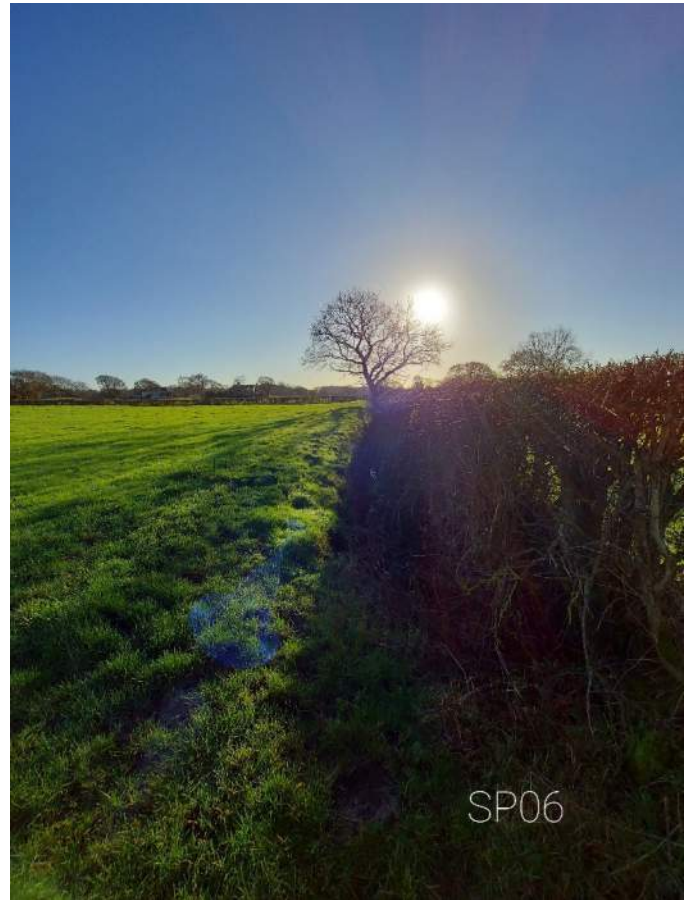
SURVEY POINT 6

Small amount of flow present (assumed from SP13).

D – 0.8m

WL – 0.050m

DW- 1m

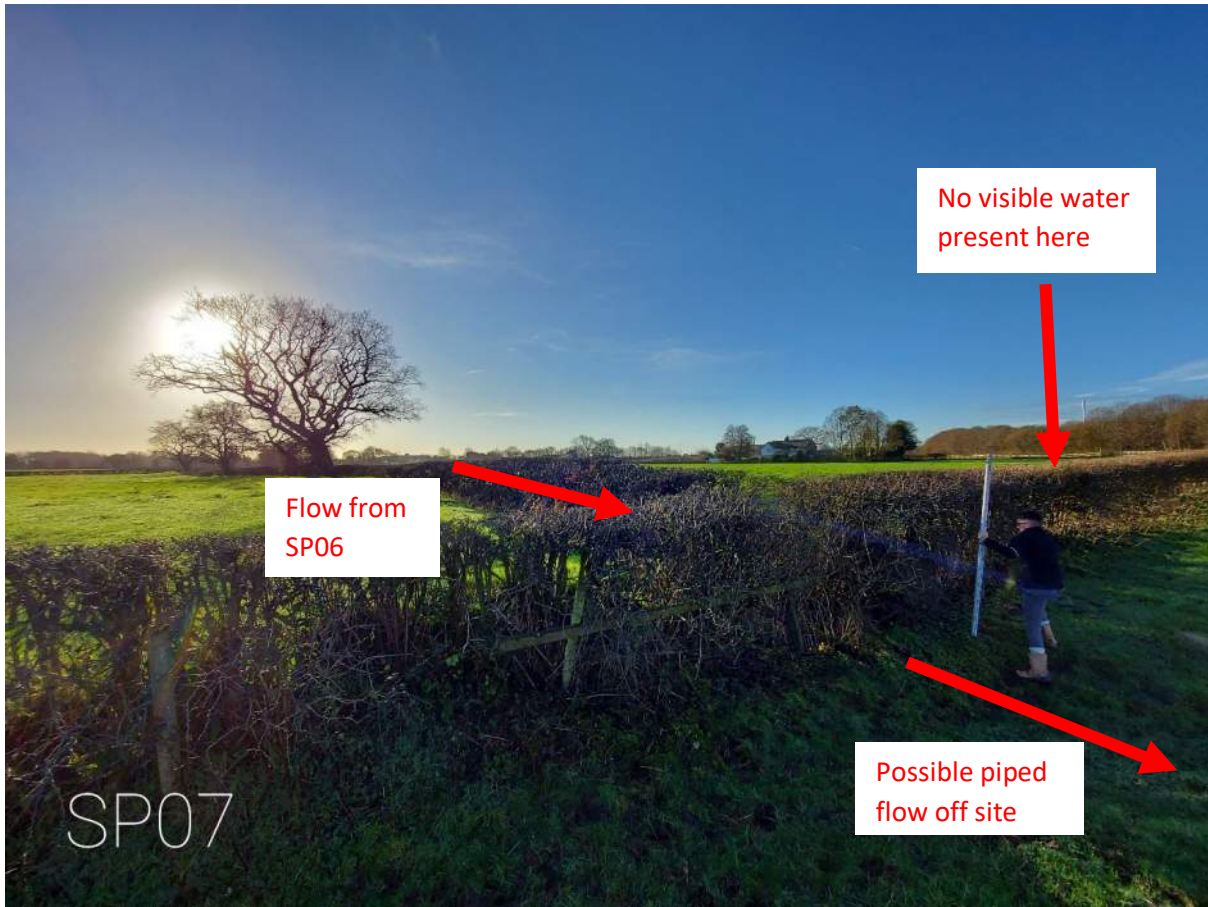
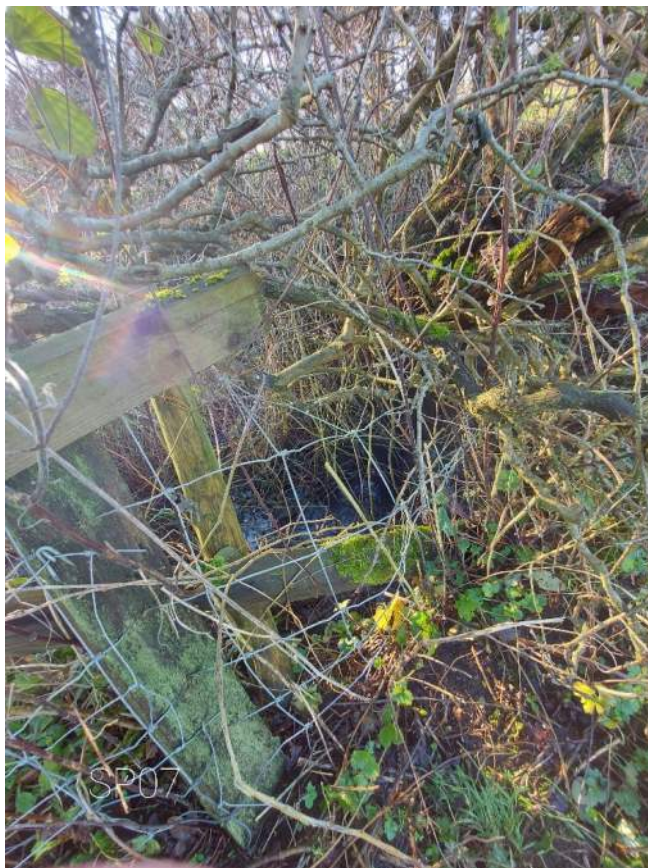
SURVEY POINT 7

Flow present into SP 07. Ponded water visible however no visible outflow could be observed. The logical assumption would be that the flow continued towards SP08 however the area of land between the two survey points was dry. It is possible an underground pipe is present which outflows off site towards Farrington Road and possibly the River Lostock.

D – 1m

DW – 0.8m

WL – 0.1

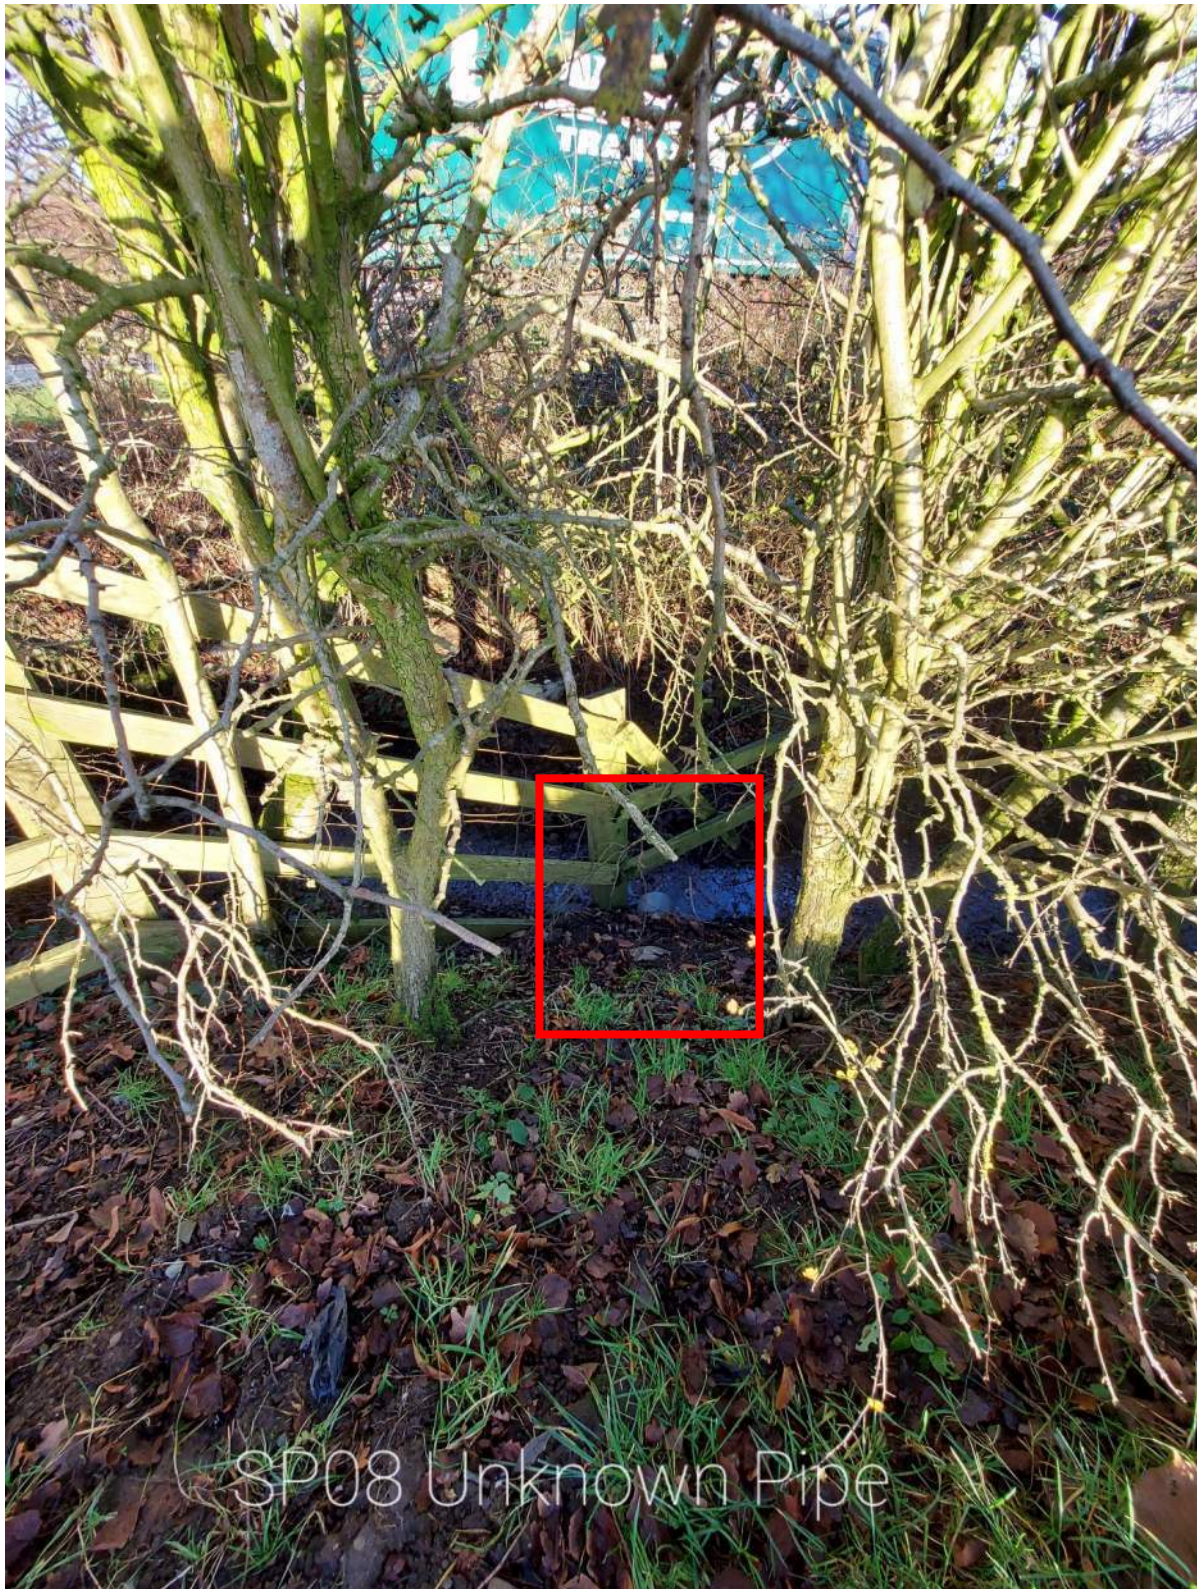
SURVEY POINT 8

Unknown pipe found out falling into SP 08 ditch. The pipe carried constant flow with the head of the pipe unfound. Assumed to be land drainage. Exposed vertical open pipe found in the field upstream of discovered pipe (See vent pipe 02 image and General arrangement for location).

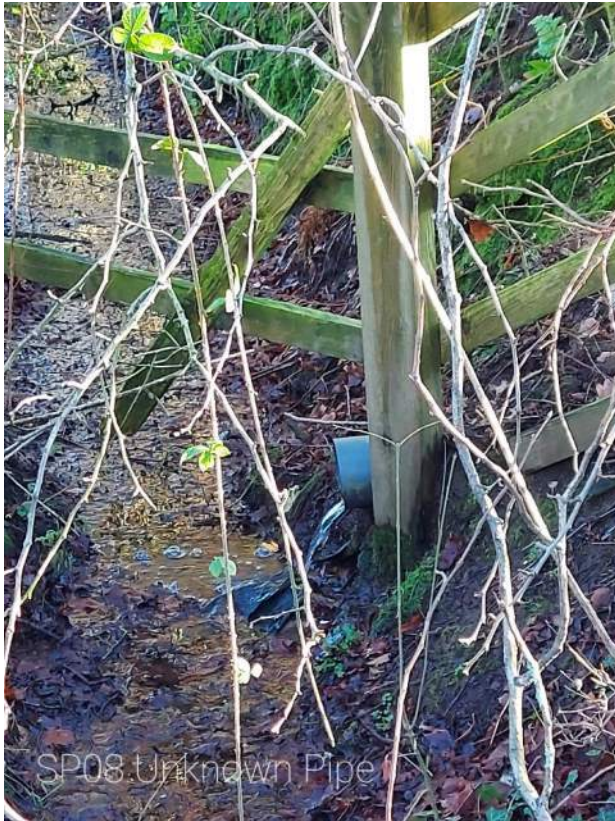
Continuous flow visible of unknown pipe.

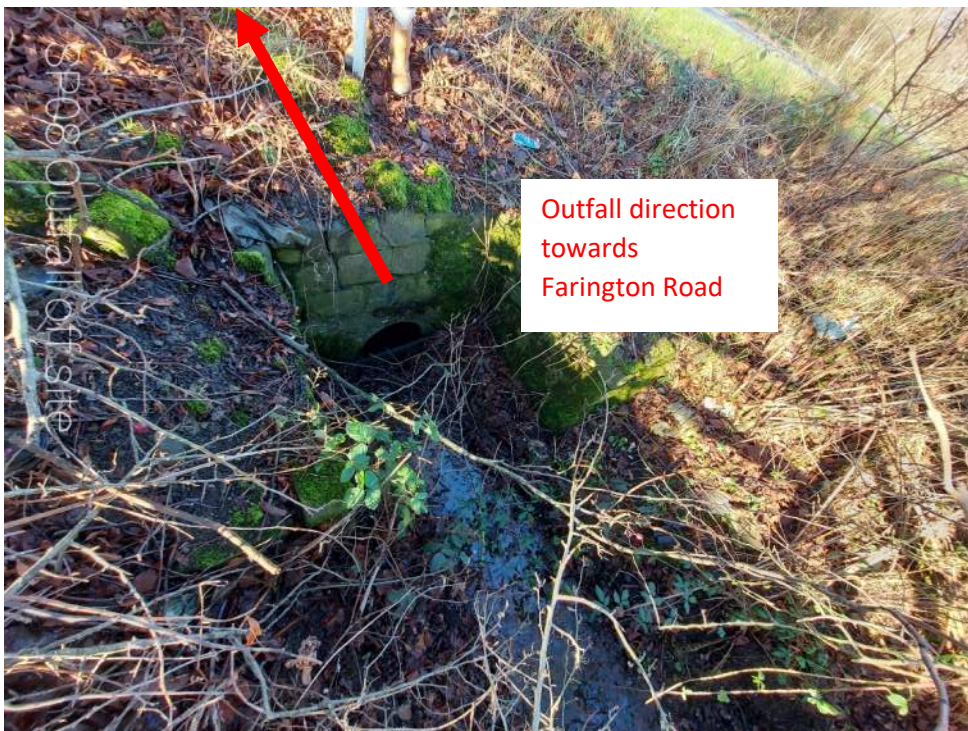
Outfall location off site. Minimal flow within ditch was present however was indicated to be flowing off site.

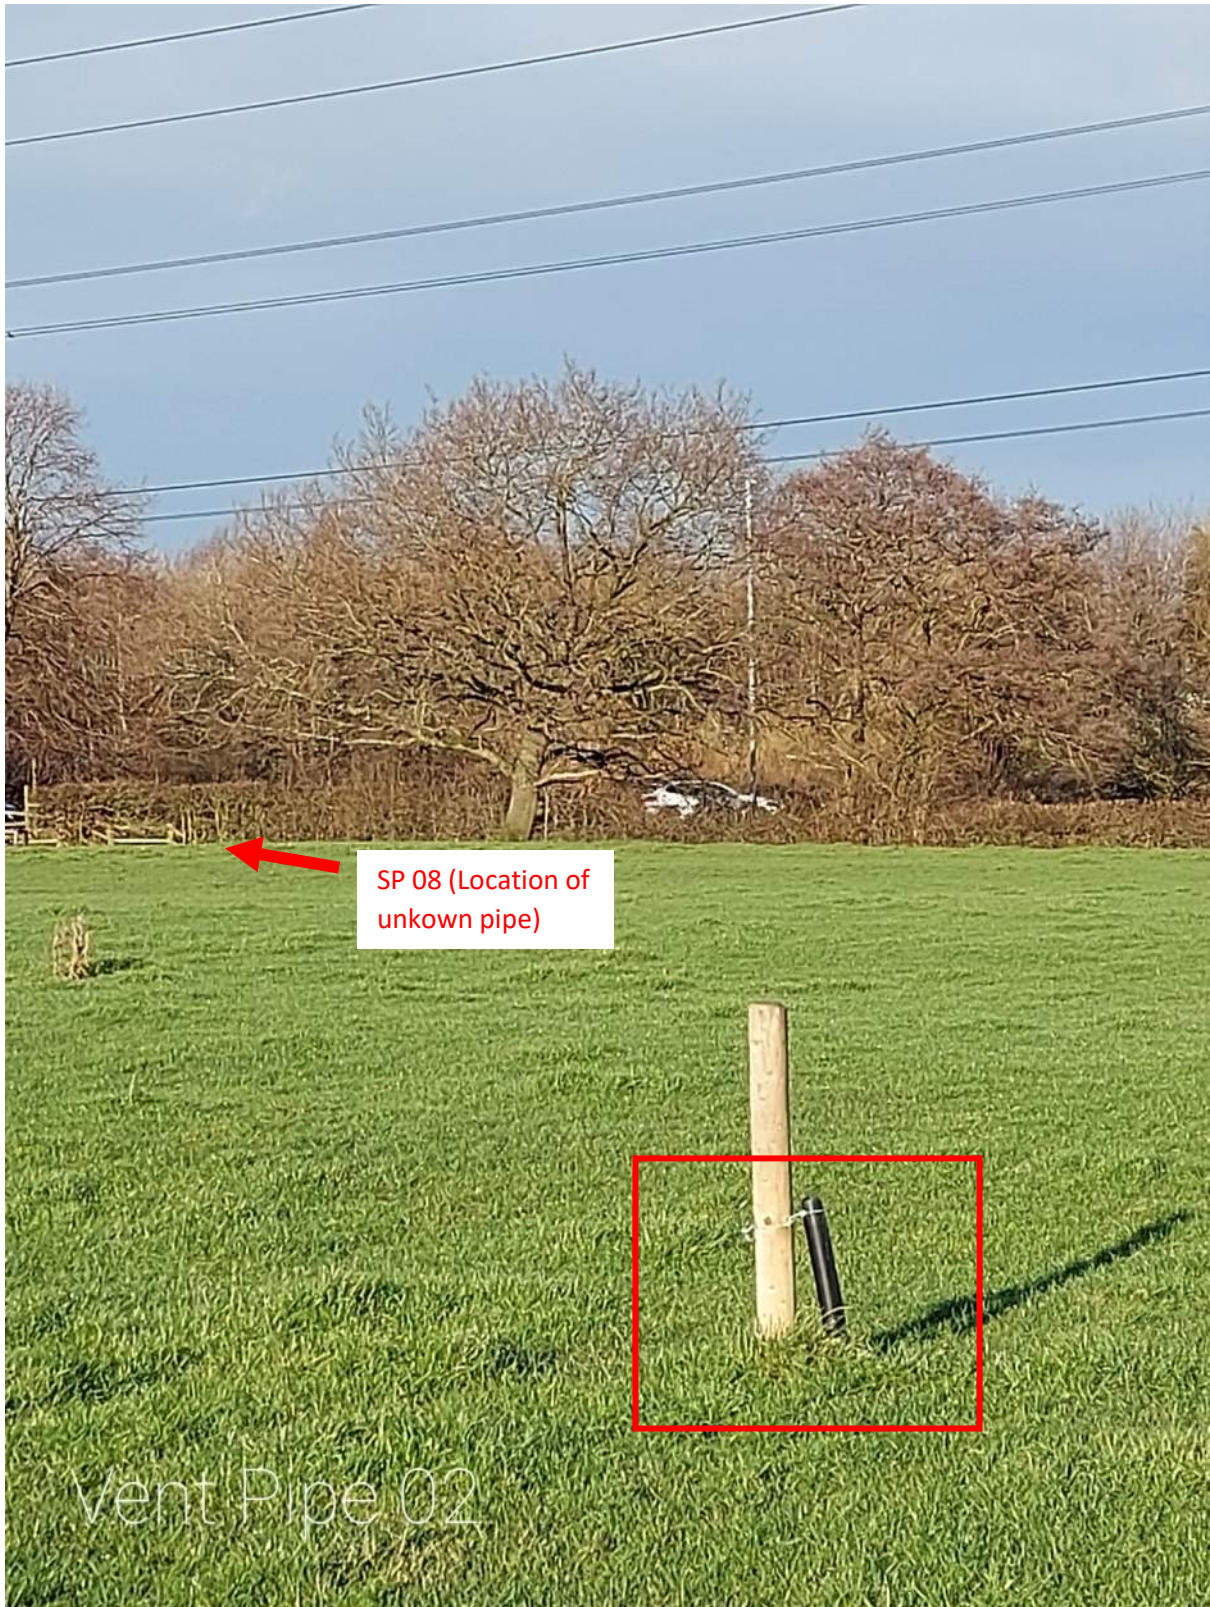
Vent Pipe 02

Open vertical pipe present within field.

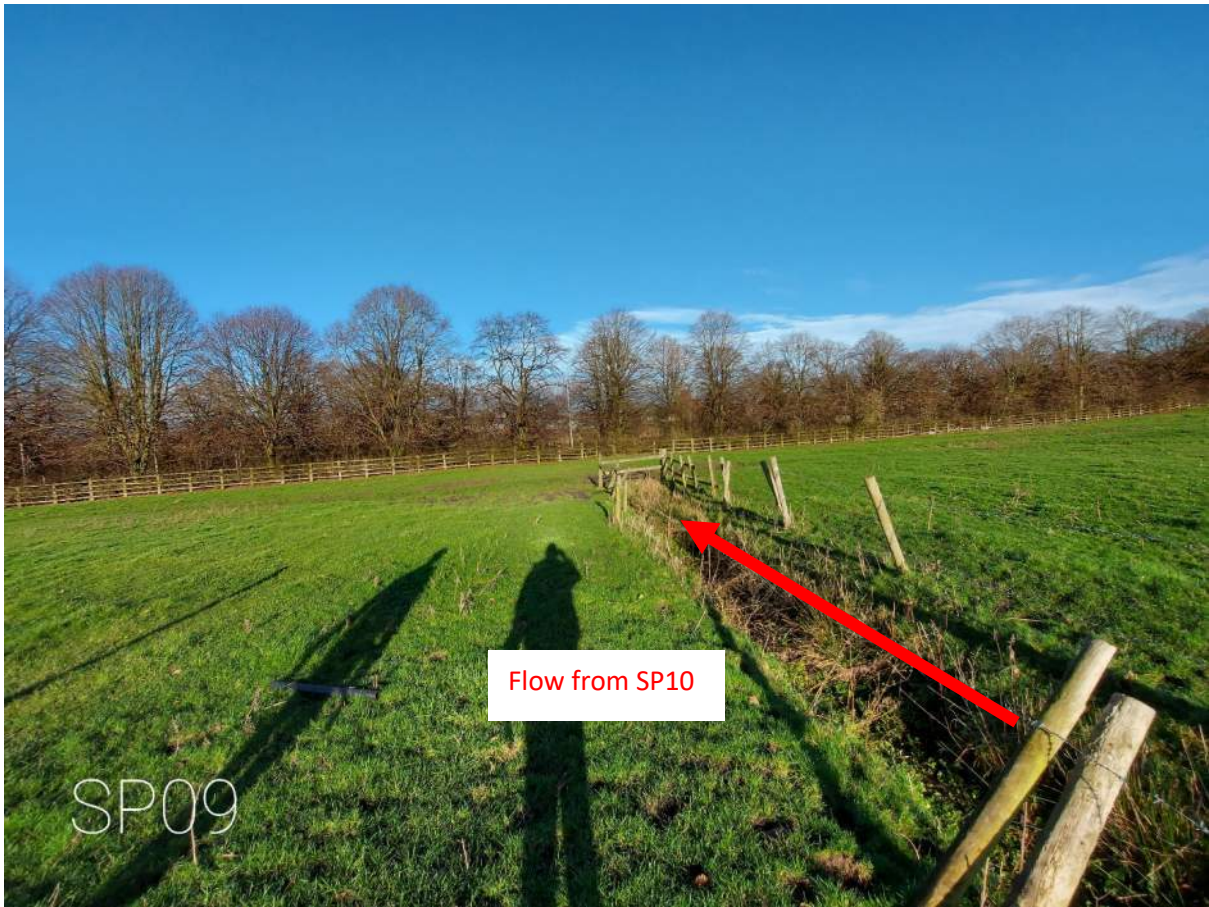
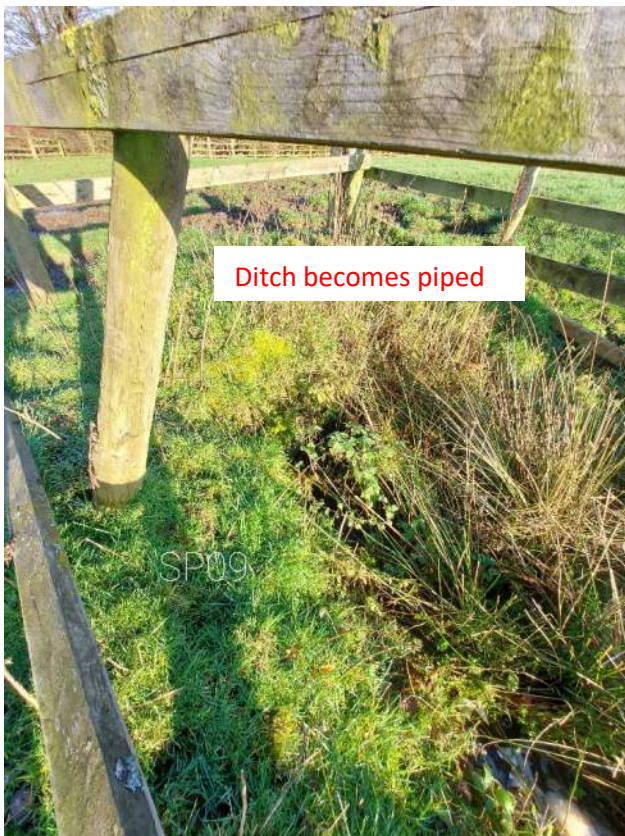
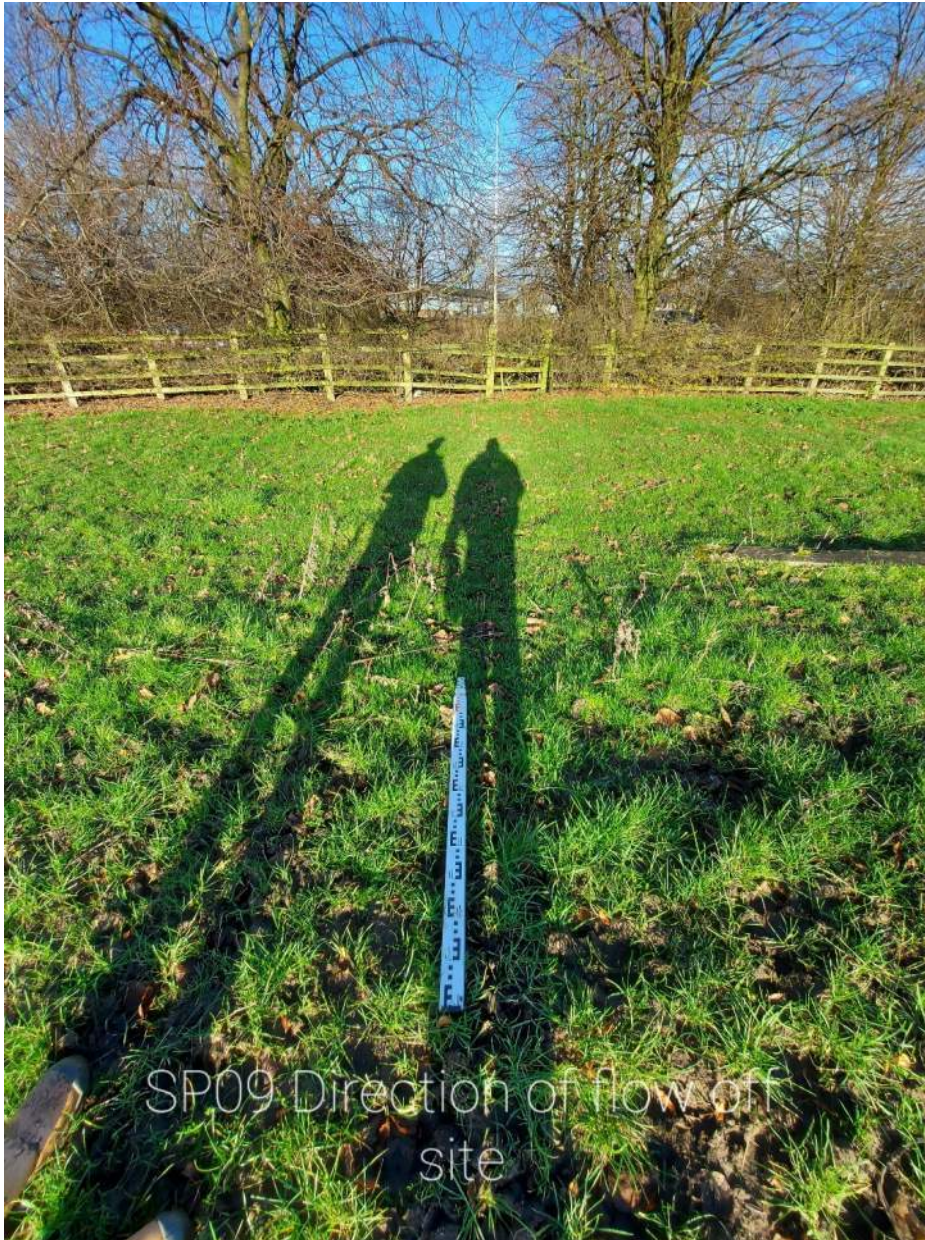
SURVEY POINT 09

Assumed direction of piped outfall towards the River Lostock

D – 1m

WL – 0.15,

DW – 1.5m

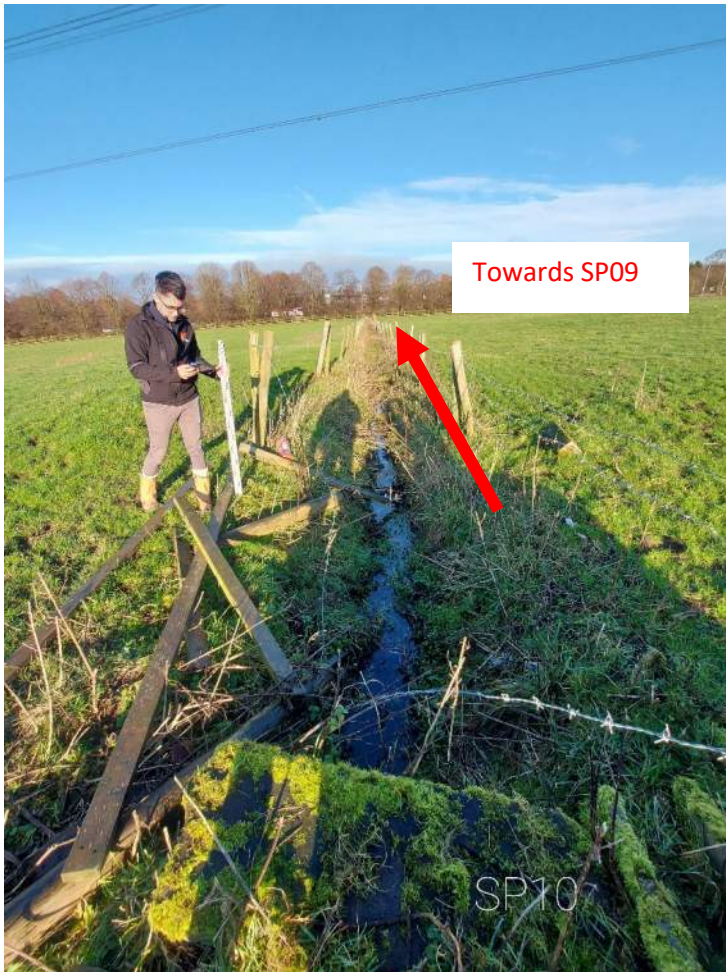
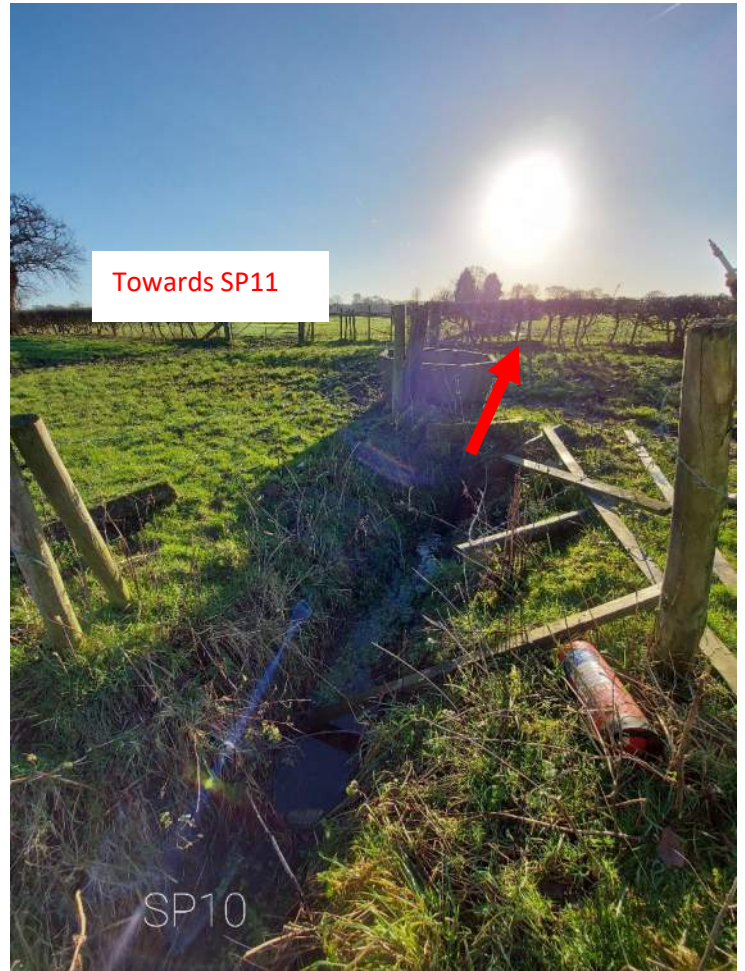
SURVEY POINT 10

Flow present through SP10.

D – 1.2m

WL – 0.2m

DW – 2m

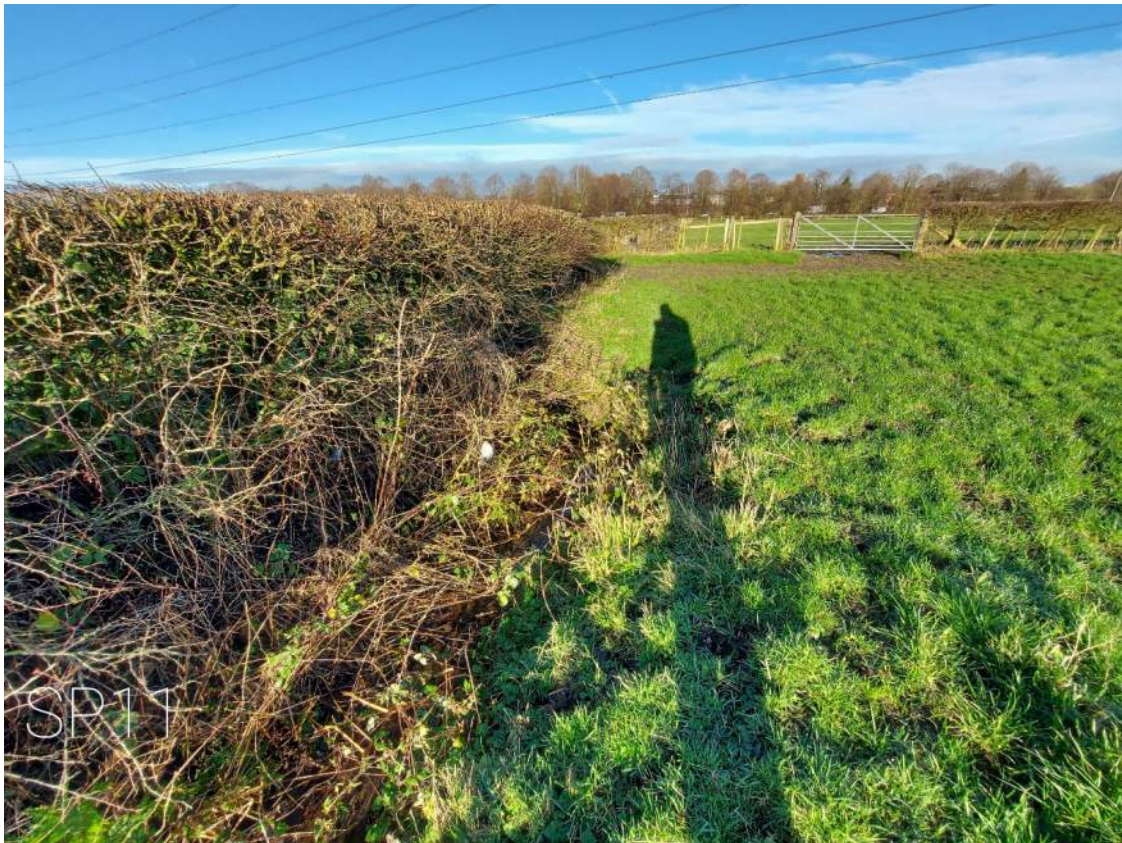
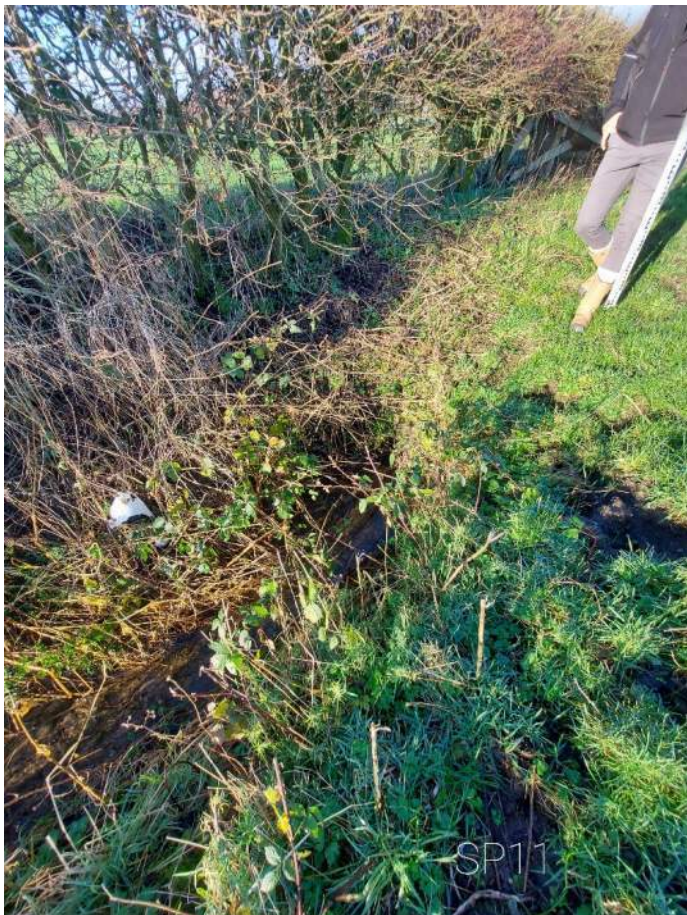
SURVEY POINT 11

Flow present through SP11

D – 1.5m

WL – 0.1m

DW – 3m

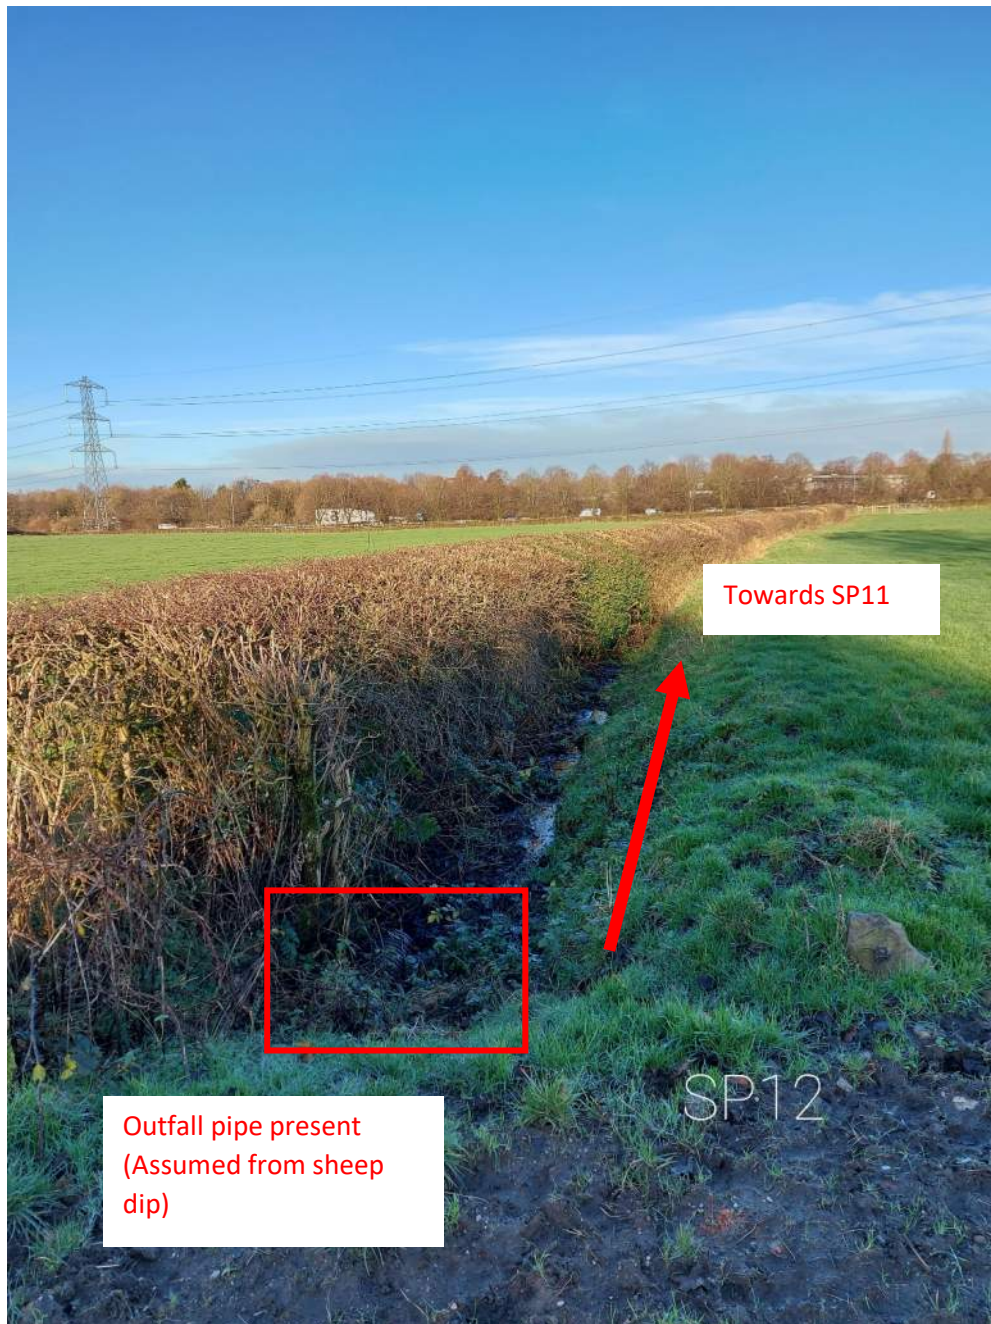
SURVEY POINT 12

D – 1.5m

WL – 0.2m

DW – 4m

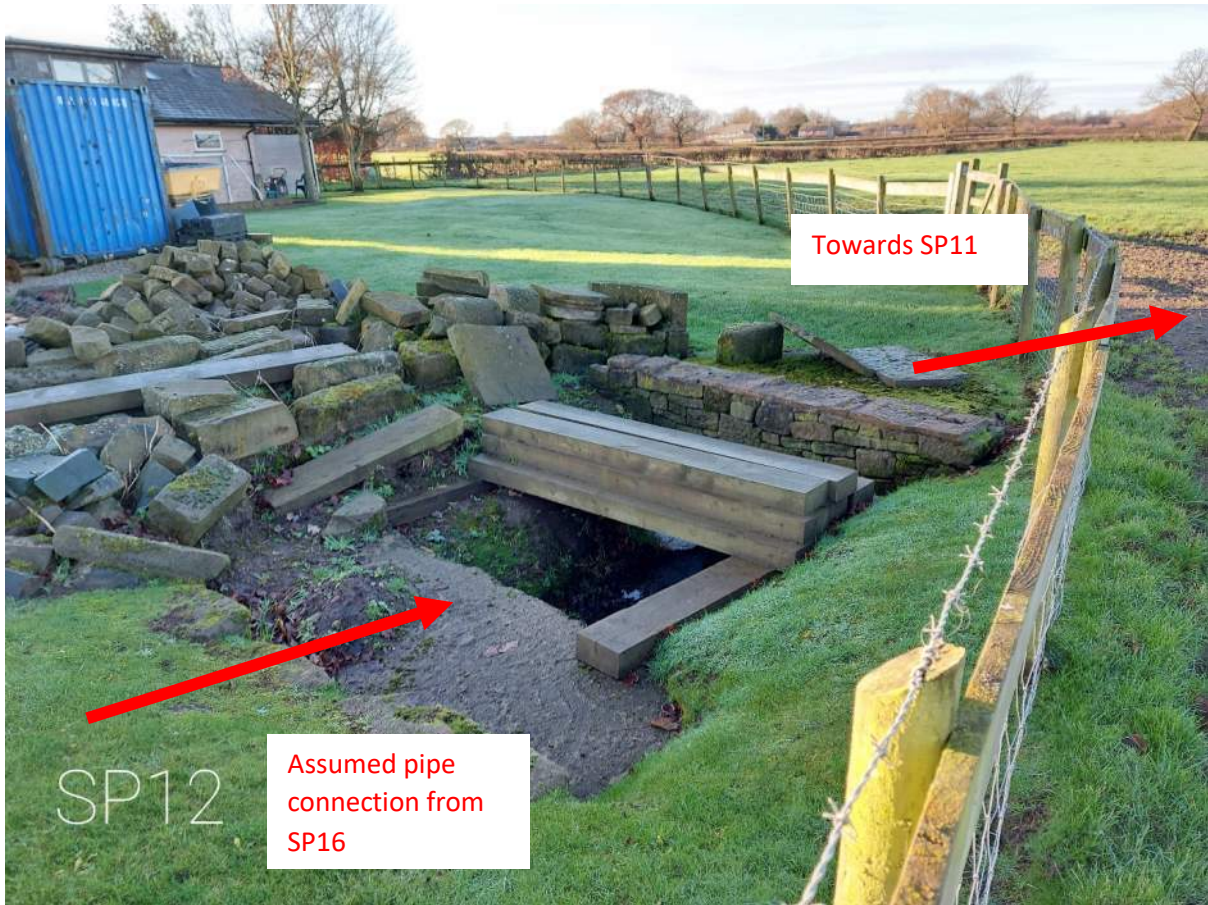
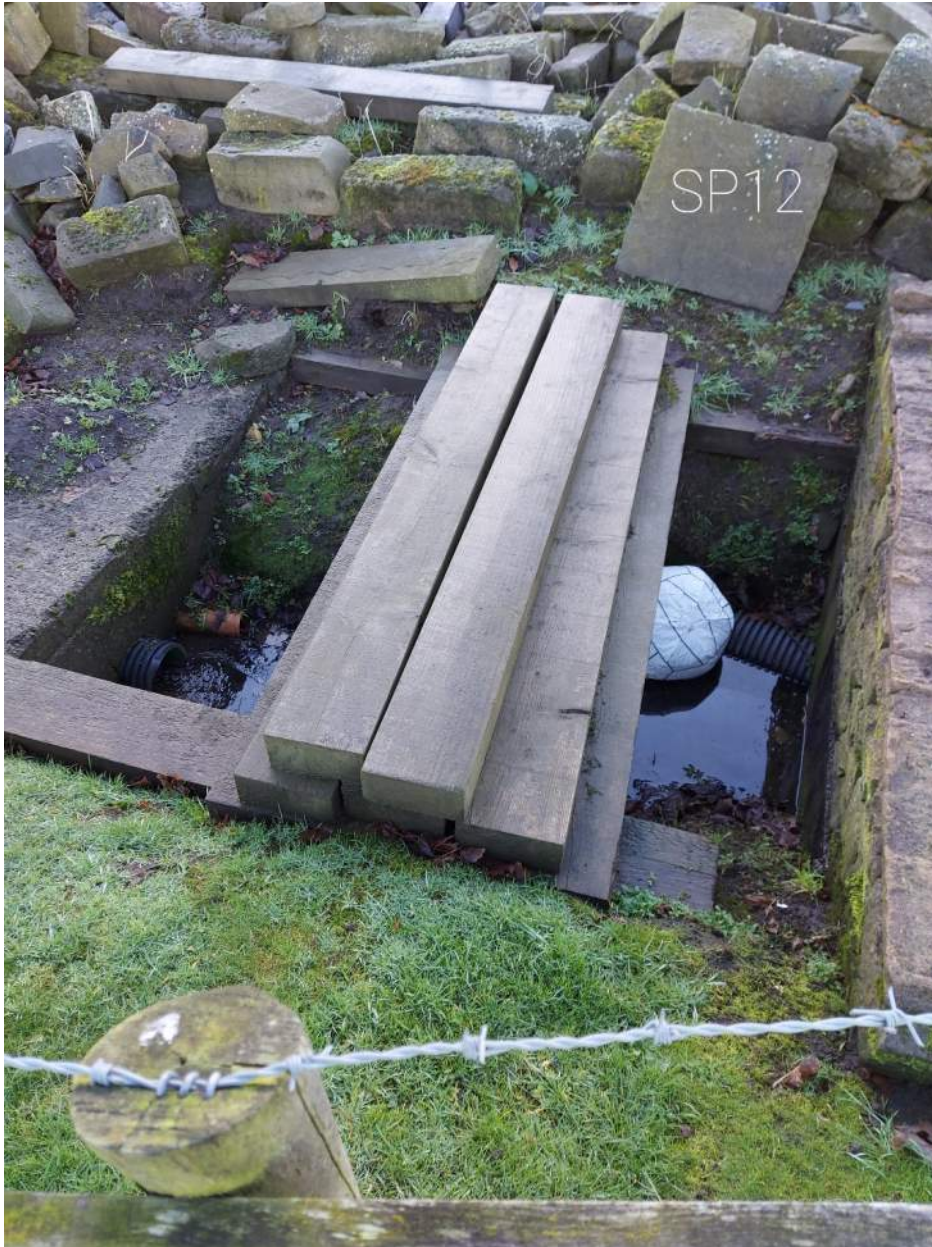
The sheep dip contained ponded water. No flow visible. The team was unable to retrieve a depth from this location.

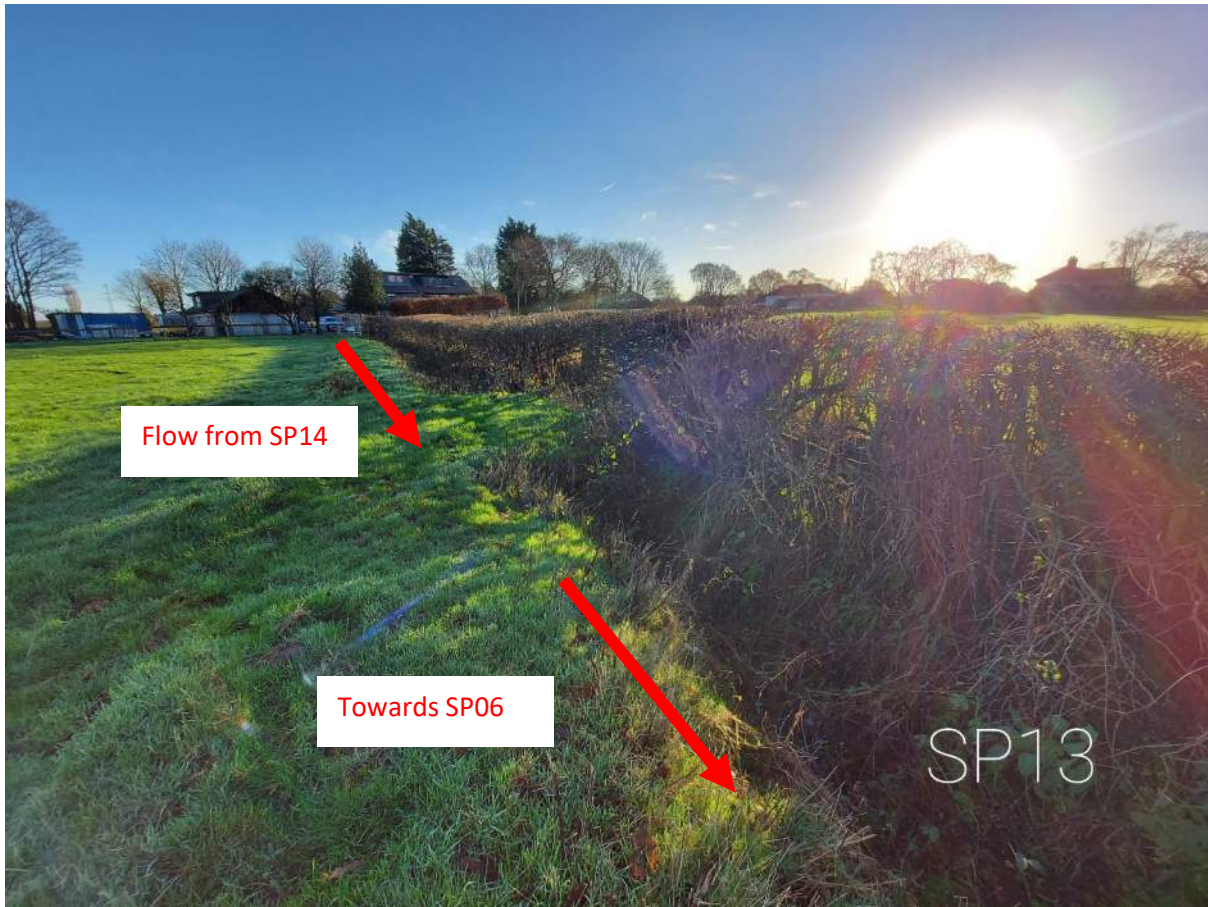
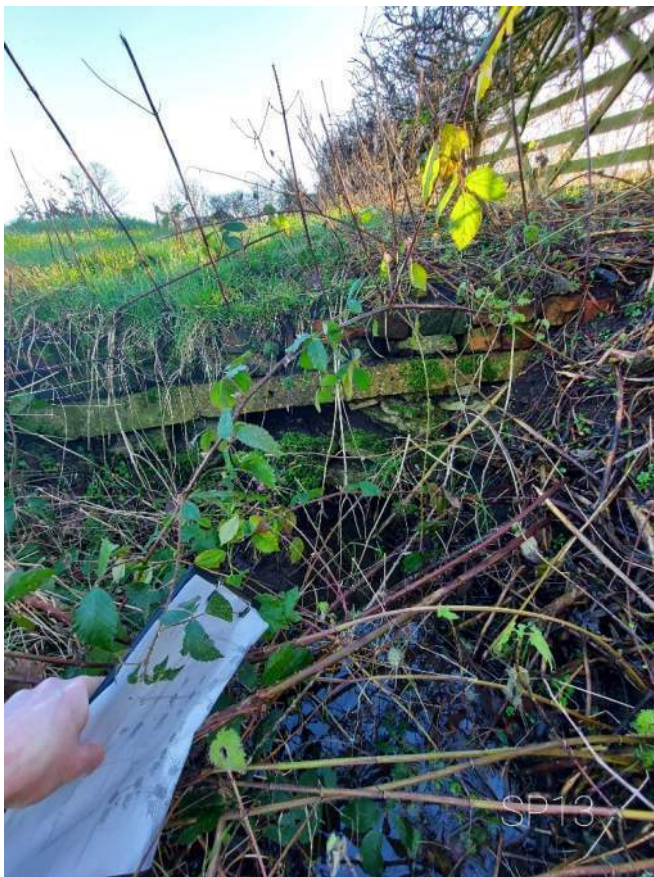
SURVEY POINT 13

Flow present through SP13

D – 1.1m

WL – 0.1m

DW – 2.2m
