Drainage Ditch Survey

Land Drainage Survey

Woodcock Estate

Doc No: LCCC-BDP-RPT-C-001

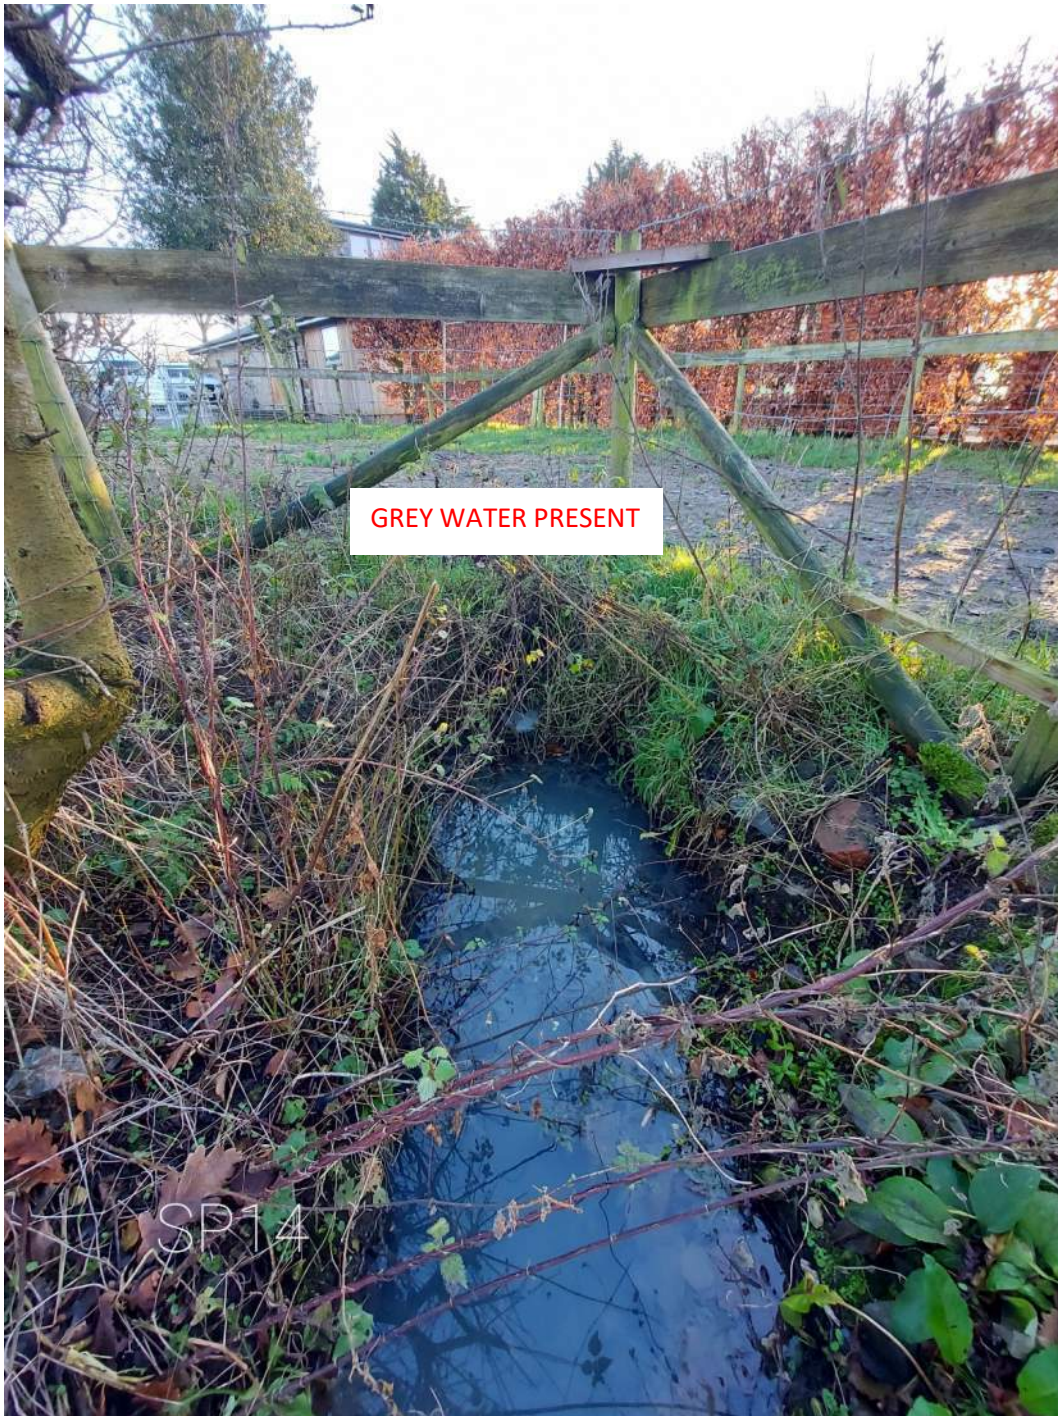
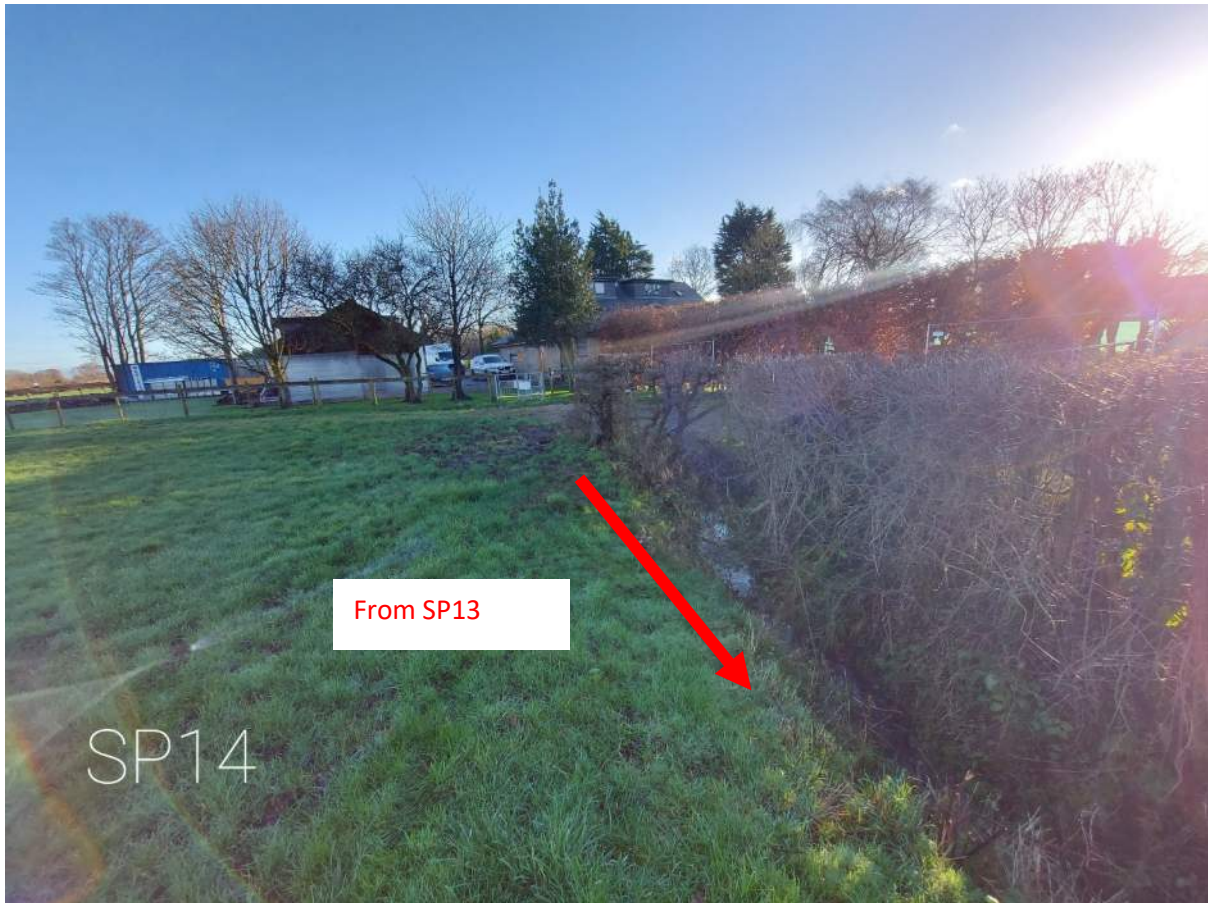
SURVEY POINT 14

A trickle of what appeared to be grey water was present at the head of this ditch. No visible inflow pipe was detected.

D – 1m

WL – 0.1m

DW – 2.1m

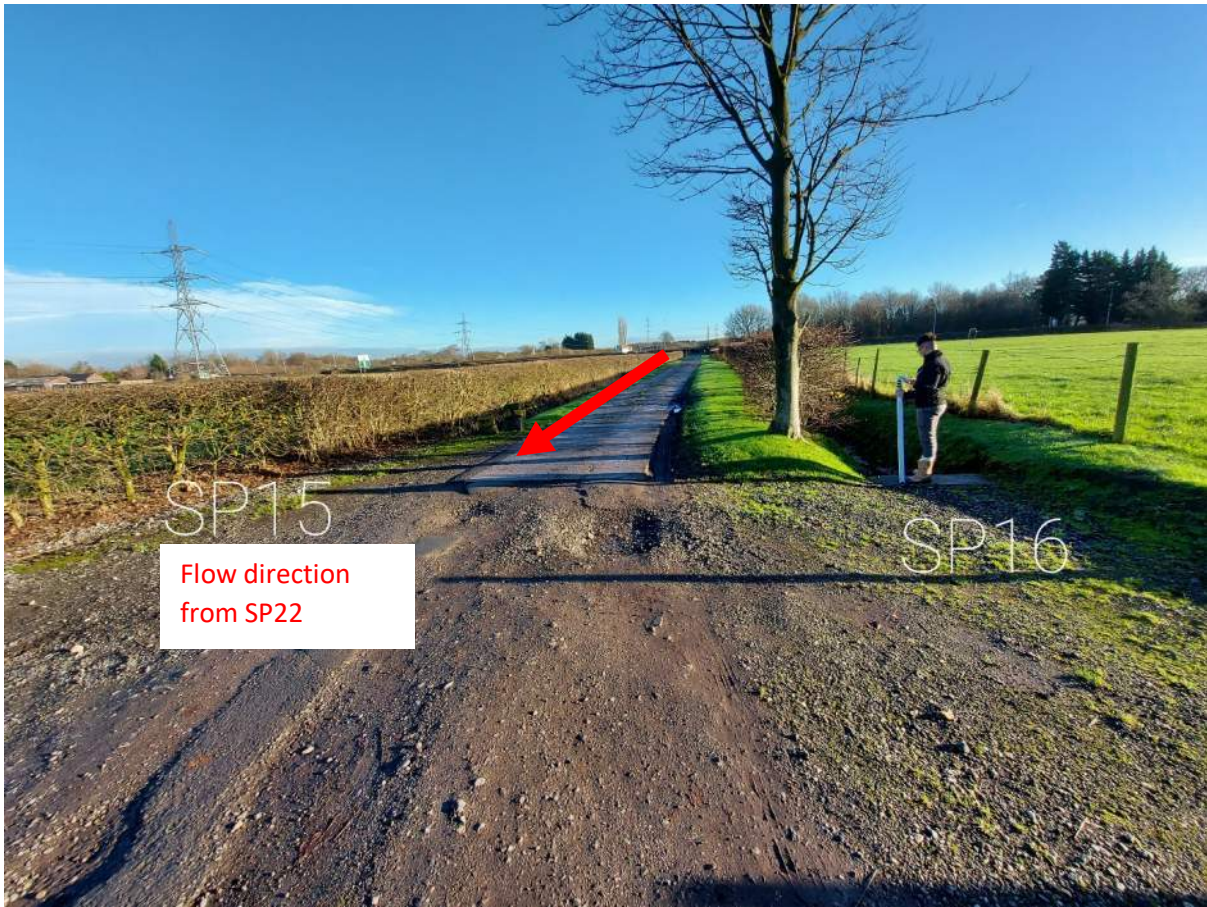
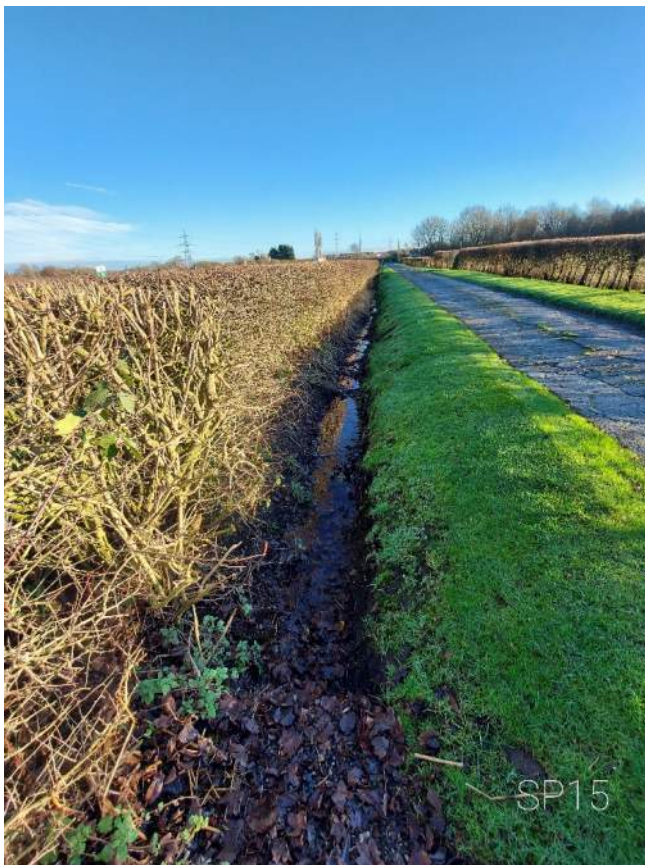
SURVEY POINT 15

Flow present through SP15

D – 1.4m

WL – 0.1m

DW – 3m

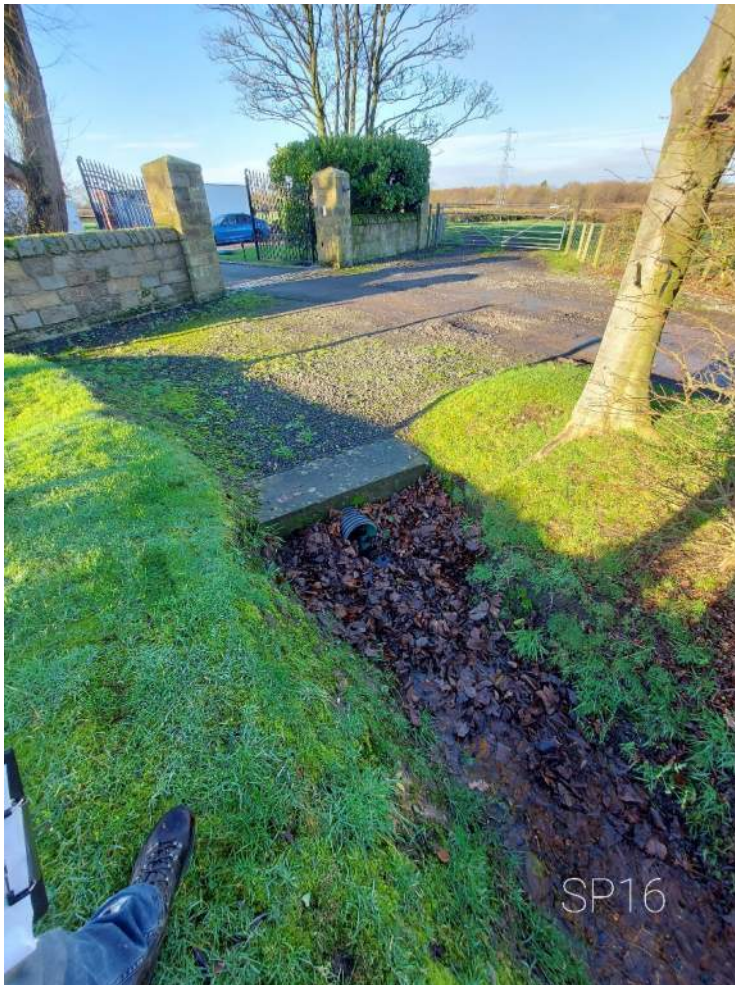
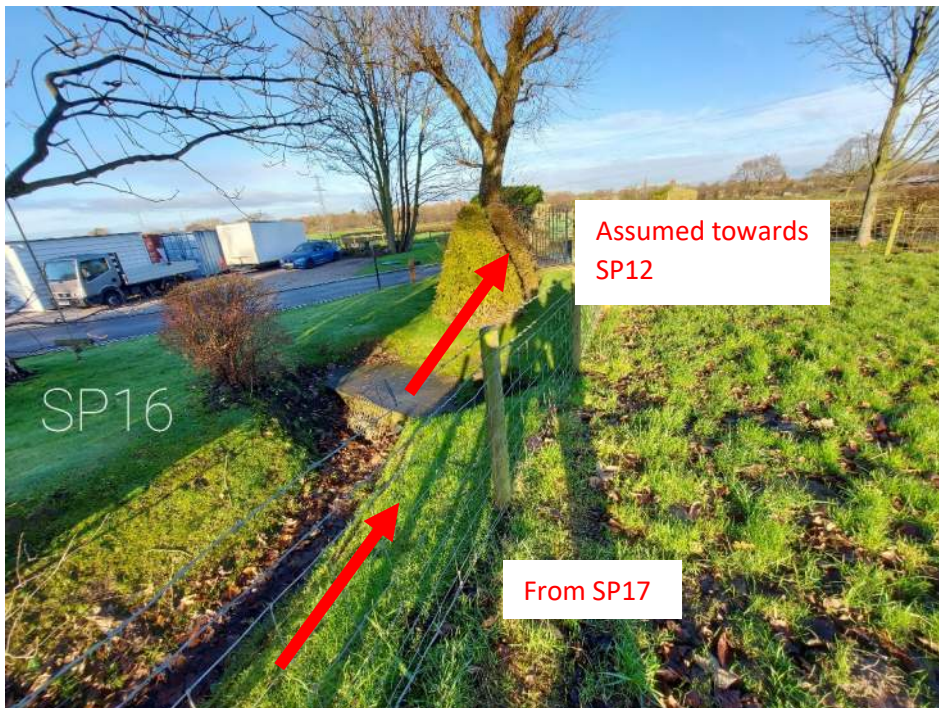
SURVEY POINT 16

Ponded water present in this location. It is assumed connection flow from SP16 to SP 16 (Internal to property grounds – see below)

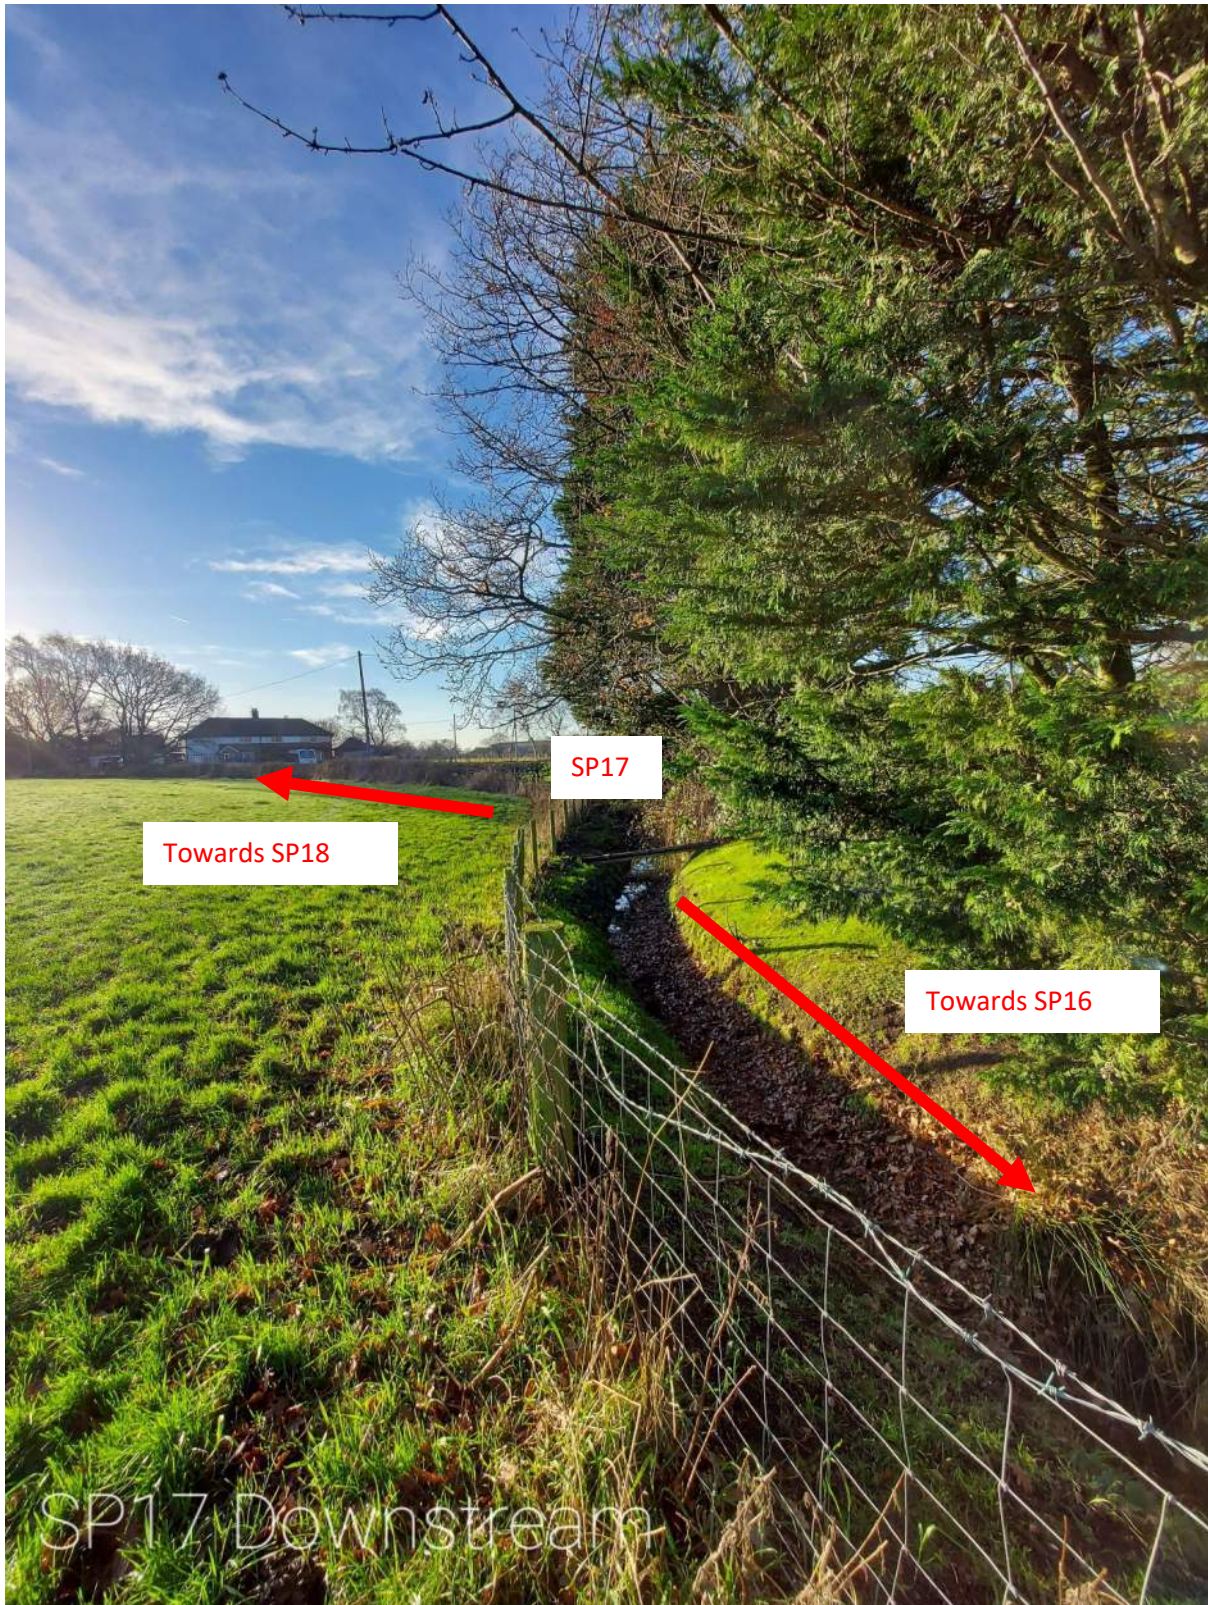
SURVEY POINT 17

D – 1.5m

WL – 0.1m

DW – 5m Ponded water - No flow present

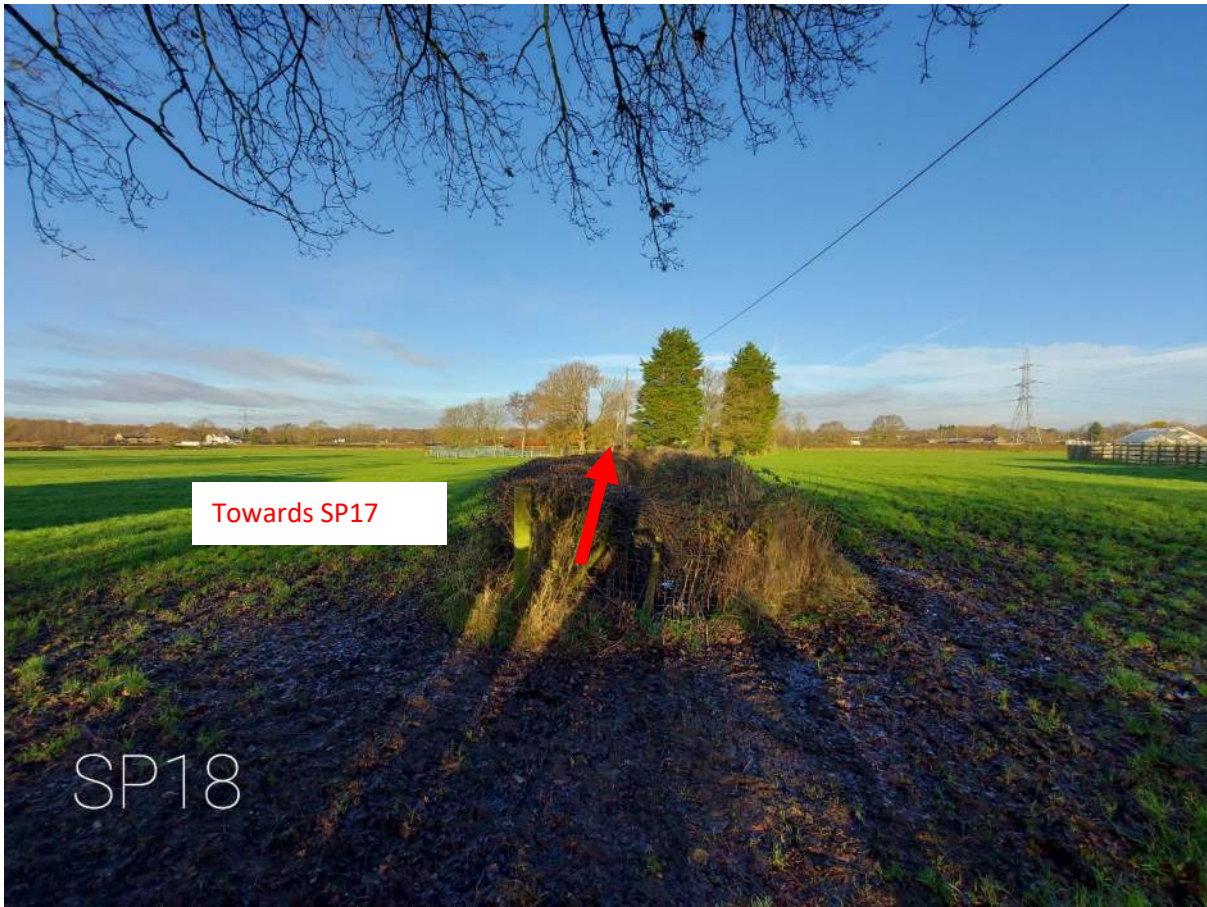
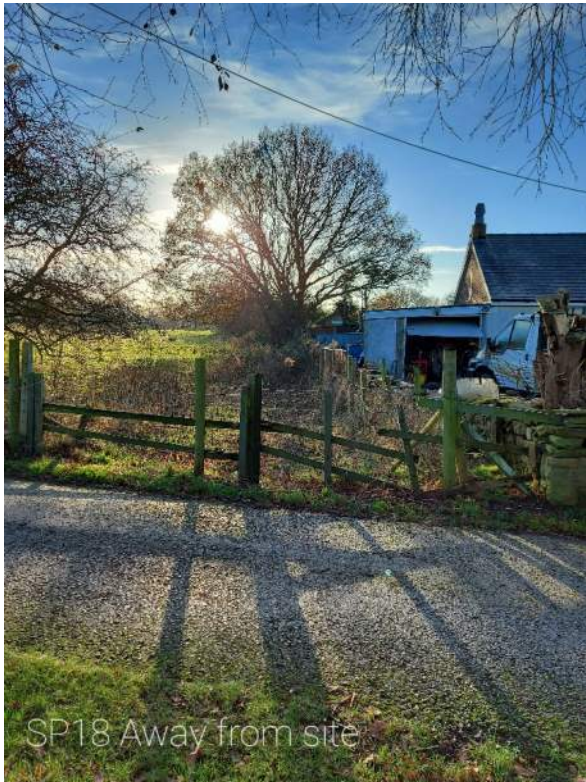
SURVEY POINT 18

Flow of ground water trickling into head of ditch at this location. No visible inflow from off site.

D – 1.5m
WL – 0.1m
DW – 3m

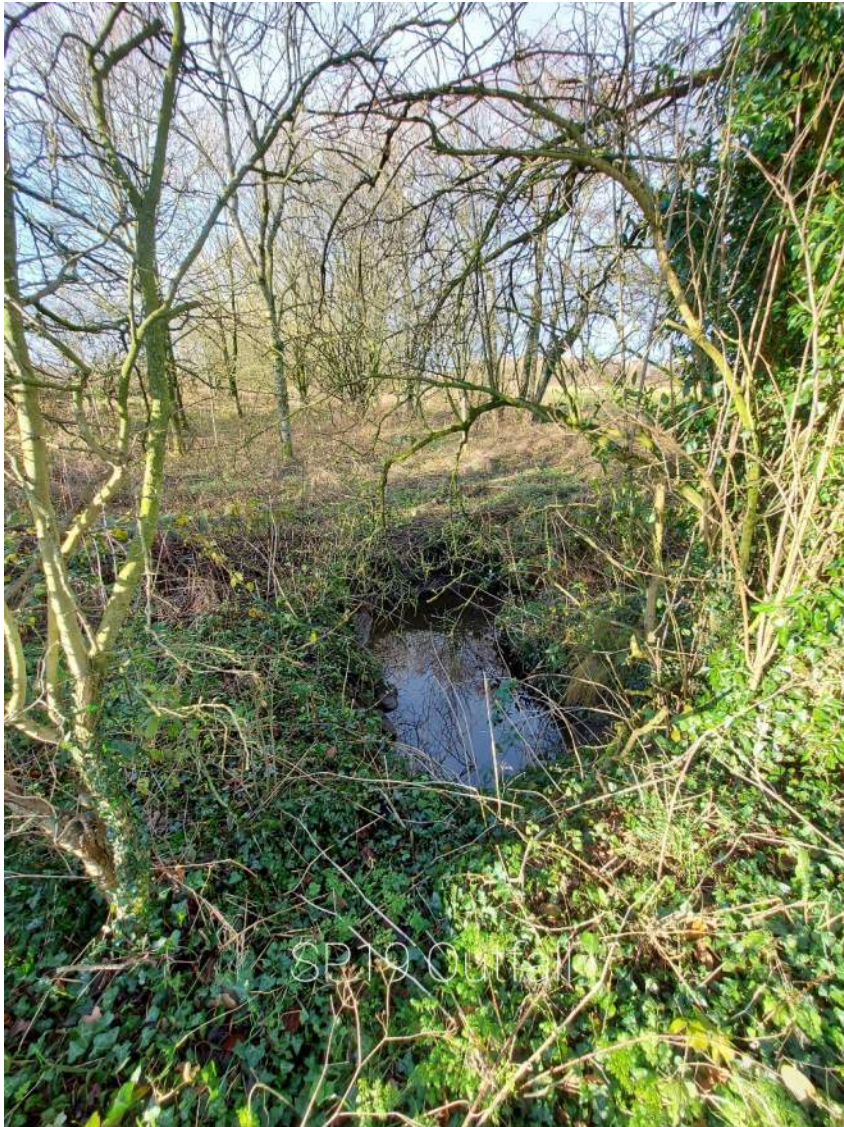
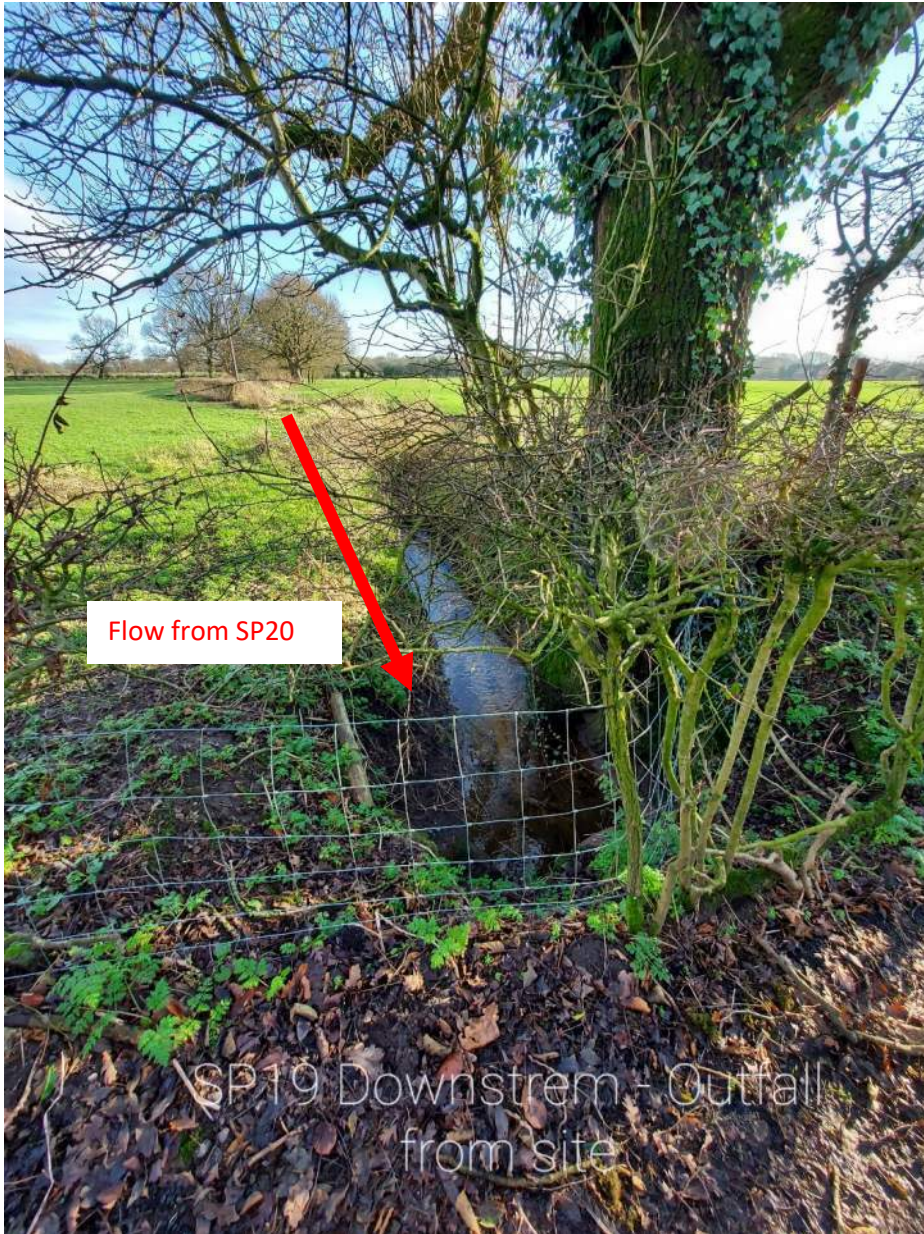
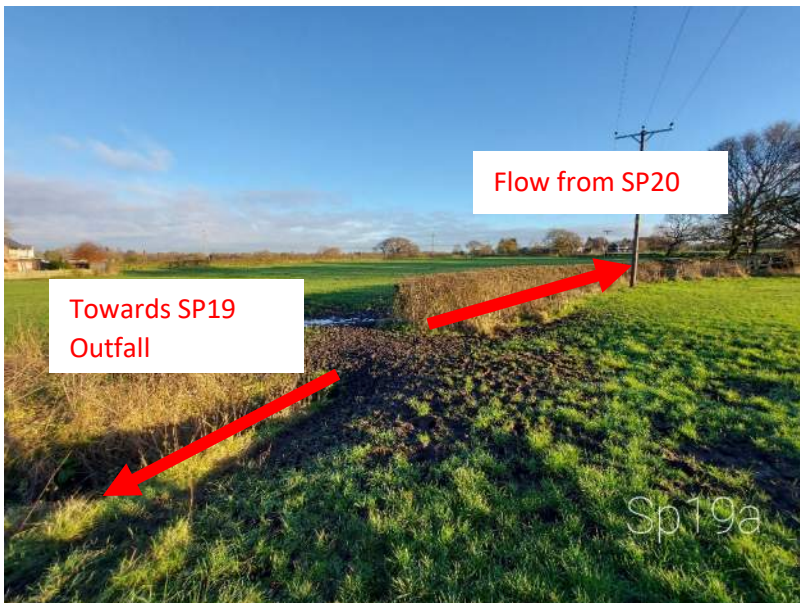
SURVEY POINT 19

Outfall away from site

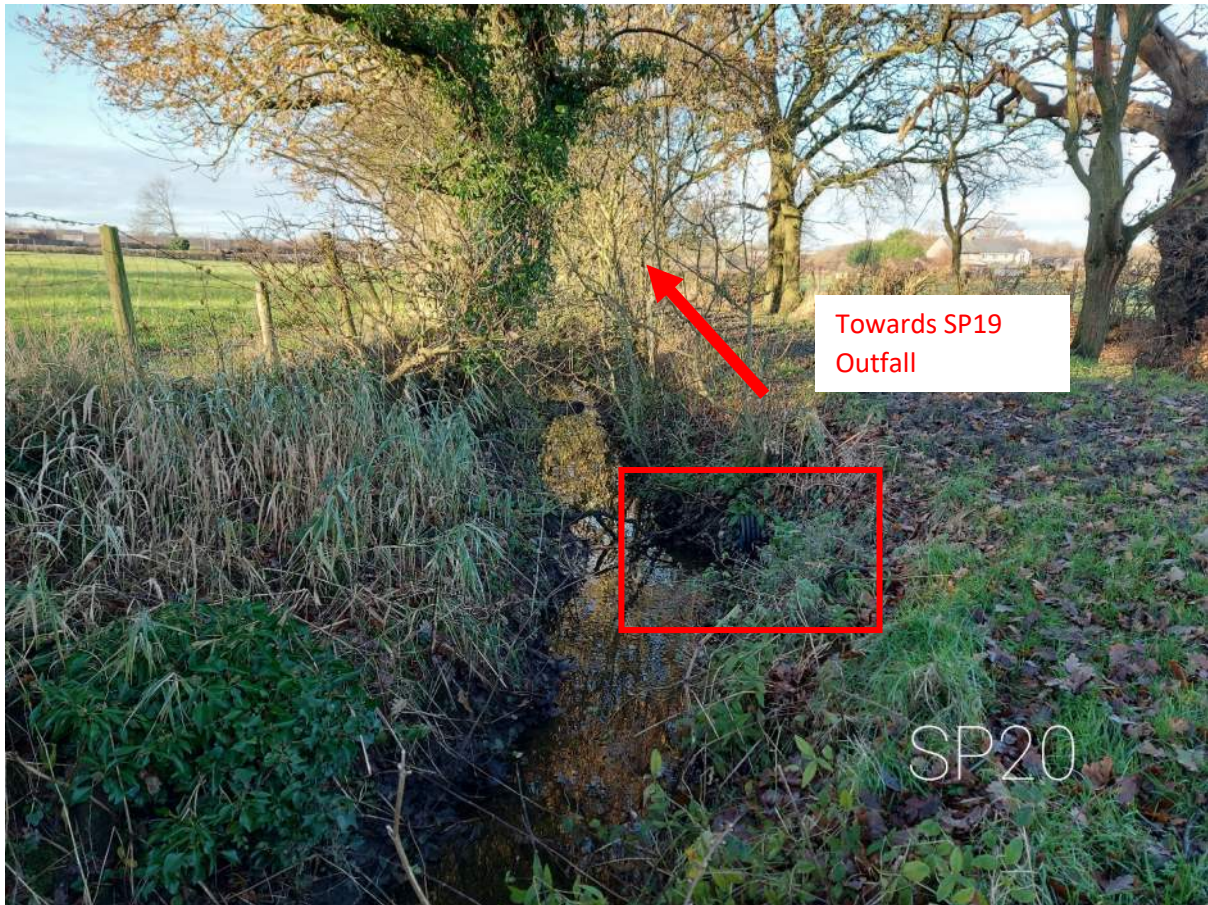
SURVEY POINT 20

Unknown pipe was discovered in this location. Assumed land drain pipe to adjacent field.

D – 1.5m

Invert to incoming pipe from bottom of ditch – 1m

WL – 0.4m

DW – 3.0m

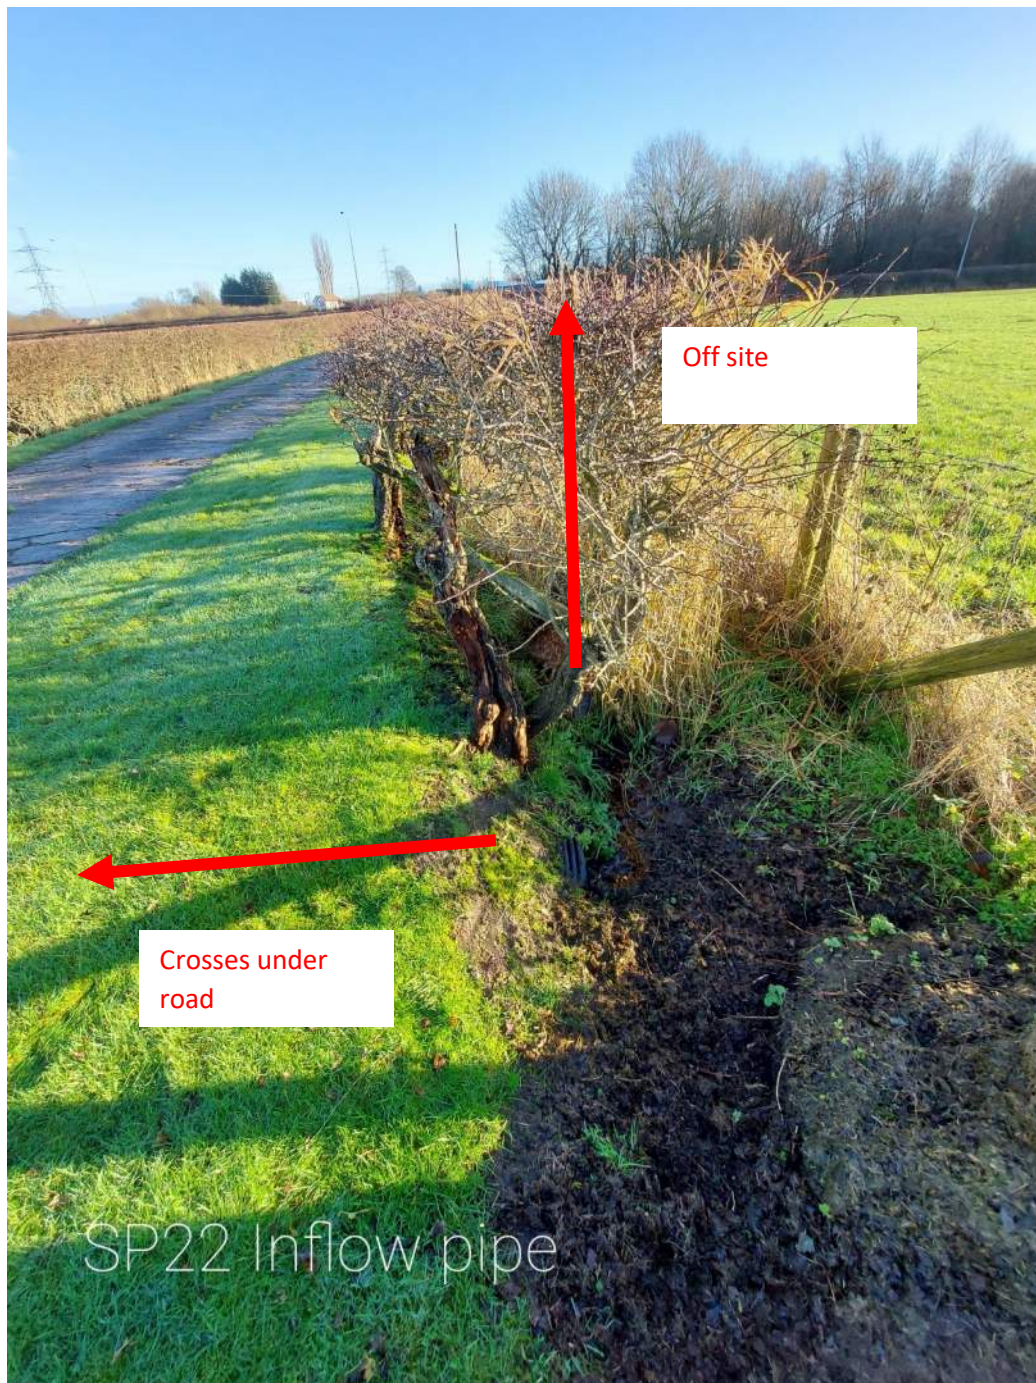
Inflow appears to originate off site.

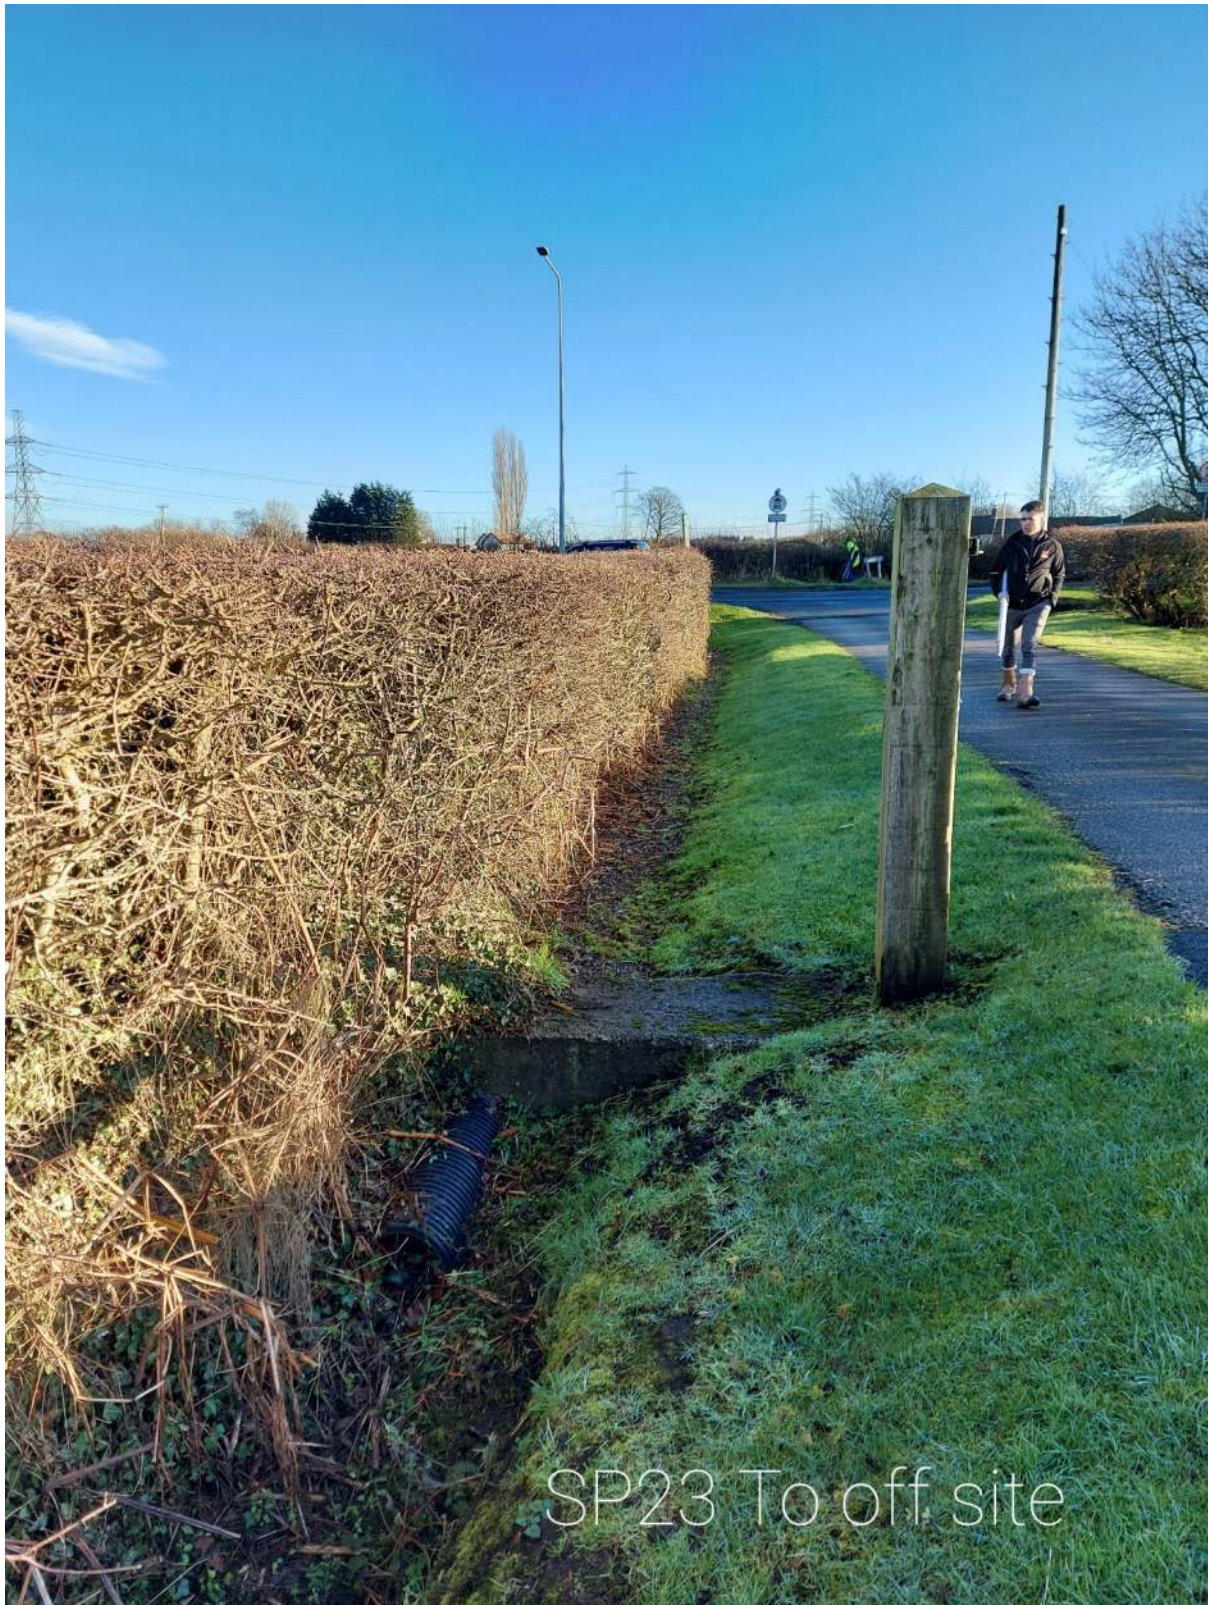
SURVEY POINT 23

No flow on this side of access road.
