Drainage Ditch Survey

Land Drainage Survey

Woodcock Estate

Doc No: LCCC-BDP-RPT-C-001

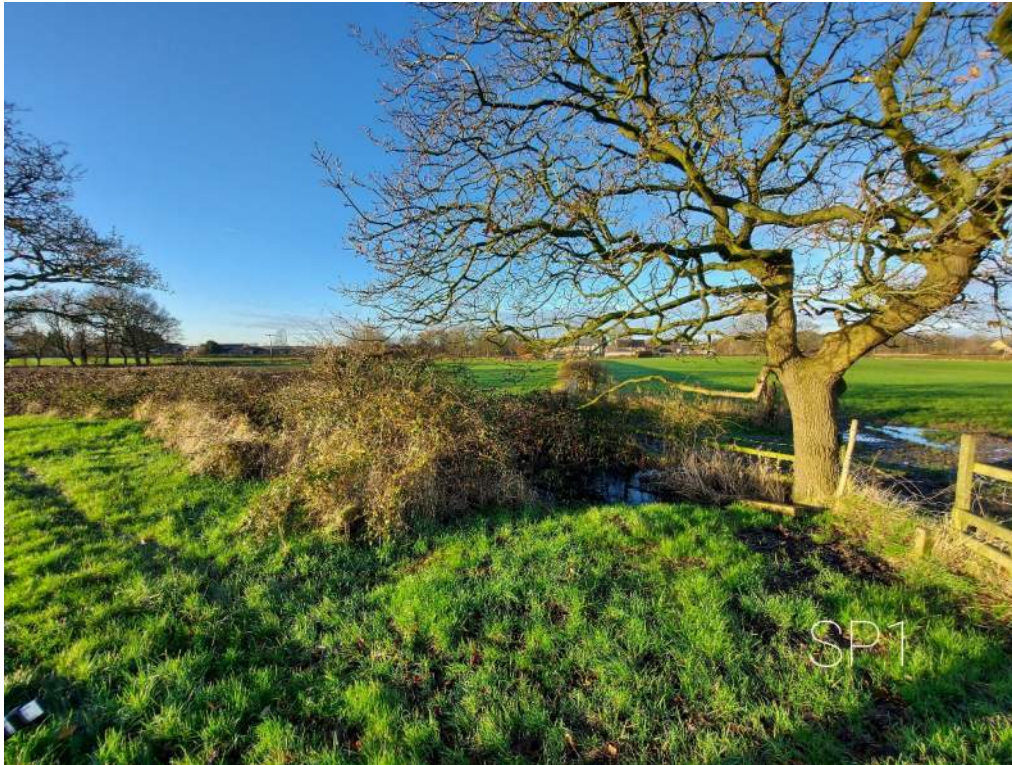
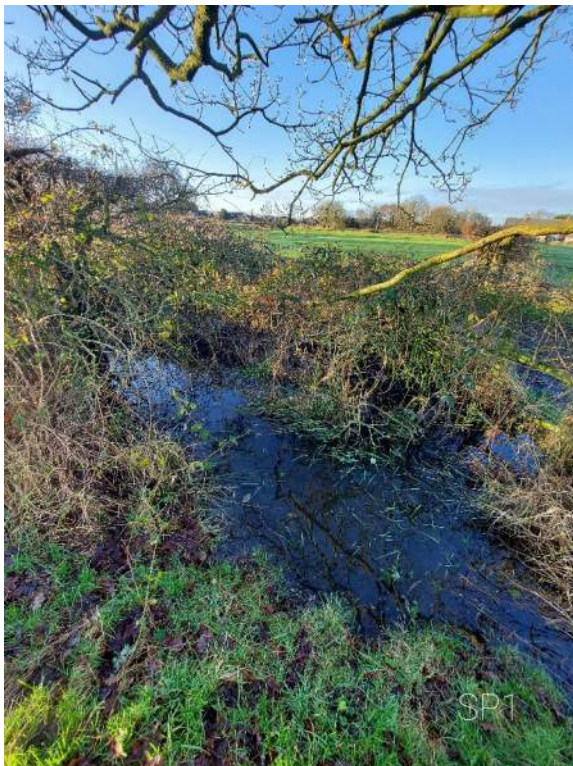
SURVEY POINT 1

Ponded water present – No flow.

WL = 0.25m

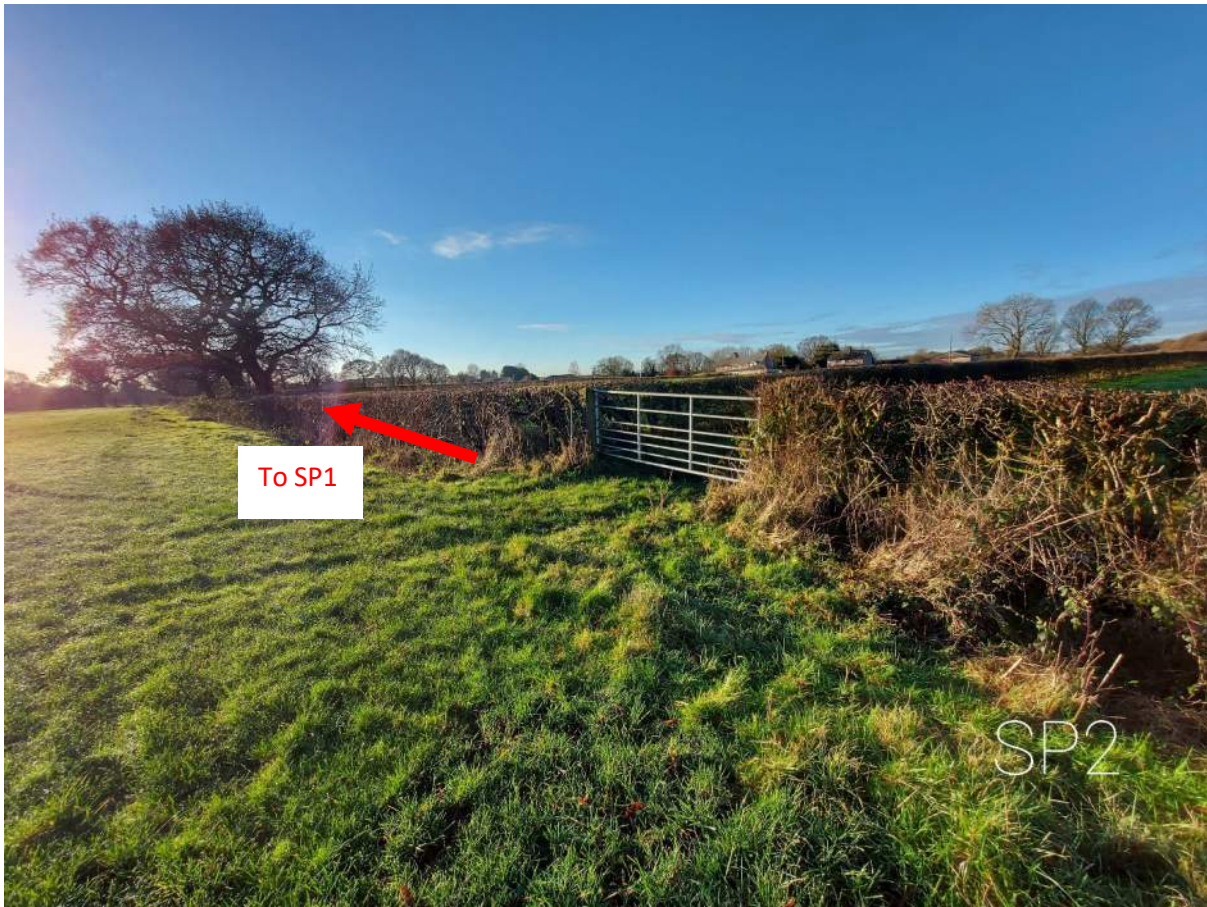
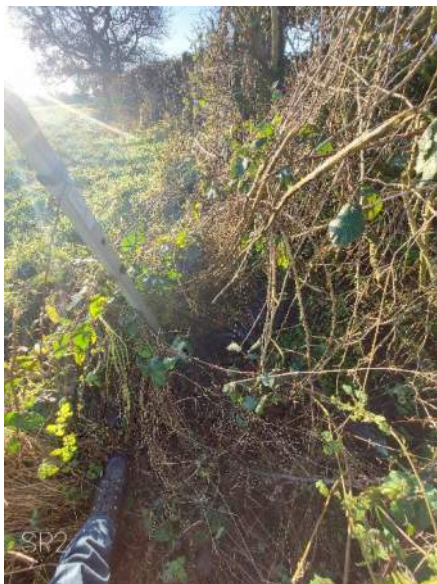
SURVEY POINT 2

No water present. Collapsed culvert under gate.

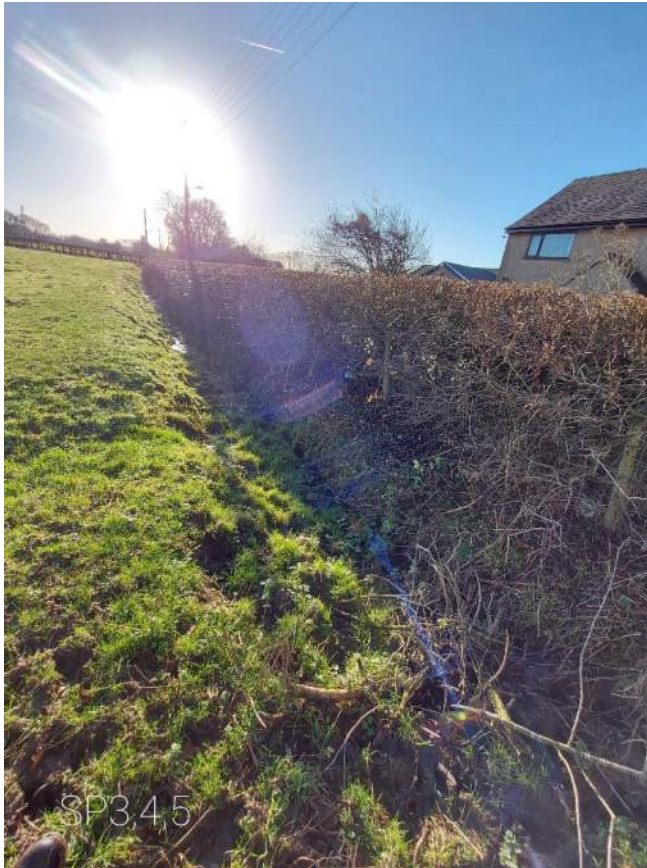
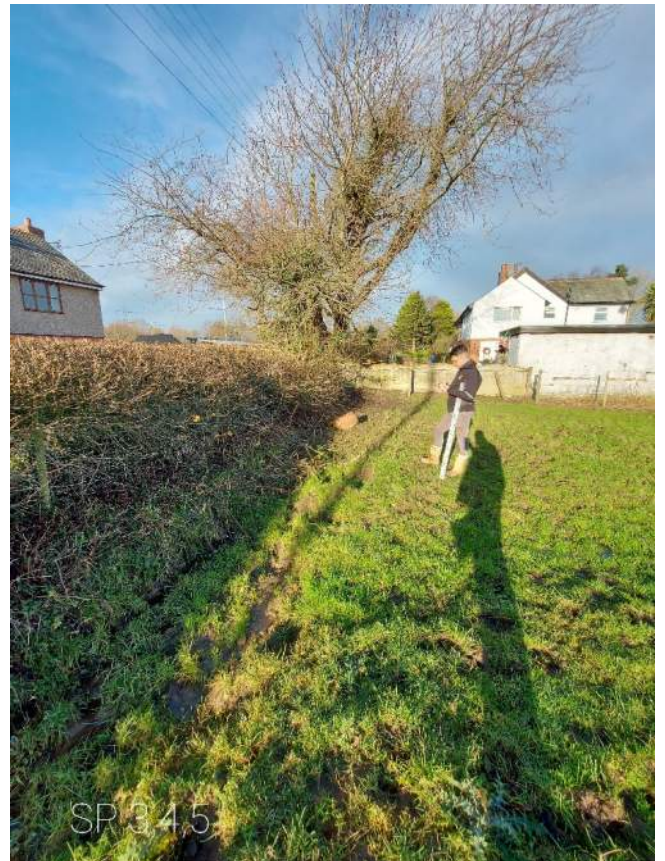
SURVEY POINT 3

The area of field to the rear of White Farm house is saturated. It appears to drain towards the ditch adjacent to the hedgerow and filter away. No flow present.

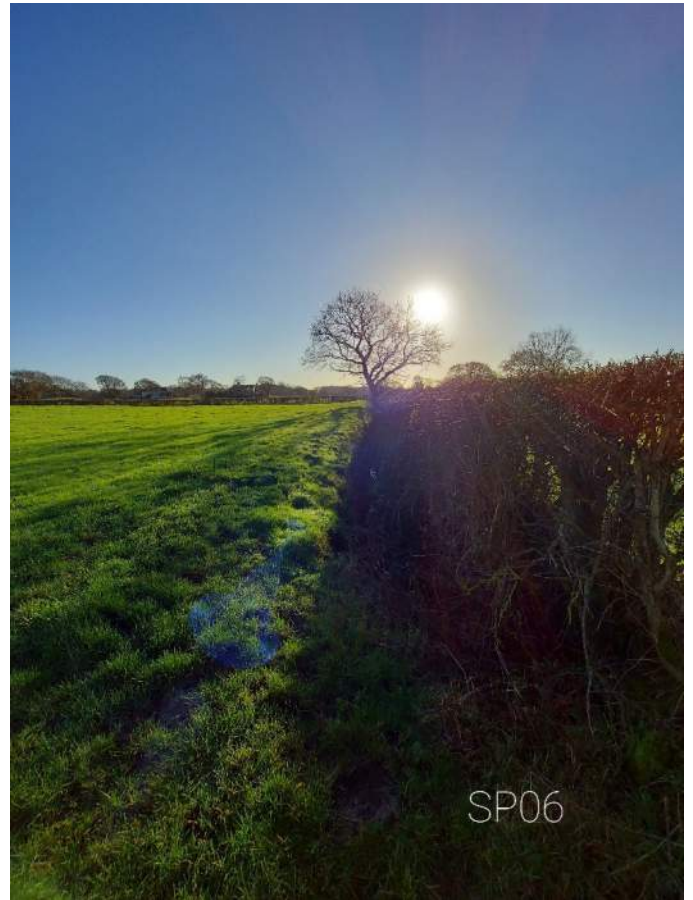
SURVEY POINT 6

Small amount of flow present (assumed from SP13).

D – 0.8m

WL – 0.050m

DW- 1m

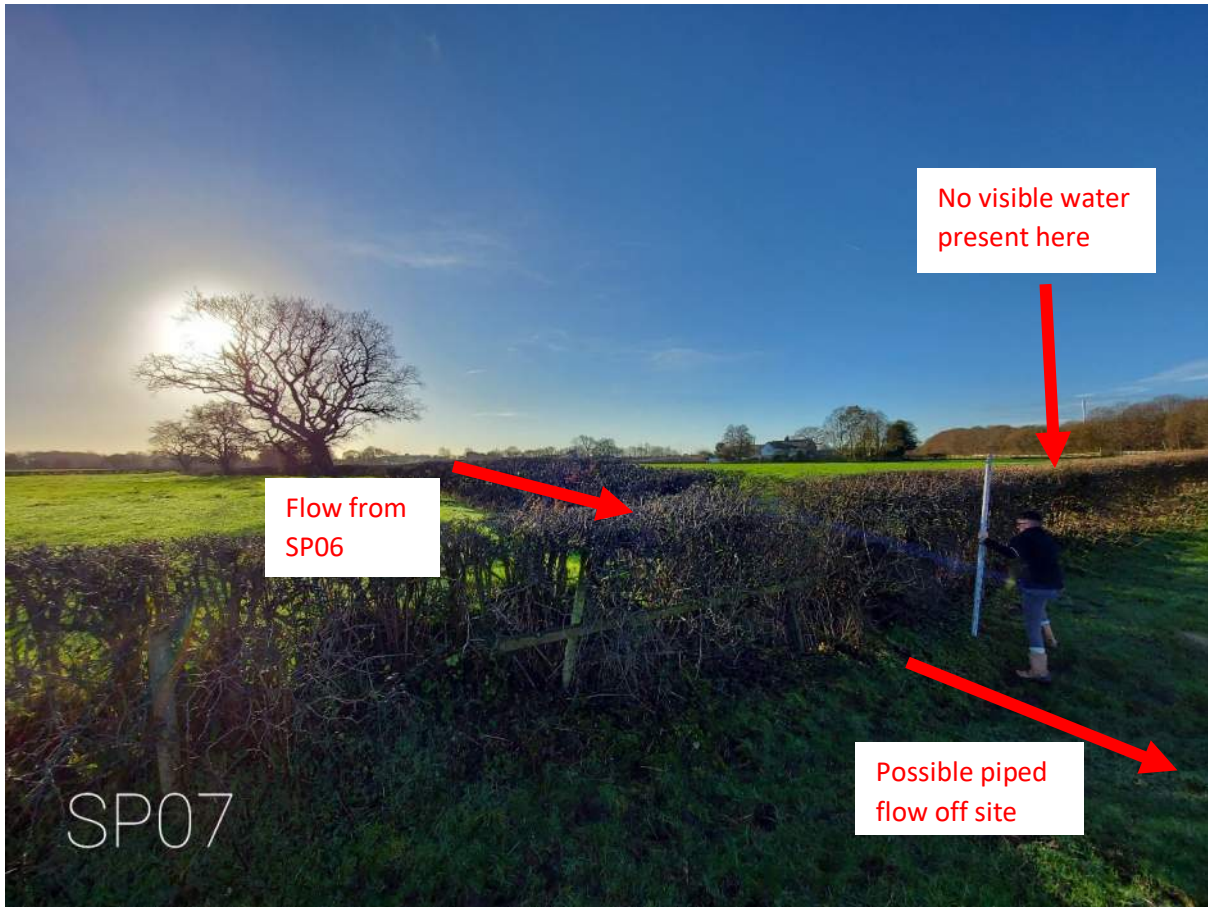
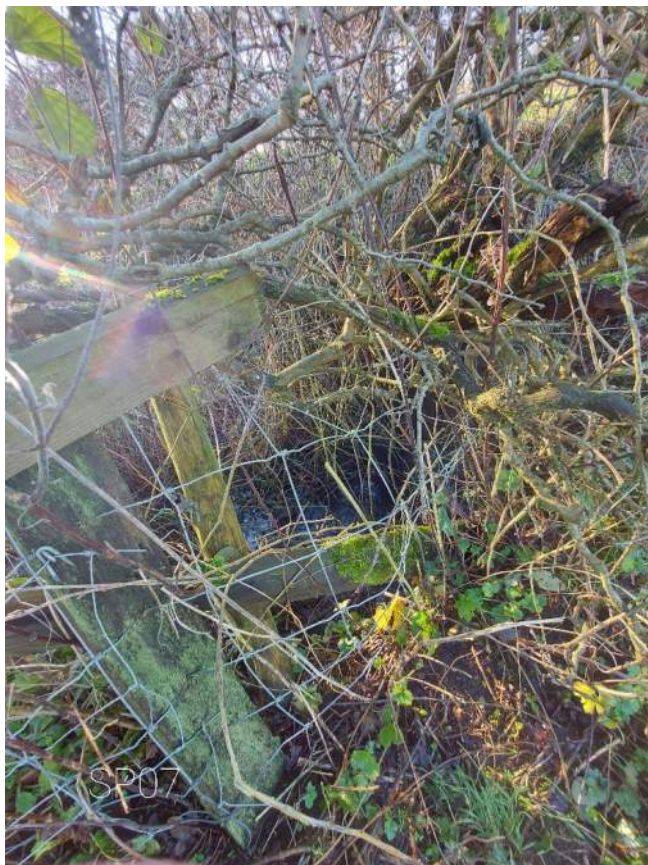
SURVEY POINT 7

Flow present into SP 07. Ponded water visible however no visible outflow could be observed. The logical assumption would be that the flow continued towards SP08 however the area of land between the two survey points was dry. It is possible an underground pipe is present which outflows off site towards Farrington Road and possibly the River Lostock.

D – 1m

DW – 0.8m

WL – 0.1

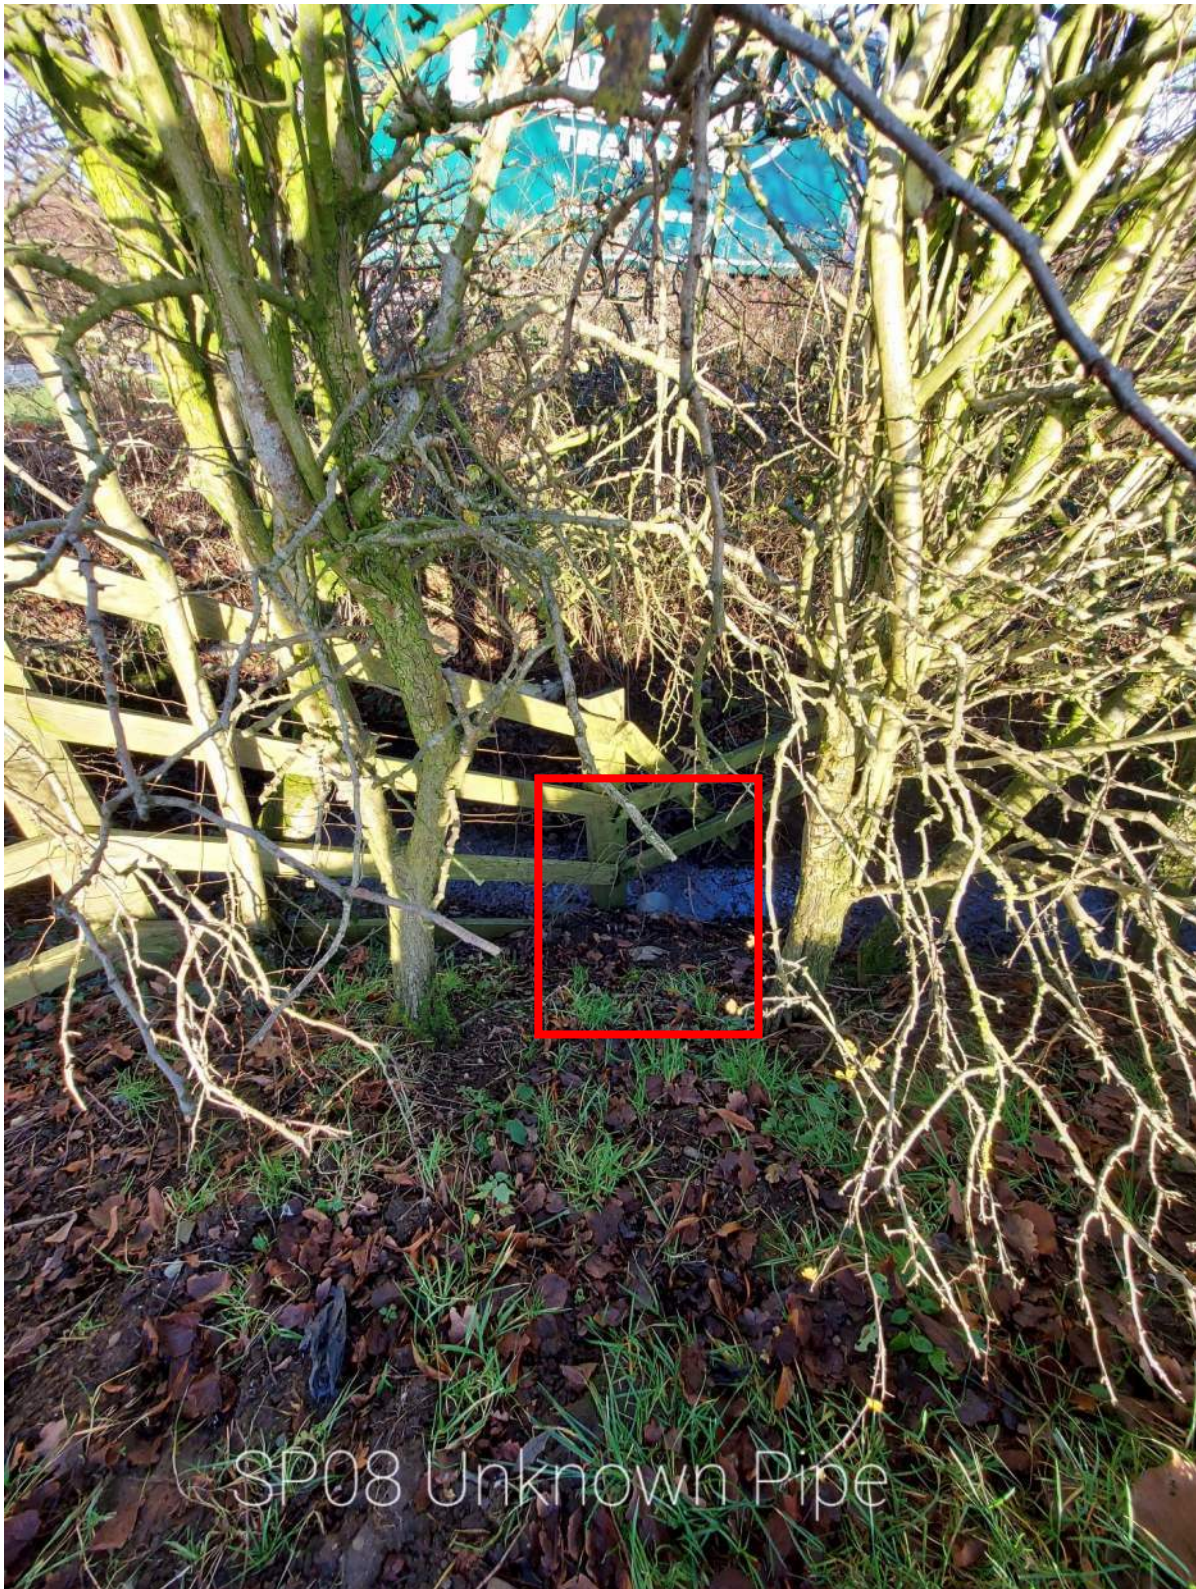
SURVEY POINT 8

Unknown pipe found out falling into SP 08 ditch. The pipe carried constant flow with the head of the pipe unfound. Assumed to be land drainage. Exposed vertical open pipe found in the field upstream of discovered pipe (See vent pipe 02 image and General arrangement for location).

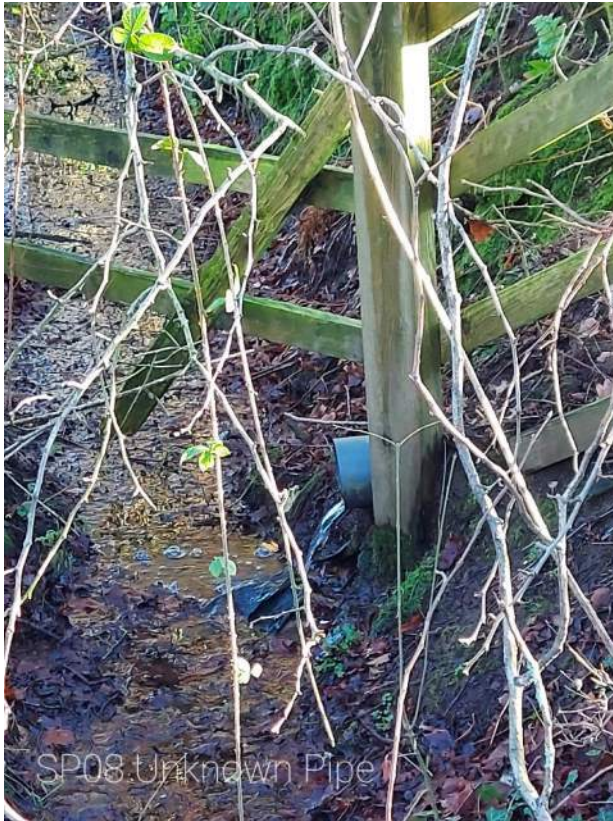
Continuous flow visible of unknown pipe.

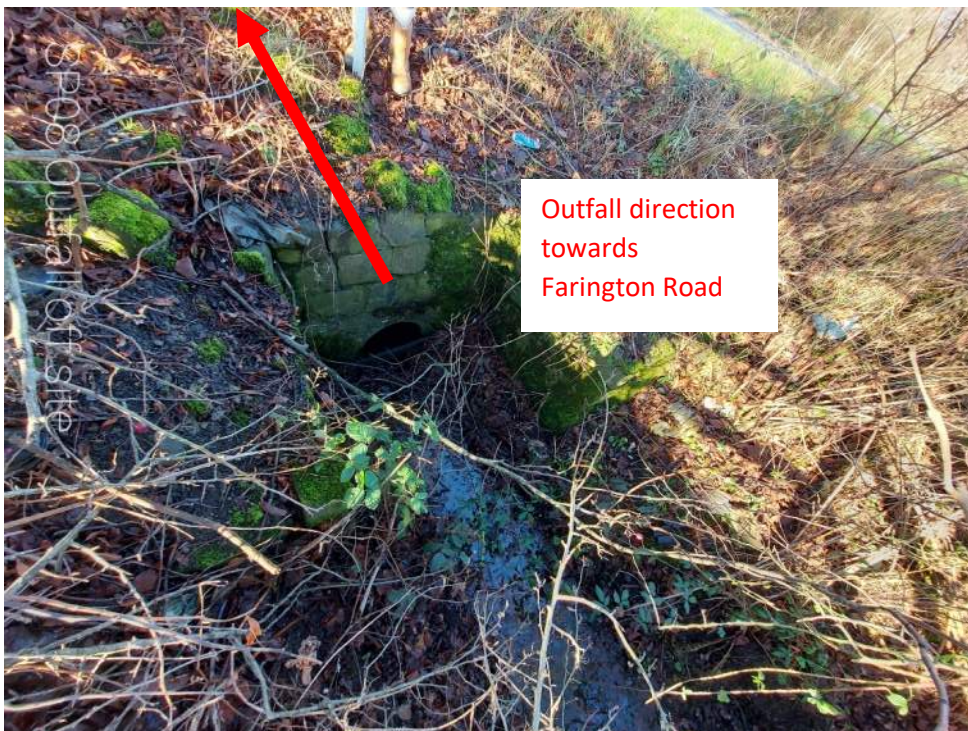
Outfall location off site. Minimal flow within ditch was present however was indicated to be flowing off site.

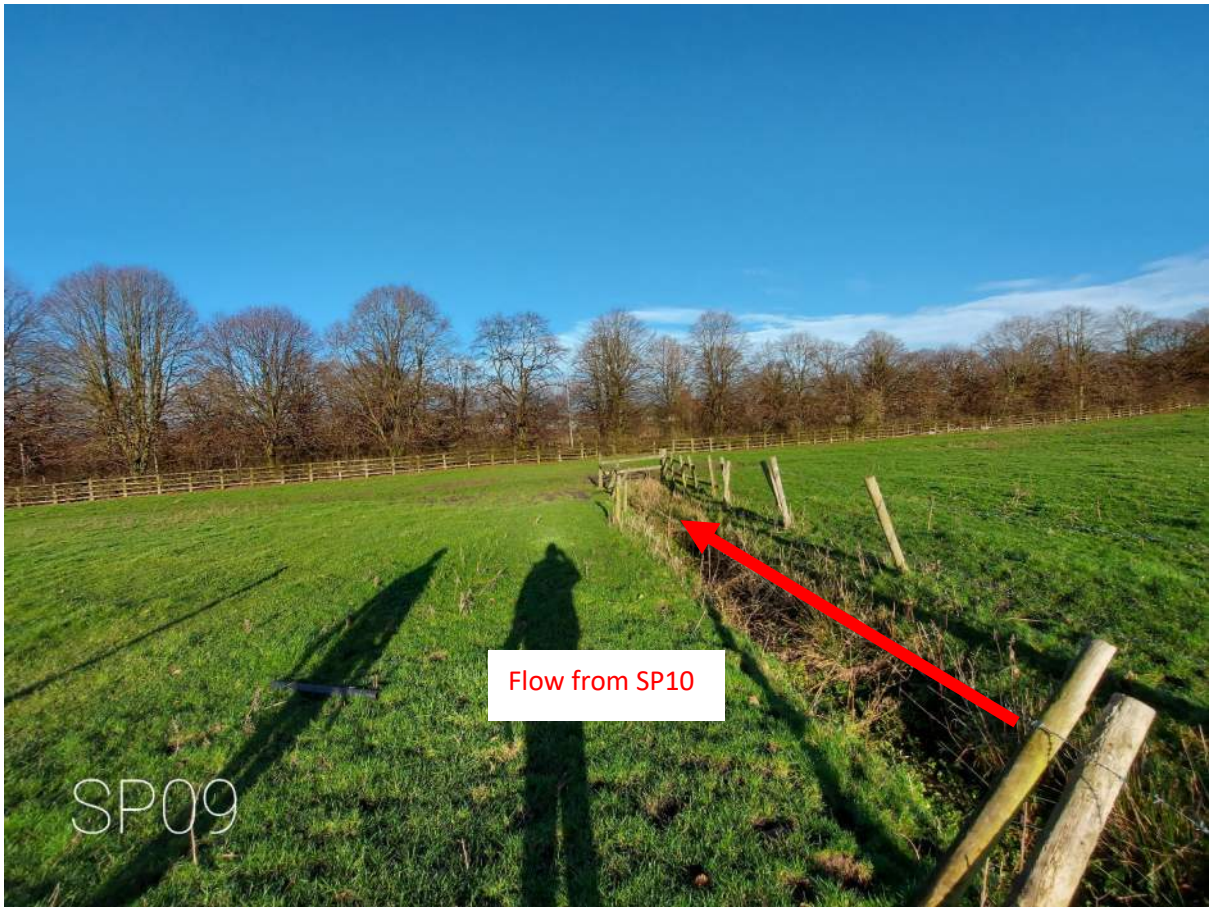
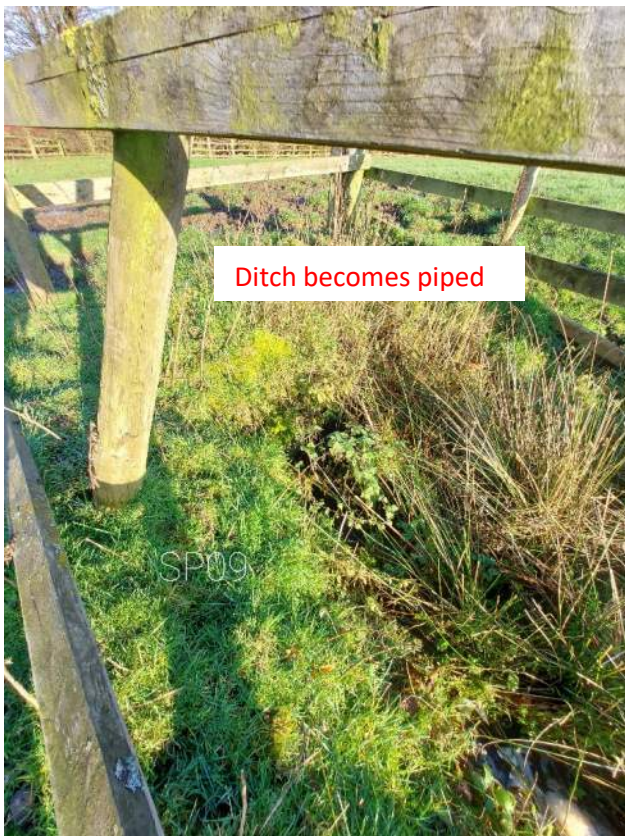
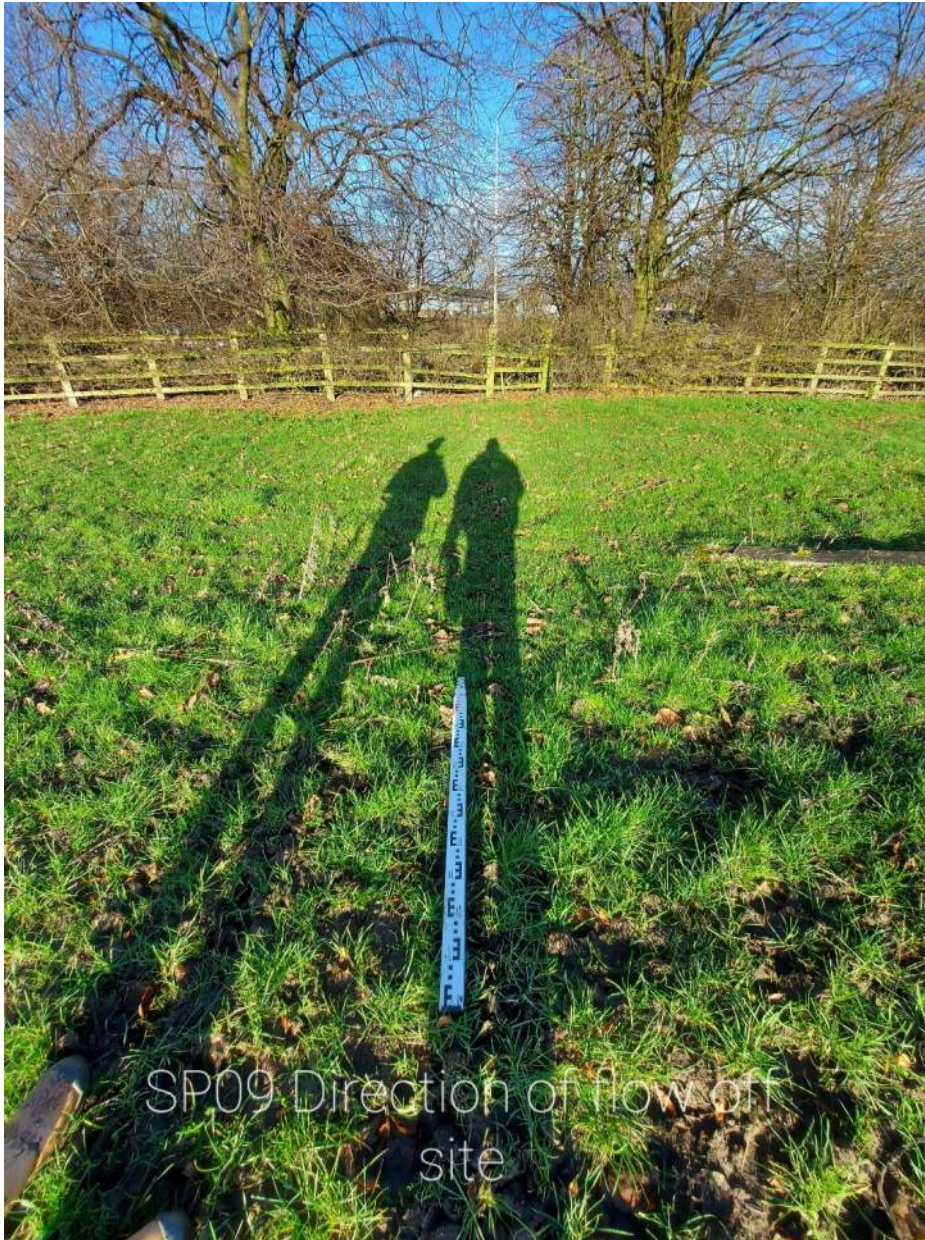
SURVEY POINT 09

Assumed direction of piped outfall towards the River Lostock

D – 1m

WL – 0.15,

DW – 1.5m

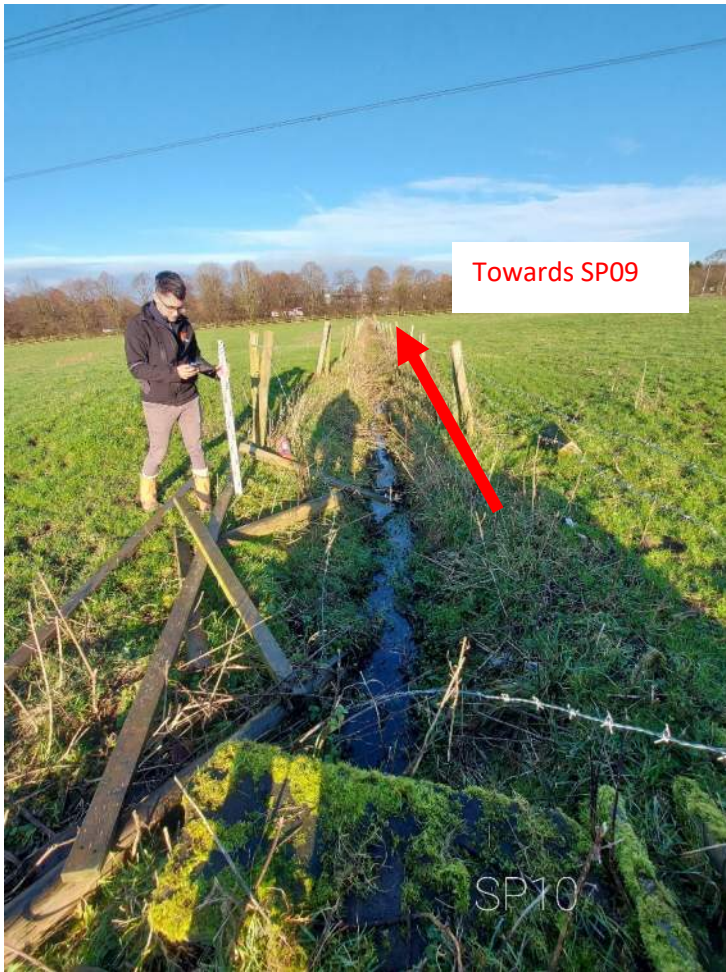
SURVEY POINT 10

Flow present through SP10.

D – 1.2m

WL – 0.2m

DW – 2m

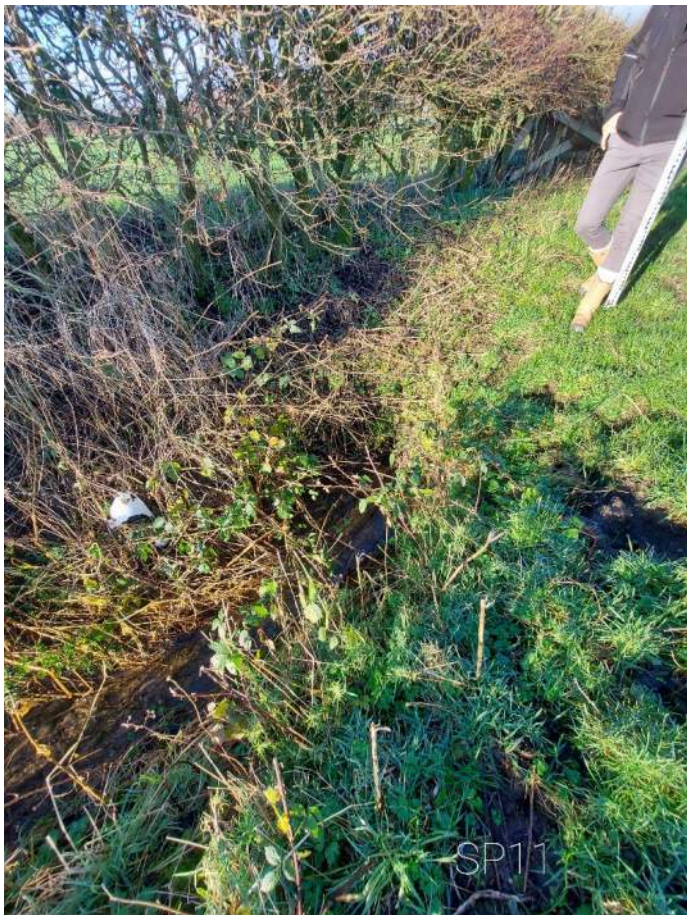
SURVEY POINT 11

Flow present through SP11

D – 1.5m

WL – 0.1m

DW – 3m

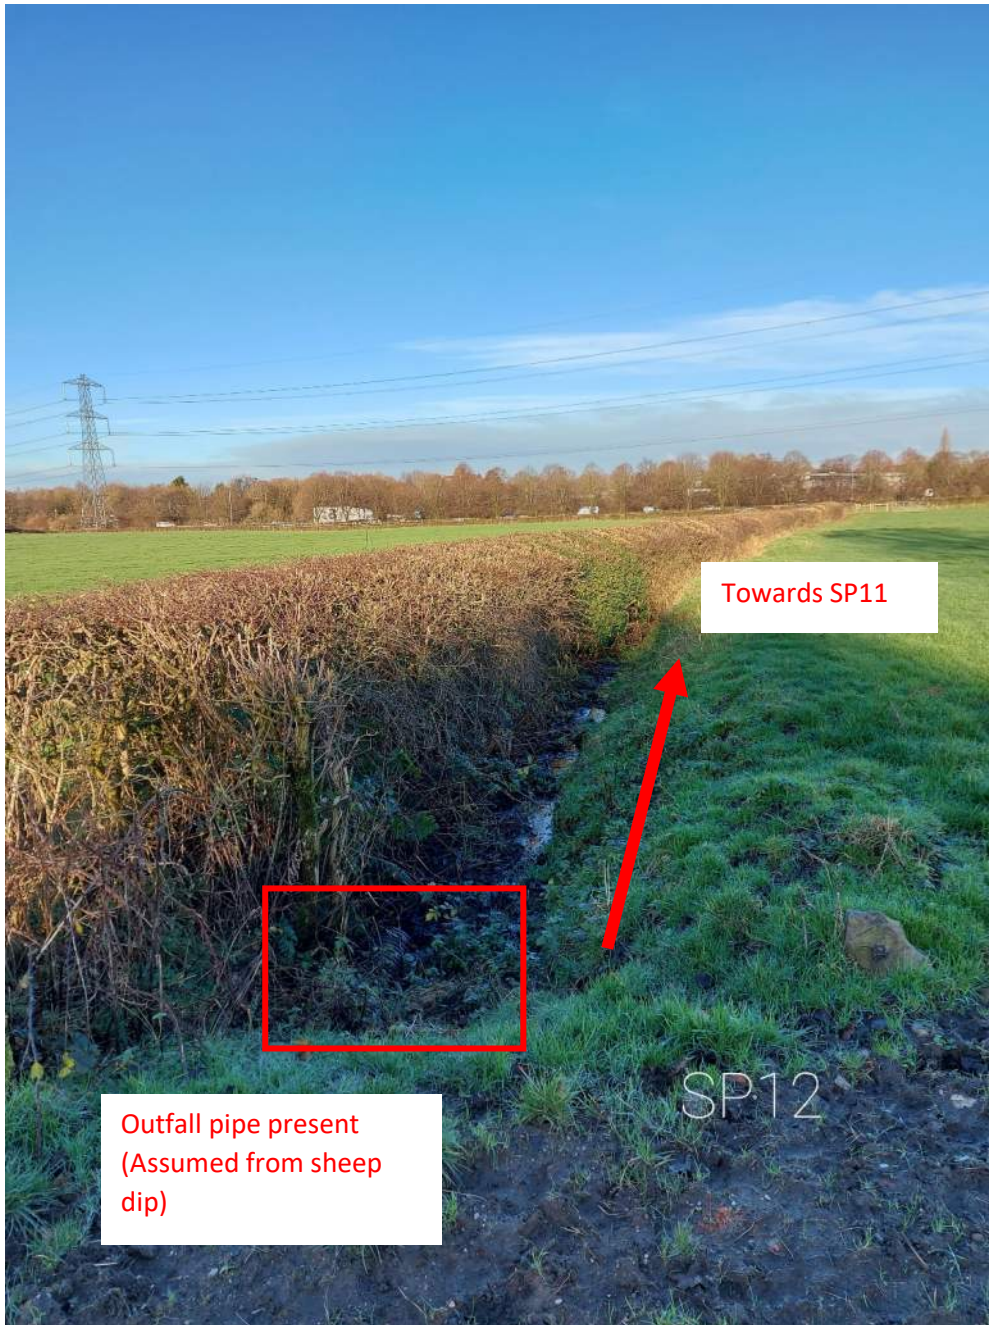
SURVEY POINT 12

D – 1.5m

WL – 0.2m

DW – 4m

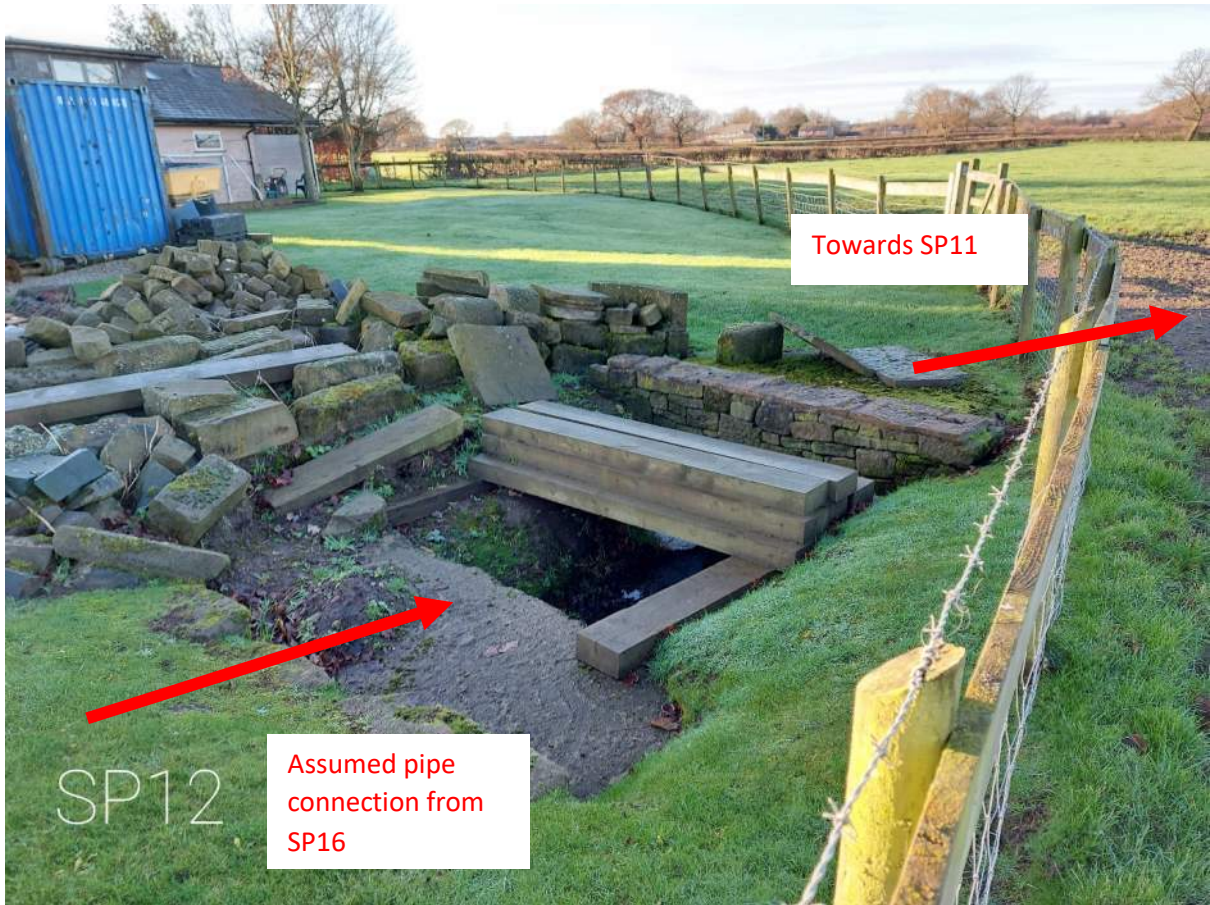
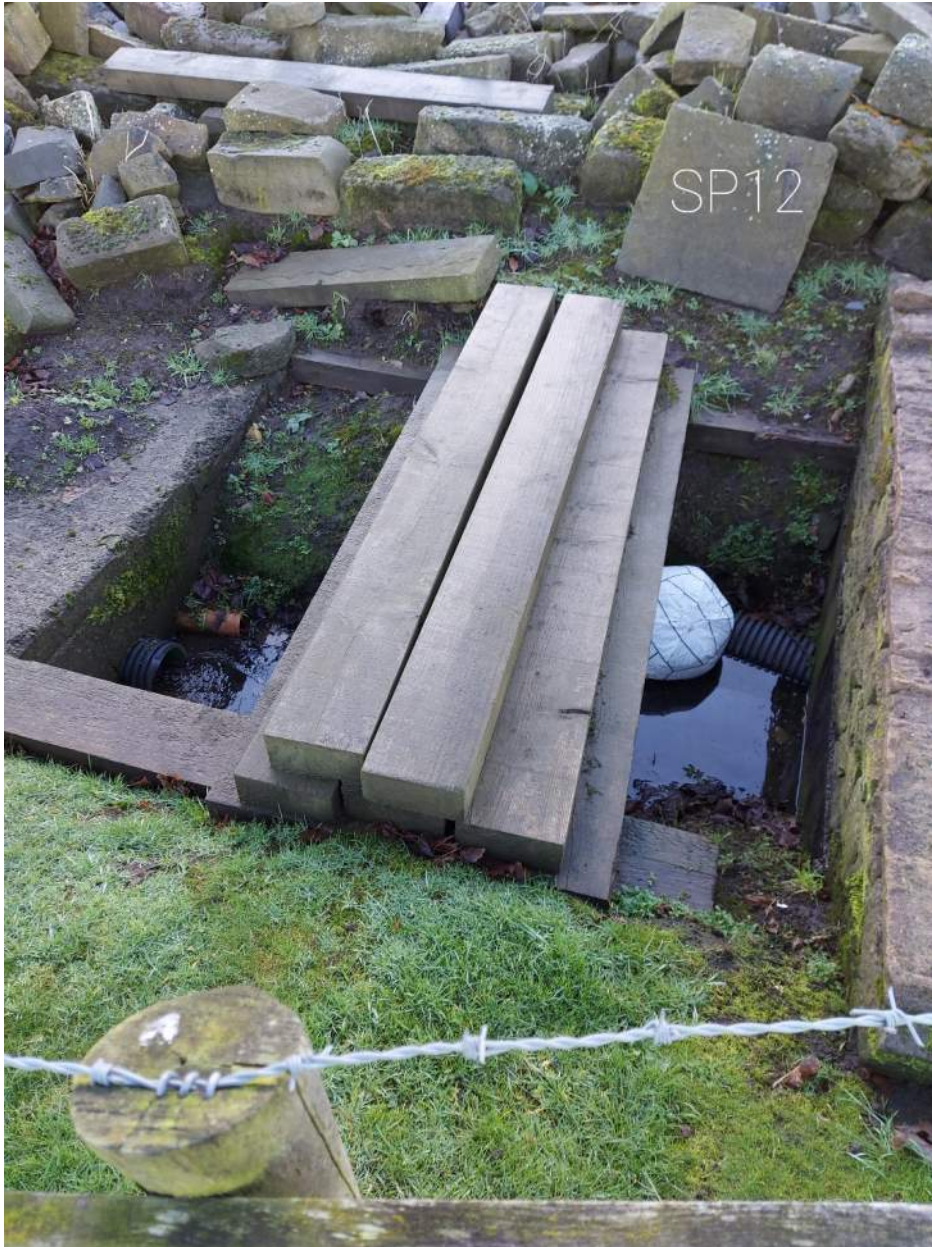
The sheep dip contained ponded water. No flow visible. The team was unable to retrieve a depth from this location.

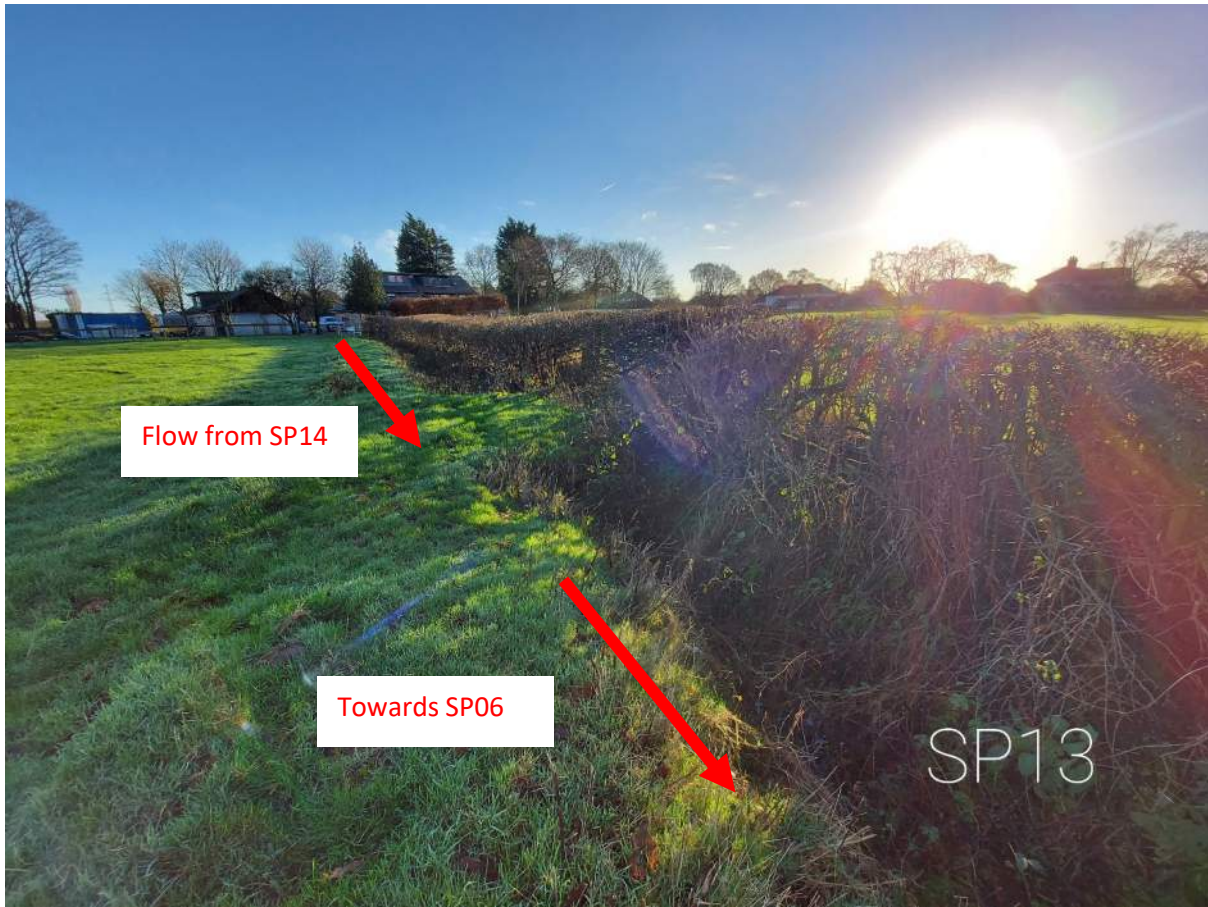
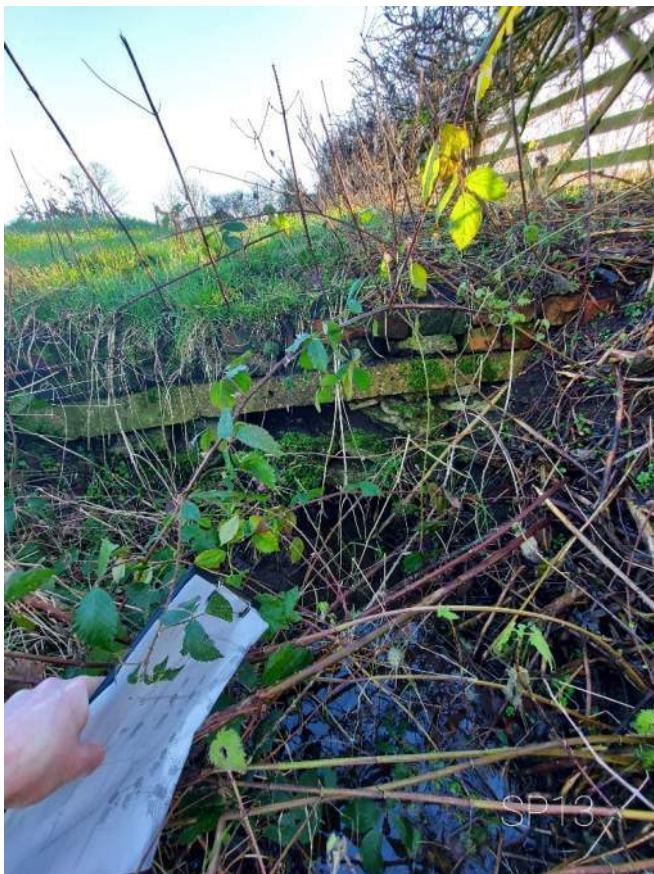
SURVEY POINT 13

Flow present through SP13

D – 1.1m

WL – 0.1m

DW – 2.2m

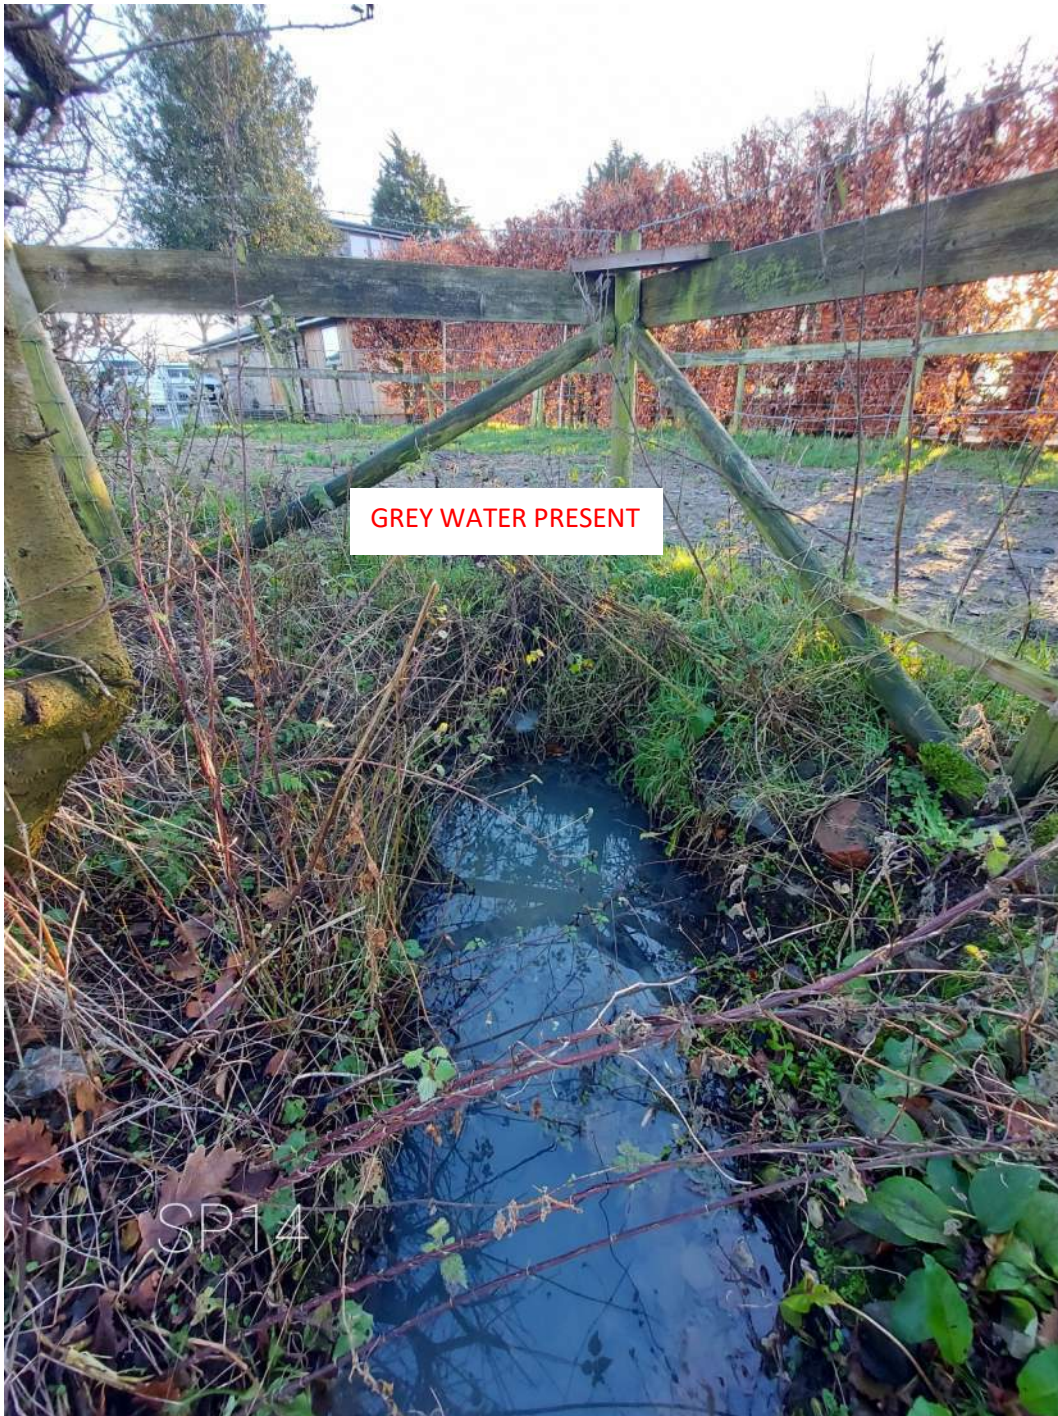
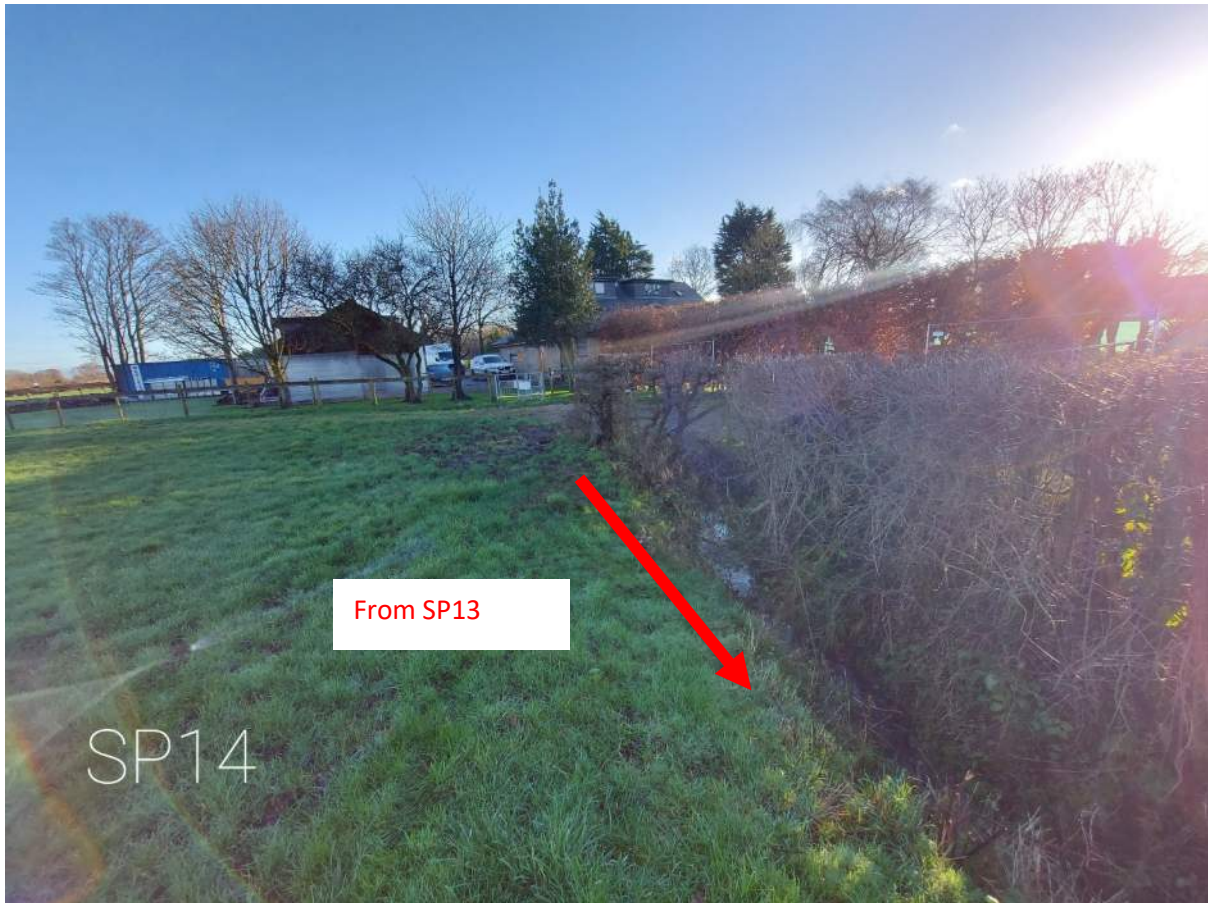
SURVEY POINT 14

A trickle of what appeared to be grey water was present at the head of this ditch. No visible inflow pipe was detected.

D – 1m

WL – 0.1m

DW – 2.1m

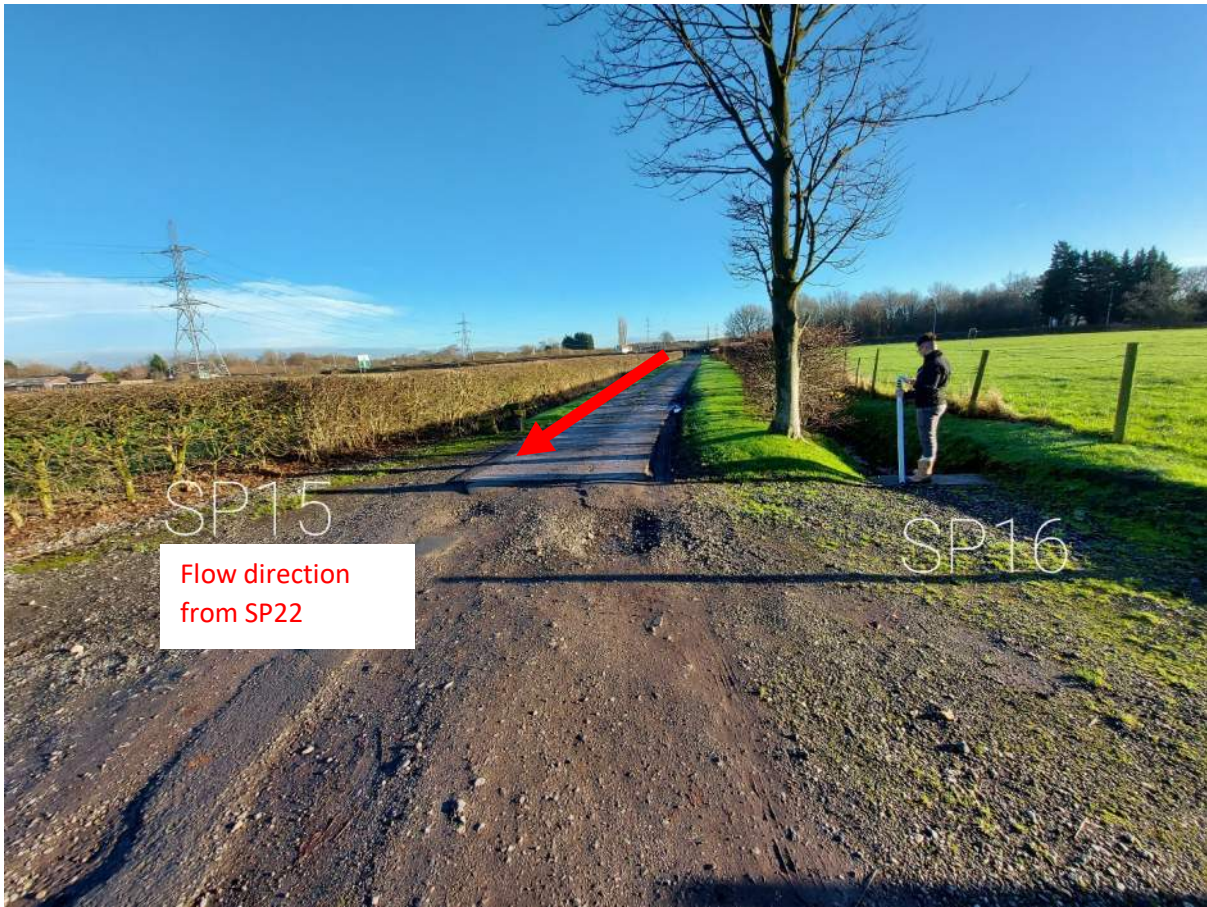
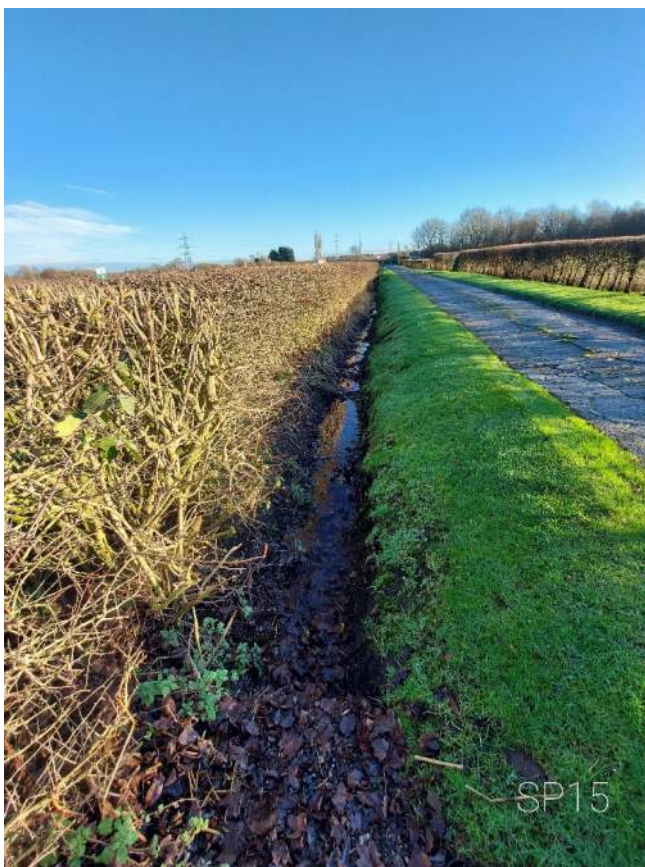
SURVEY POINT 15

Flow present through SP15

D – 1.4m

WL – 0.1m

DW – 3m
