Drainage Ditch Survey

Land Drainage Survey

Woodcock Estate

Doc No: LCCC-BDP-RPT-C-001

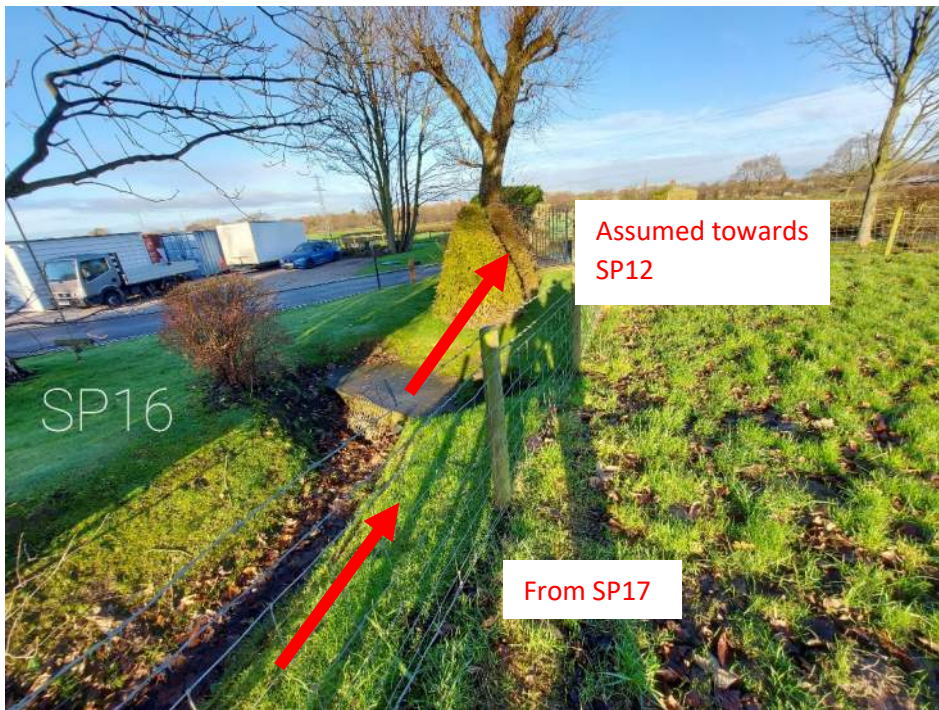
SURVEY POINT 16

Ponded water present in this location. It is assumed connection flow from SP16 to SP 16 (Internal to property grounds – see below)

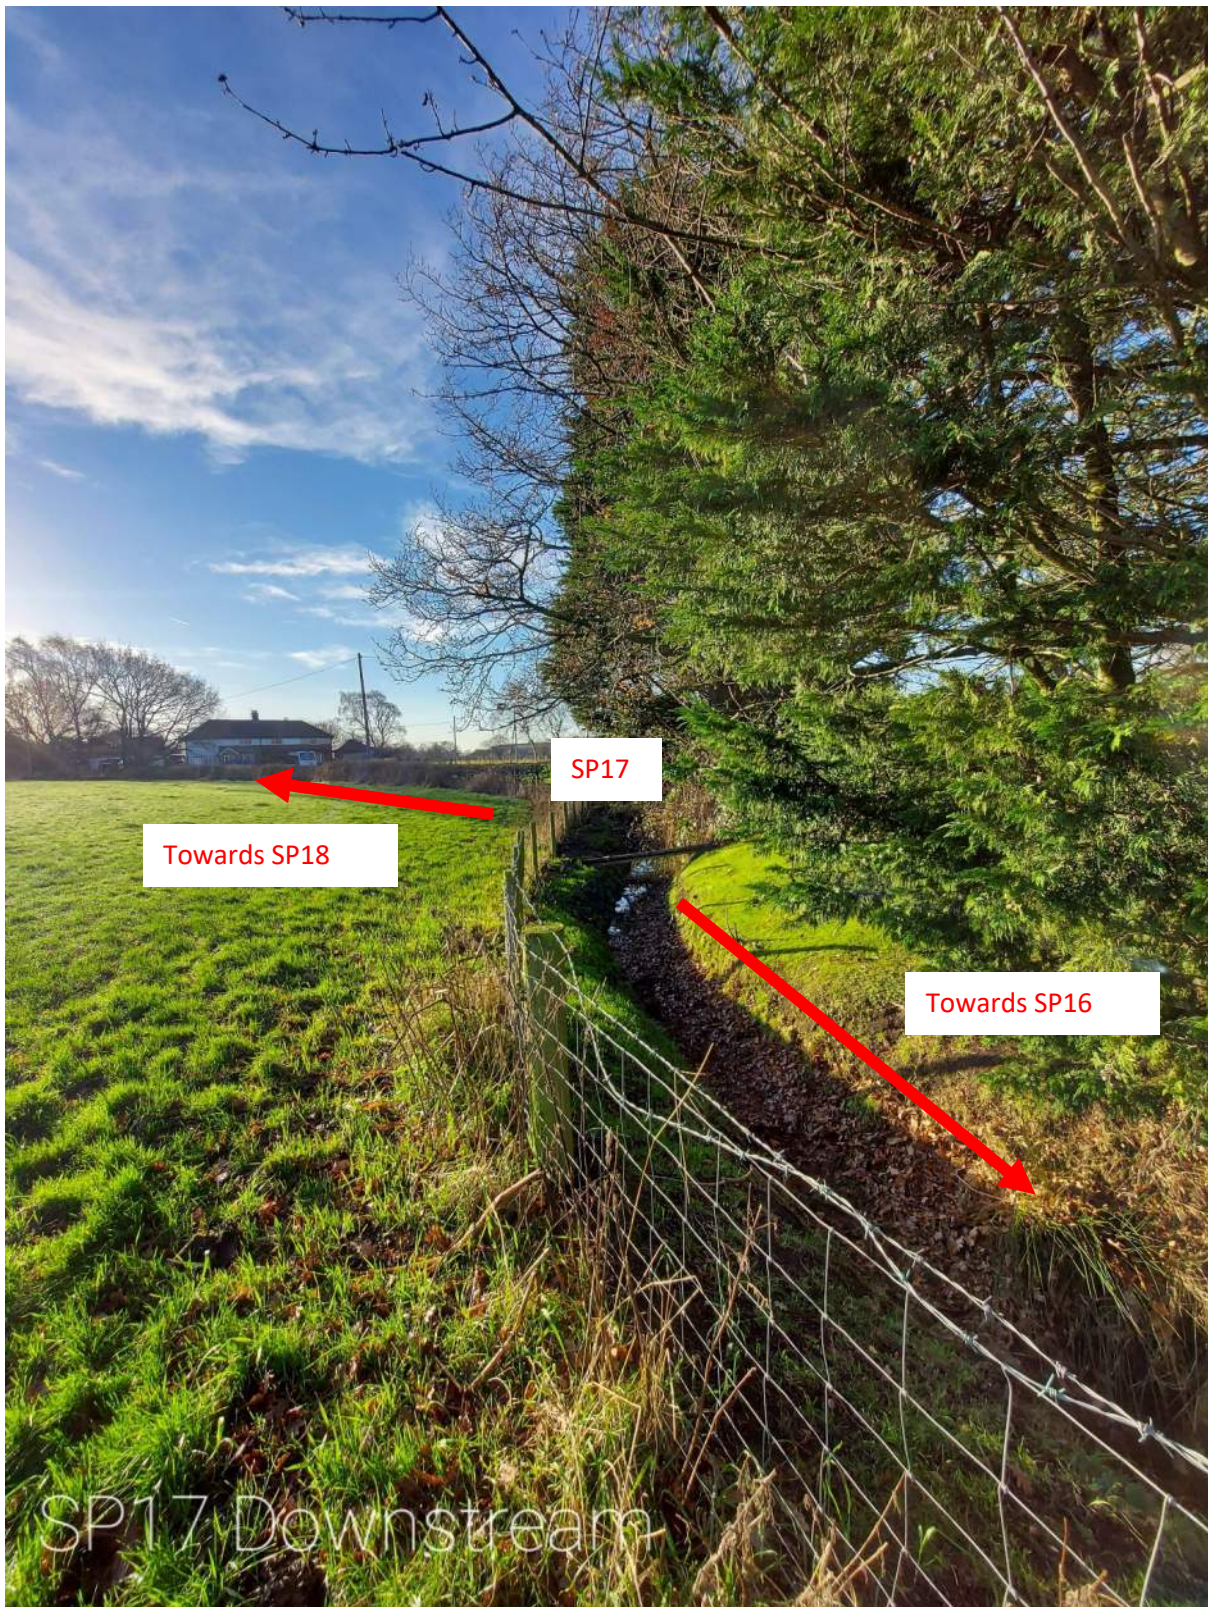
SURVEY POINT 17

D – 1.5m

WL – 0.1m

DW – 5m Ponded water - No flow present

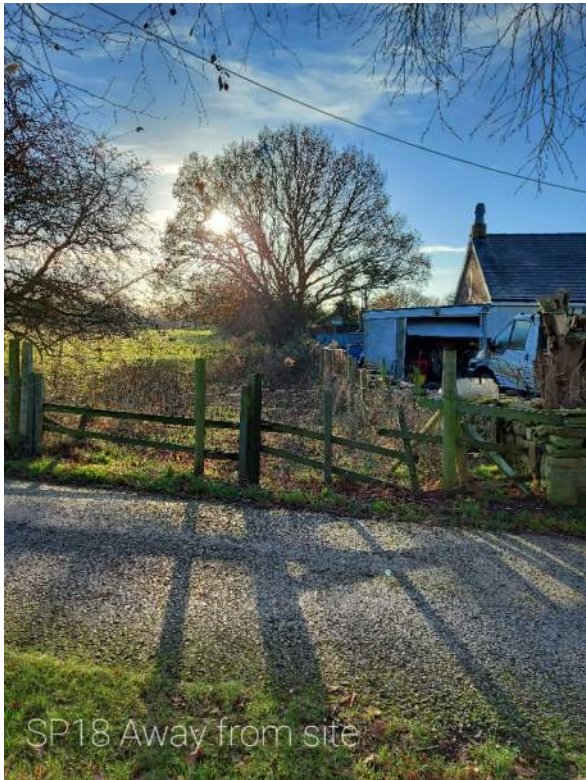
SURVEY POINT 18

Flow of ground water trickling into head of ditch at this location. No visible inflow from off site.

D – 1.5m
WL – 0.1m
DW – 3m

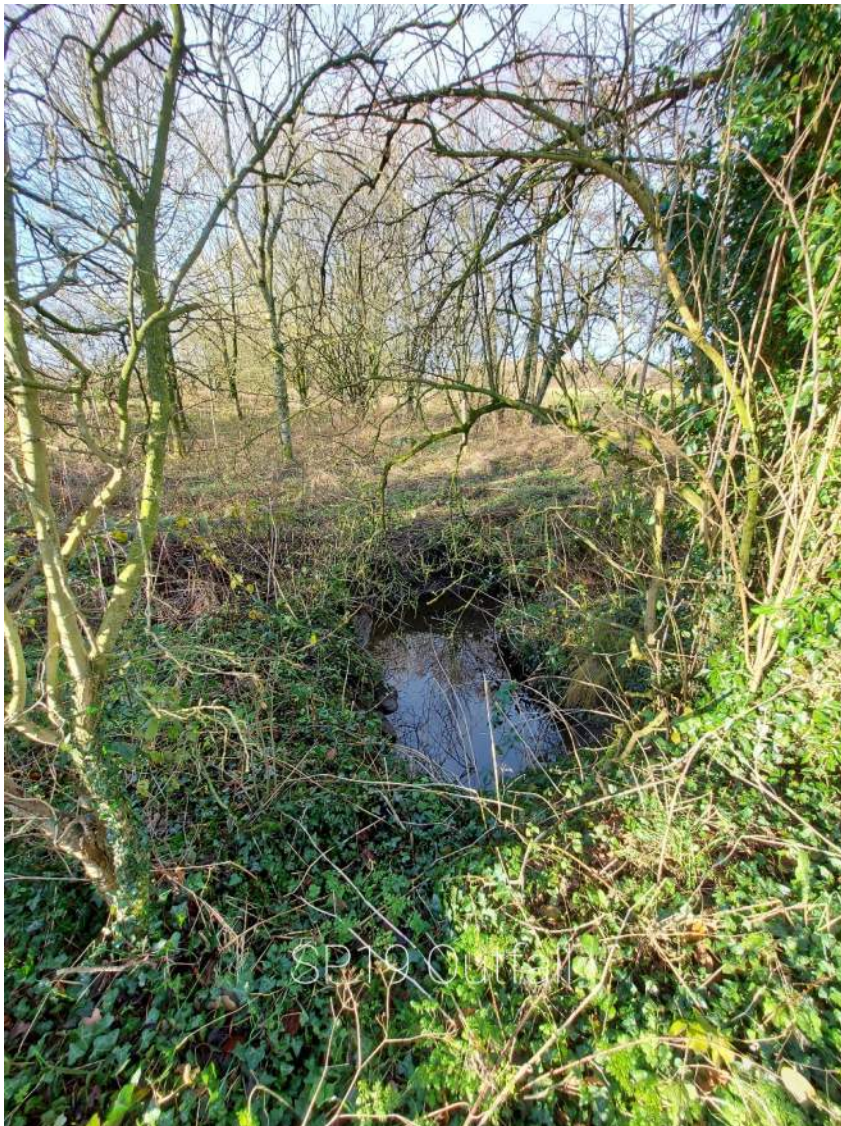
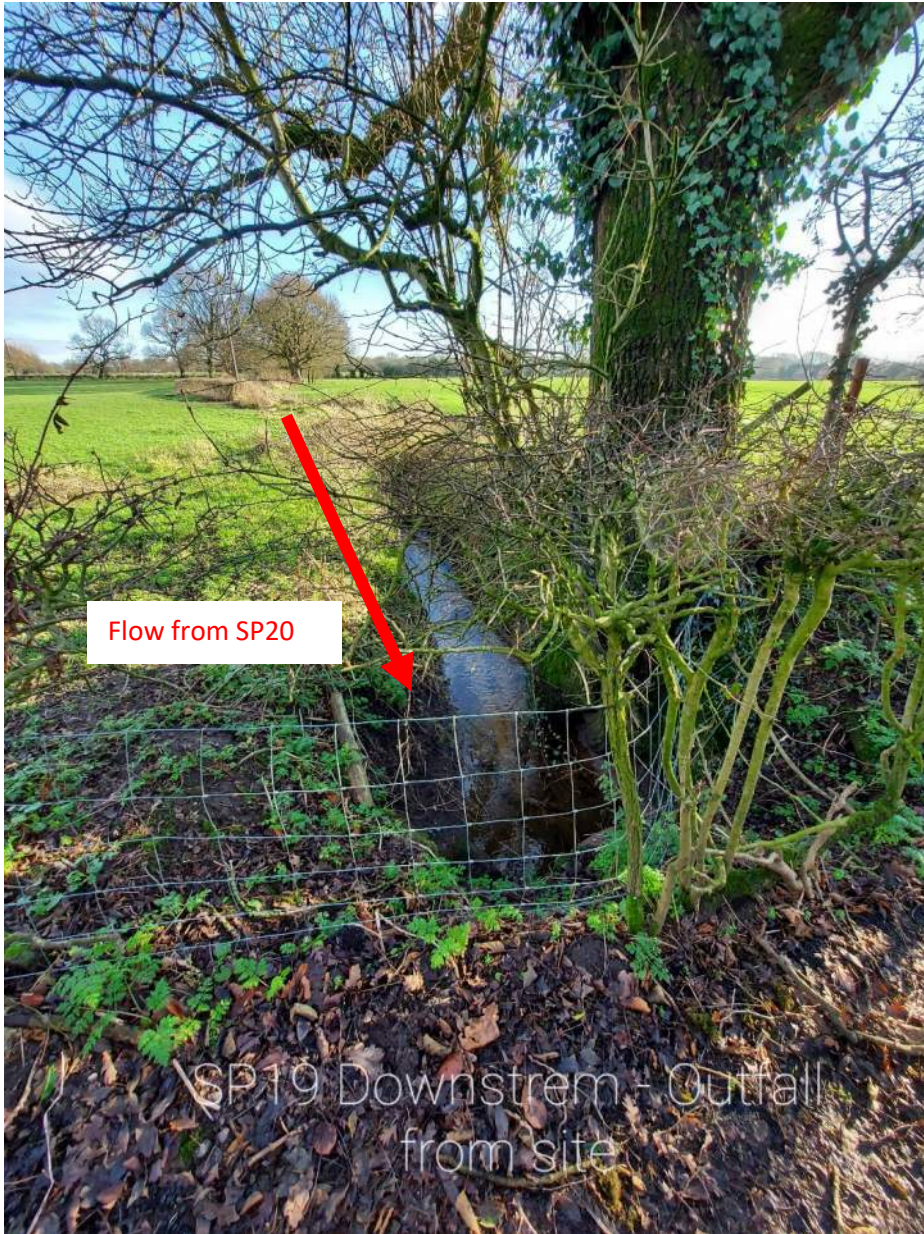
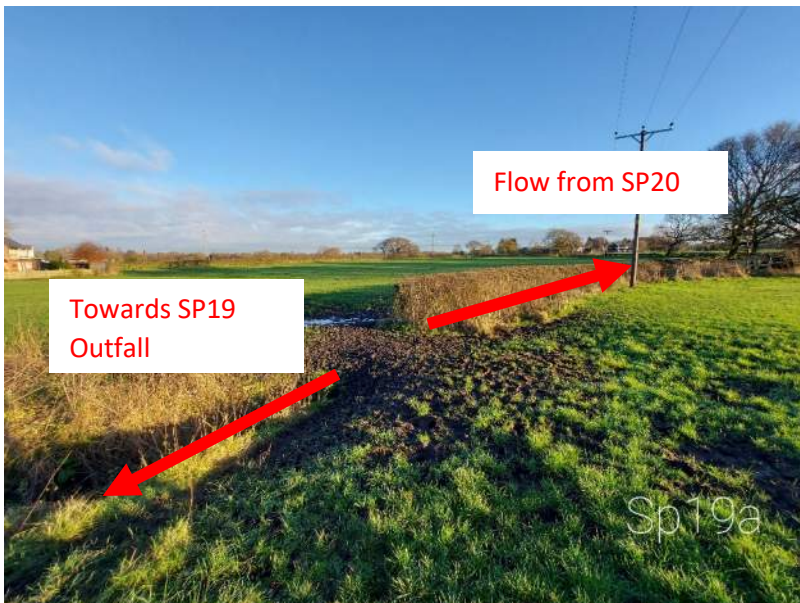
SURVEY POINT 19

Outfall away from site

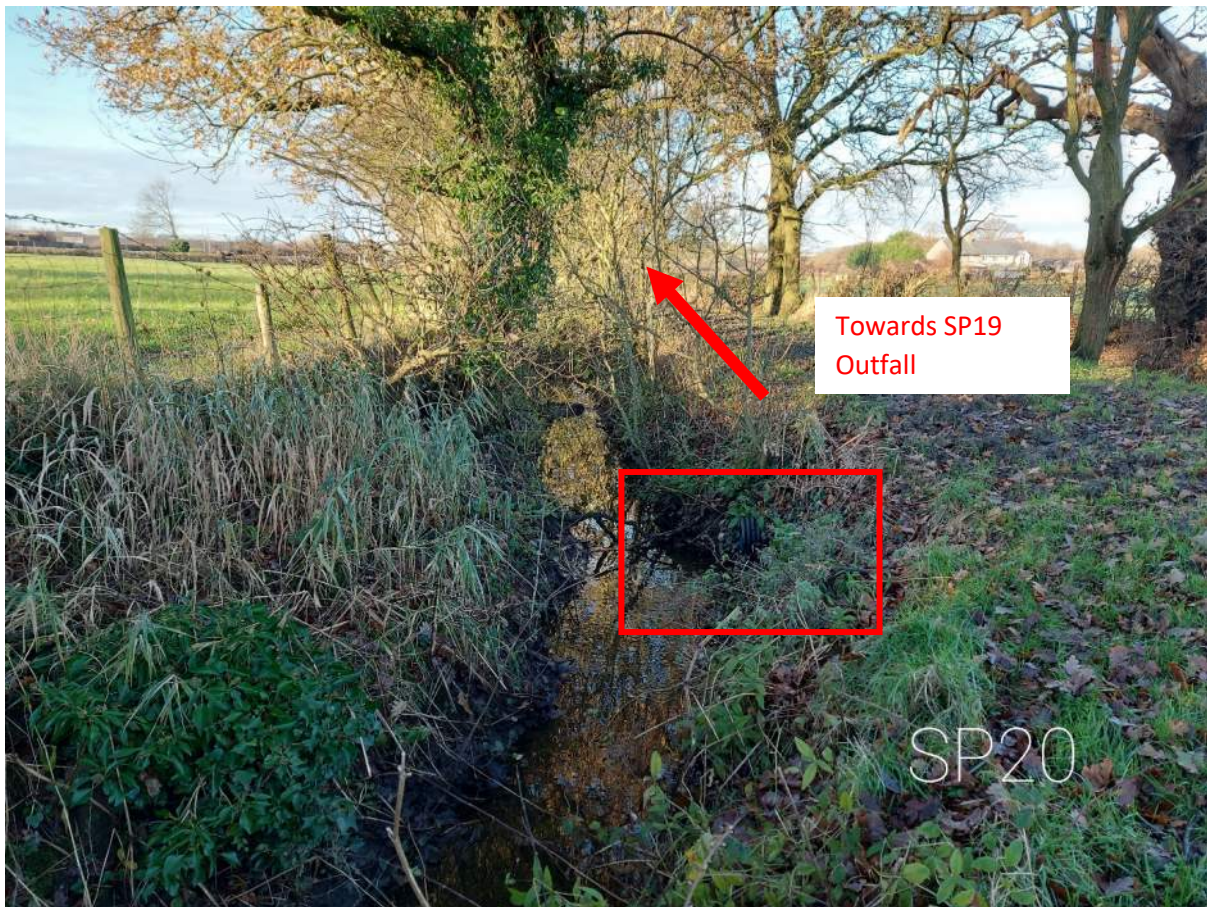
SURVEY POINT 20

Unknown pipe was discovered in this location. Assumed land drain pipe to adjacent field.

D – 1.5m

Invert to incoming pipe from bottom of ditch – 1m

WL – 0.4m

DW – 3.0m

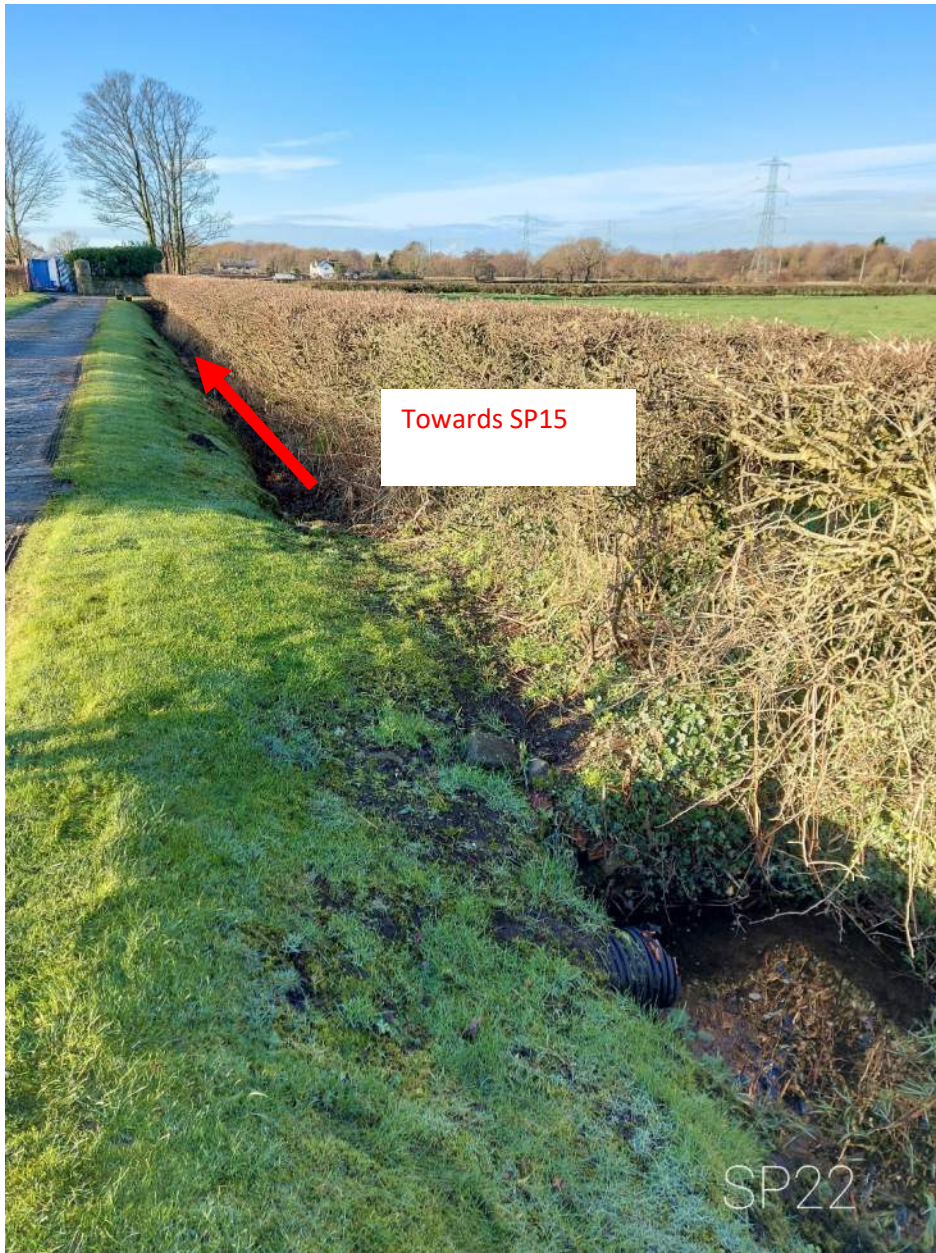
SURVEY POINT 22

Flow of incoming water crosses under access road at this location and flows towards SP15.

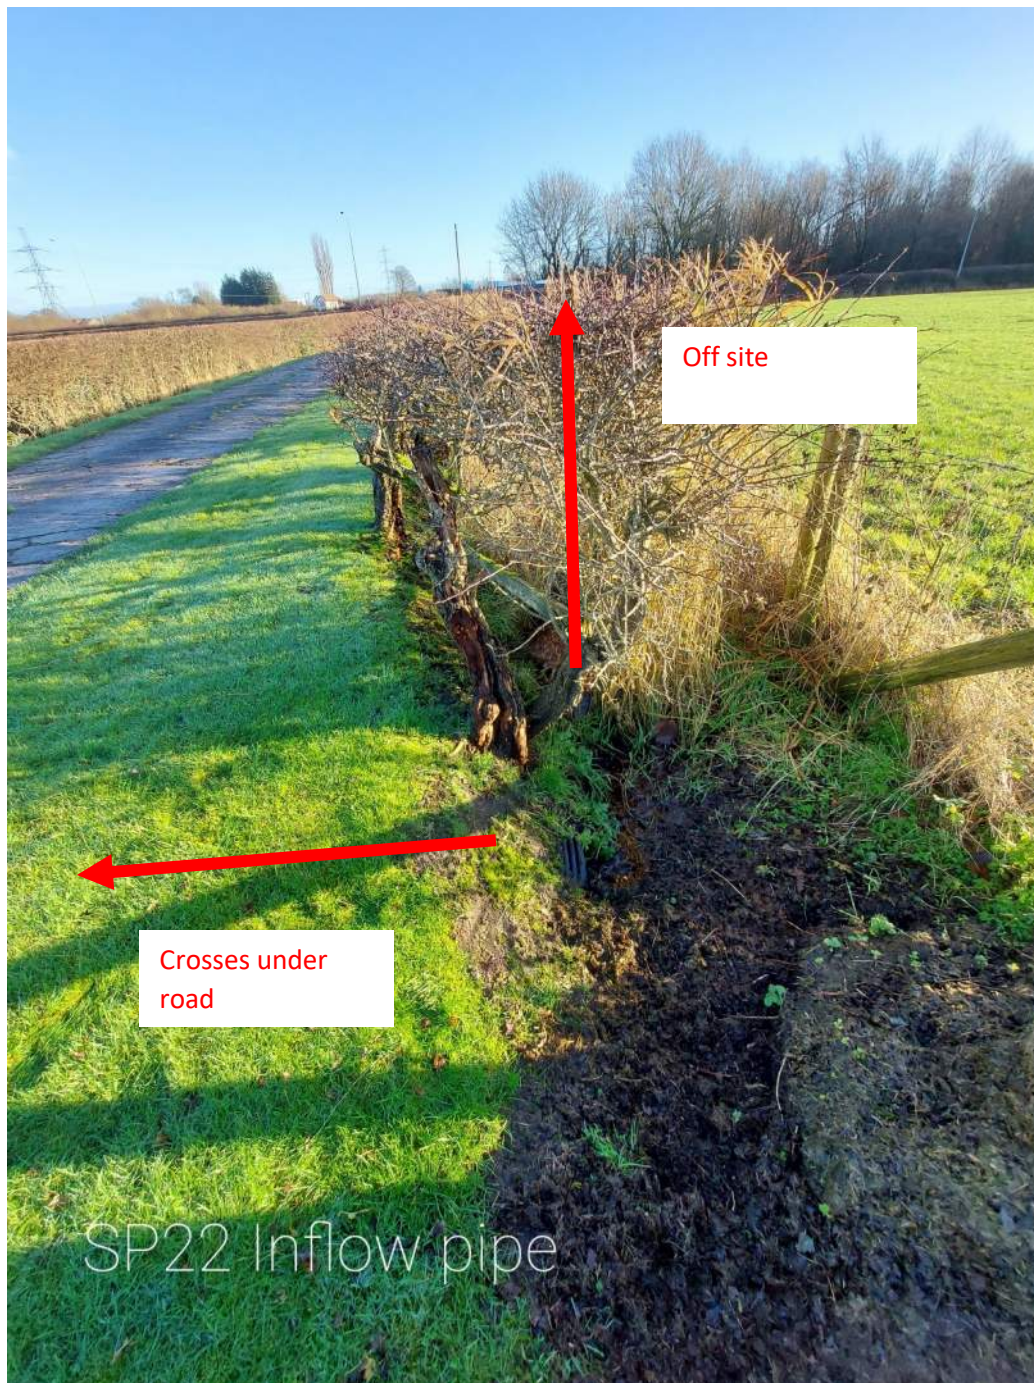
Inflow appears to originate off site.
