Ref: 14-244-L1-RevB Date: 5th May 2022

ANALYSIS OF SLOPE STABILITY GALE MOSS, CHORLEY

Gale Moss, Chorley Ruttle Plant Hire / MPG May 2022

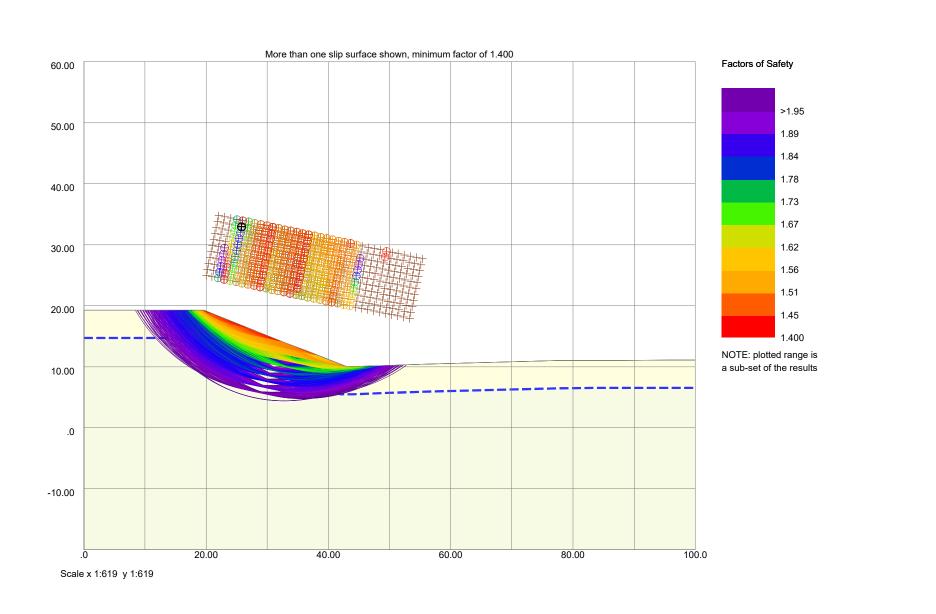
Gale Moss, ChorleySlope Stability Assessment
Section 1

[^]Section 3 is unstable due to the angle on the excavation being over steepened - slight modification on design required.

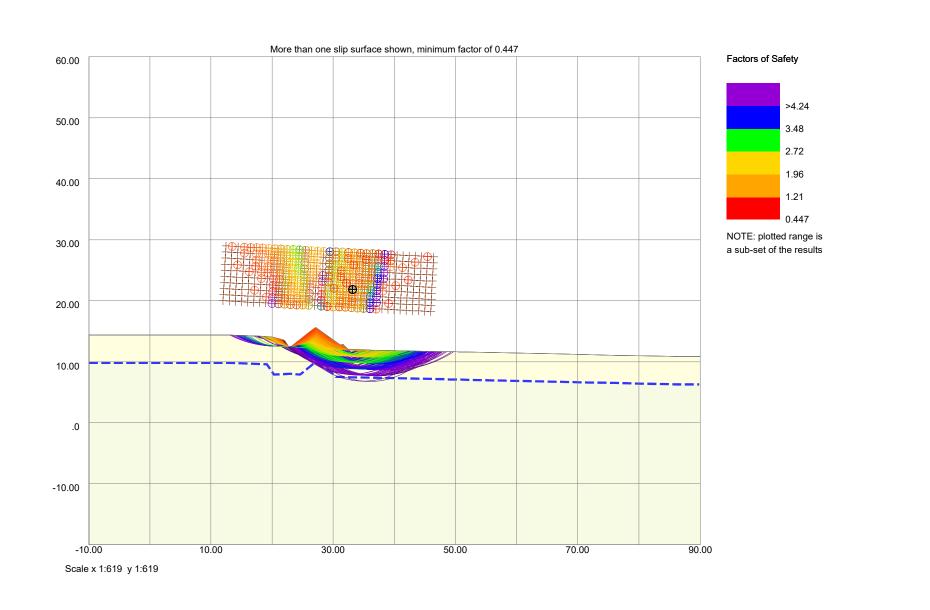
Gale Moss, ChorleySlope Stability Assessment
Section 7

It is evident from the review of the proposed construction drawings, scaled cross sections and slope stability modelling that the slope has potential failure mechanisms where the FOS falls below 1 due to the bund within sections 3, 4, 5, 7, 8, 9 & 10. The 3.00m excavation without the bund is likely to support the application of a load up to 300kN at the top of the slope without failure.
