## **Cottam Parkway Railway Station**

**Arboricultural Impact Assessment Report**

B2327FEF-JAC-ELS-00-RP-ENV-0007 | P04 2022/07/19

**Lancashire County Council**

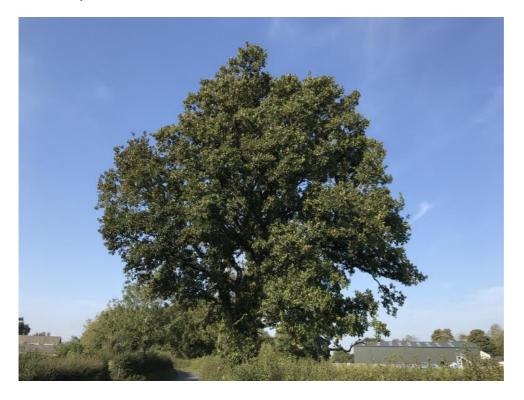
Image 1: Tree T009

T009 (Image 1) is recorded as an early mature roadside oak set within the existing hedge line. This has been assessed as removed as it sits directly under the highway footprint.

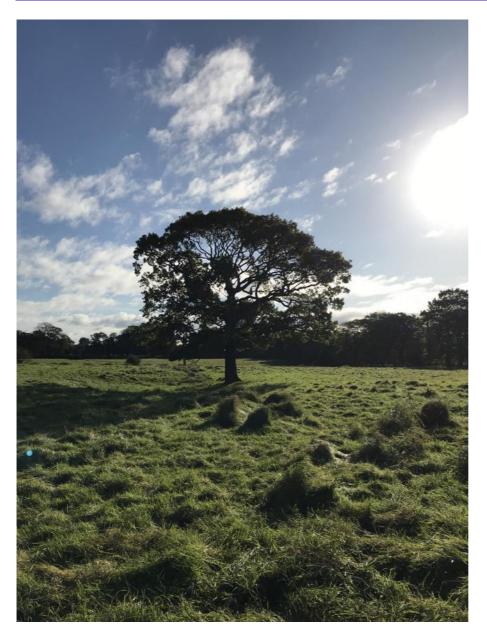
Image 2: Tree T063

T063 (Image 2) is recorded as a mature oak tree, this tree has been assessed for removal as it currently sits under the railway station car park design, and associated access road footprint.

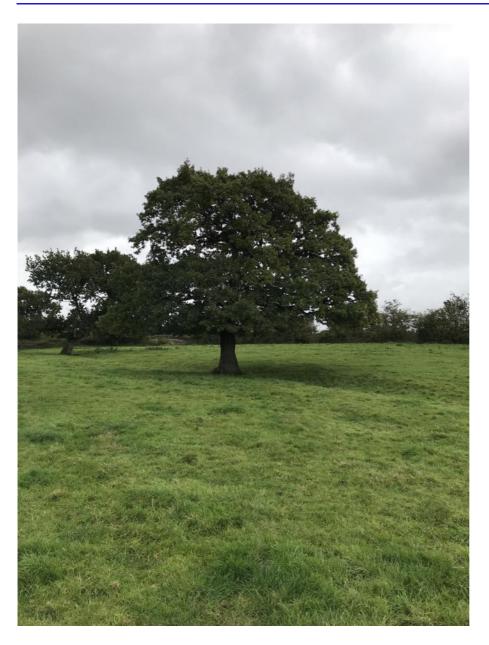
Image 3: Tree T057

T057 (Image 3) is recorded as a B grade mature oak tree. Located in an agricultural field, this tree has been assessed as encroached as it sits within the 'Temporary Working Area'. As this area is temporary, it is viable that this tree could be retained. However, retention will only be possible provided that protective measures are put in place to protect this tree (and others listed as encroached within this report). This should require the contactor to submit a SS-AMS and associated Tree Protection Plan prior to works commencing which should reduce the likelihood of direct / indirect impacts to these features.

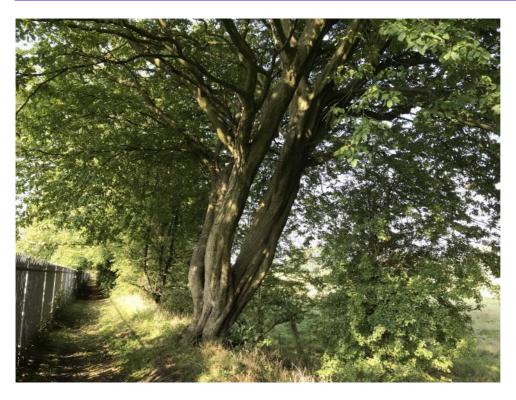
Image 4: Tree T018

T018 (Image 4) is a lapsed hornbeam coppice located adjacent to the public footpath that runs along the existing public right of way between Lea Road and Sidgreaves Lane. This high value tree has an RPA of approximately 12 metres, and as such is encroached on its northern margin by the railway station design. As mentioned above, it is the understanding of Jacobs arboriculturists that efforts have been made to move the position of the car park further north to reduce the encroachment. It is recommended that the appointed contractor submits a SS-AMS to indicate how construction will consider this existing tree.
