### **Cottam Parkway Access Bridge and Road Preliminary Sources Study Report**

Geotechnical Report No. CLM07

Cottam Parkway Access Bridge and Road

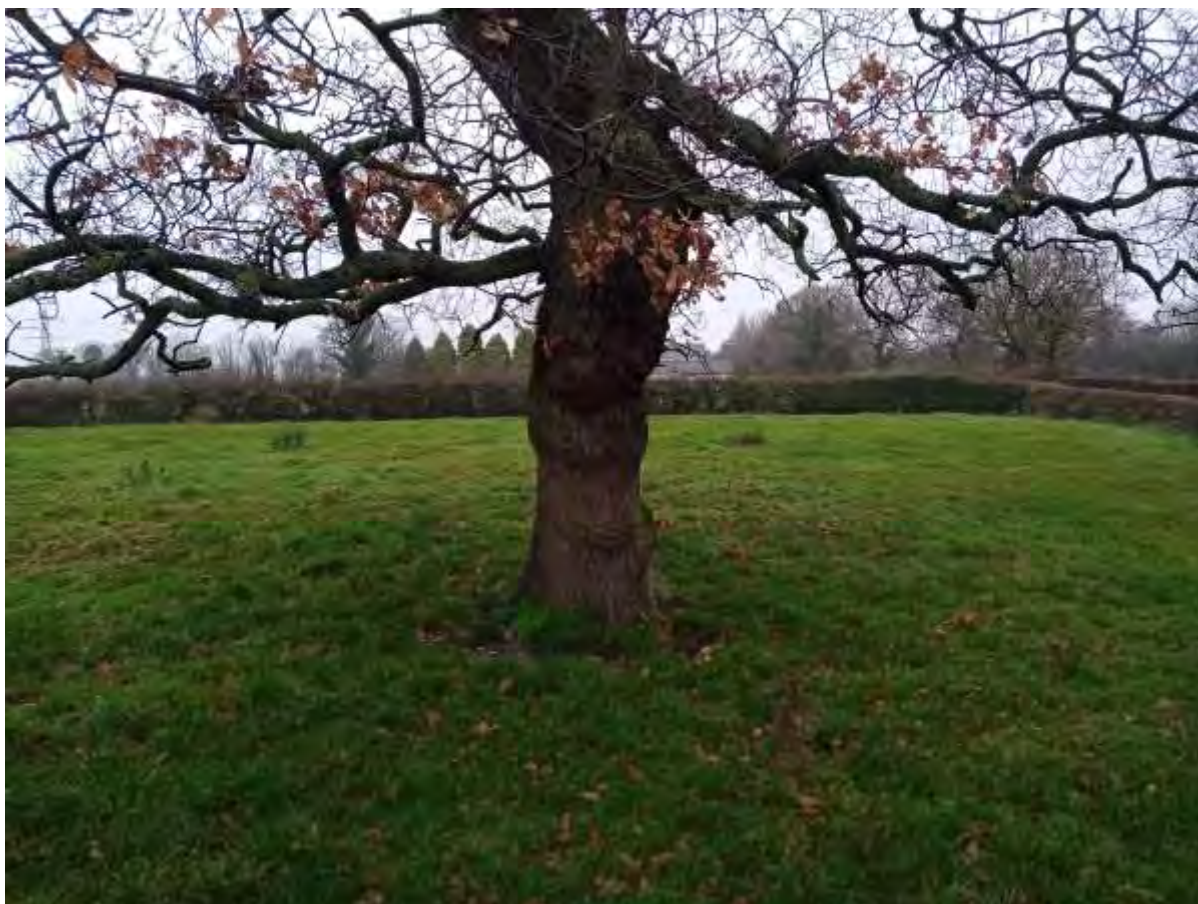
349031:431659

Tree that must be removed to build embankment

Sidgreaves Lane and along the railway will be required in order to allow for the construction of the proposed structures. It is recommended that ecology surveys are undertaken in these areas, and that any trees, hedgerows and vegetation are removed outside of bird nesting season.

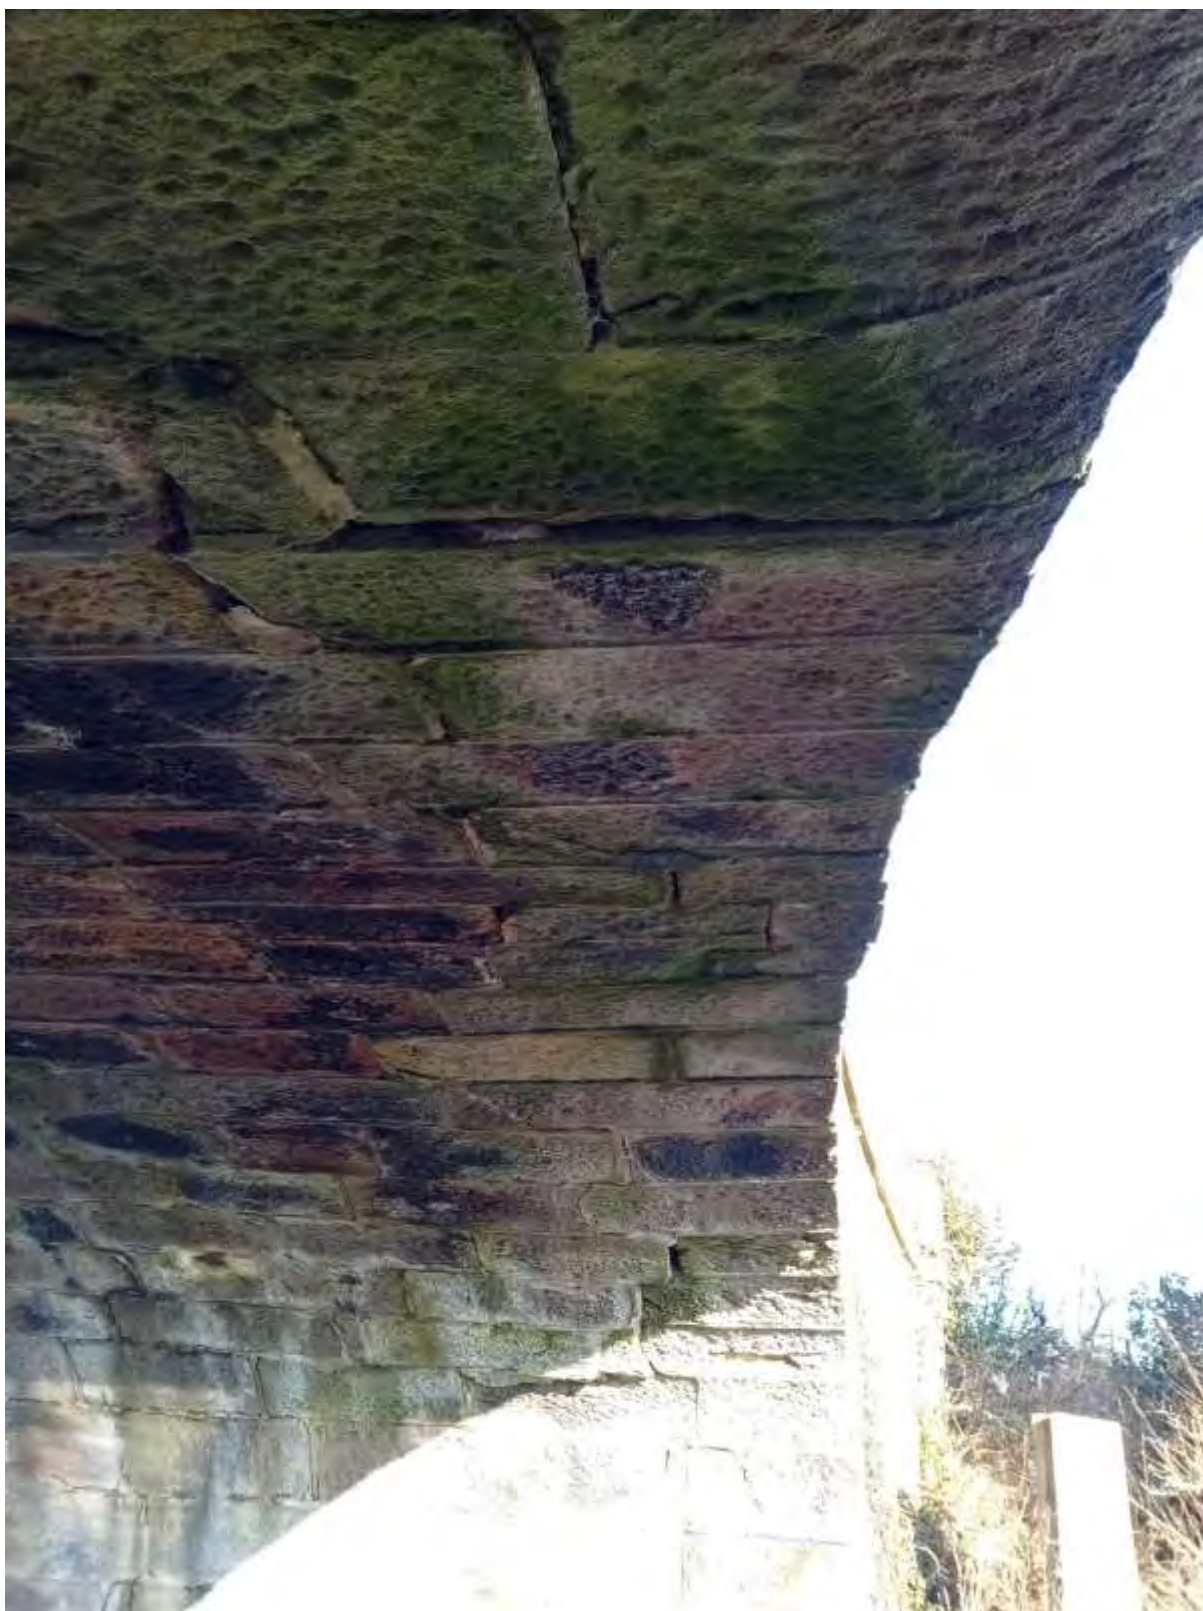
E349066:N431625

- There were no visual or olfactory signs of contamination at the site during the site walkover.
- Quakers Canal Bridge was noted to have a large crack on the underside of the bridge and masonry protruded from the main structure by 10-30mm, which may be indications of structural instability. In addition, Quakers Bridge is quite narrow and has notable scrapes along its parapets, presumably caused by traffic.

Quaker's Bridge under side

The only above ground structure currently within the proposed route is Quakers Canal Bridge (Structure Reference: 837B), a single arch span Victorian bridge roughly 4.00m in height and with a span of 10.00m. No bearing capacity or technical drawings of the bridge are available. As noted in the site walkover section, the bridge shows signs of structural damage. It is therefore recommended that an assessment by a bridge engineer be undertaken as to instruct on its stability during and after the construction of the new bridge.

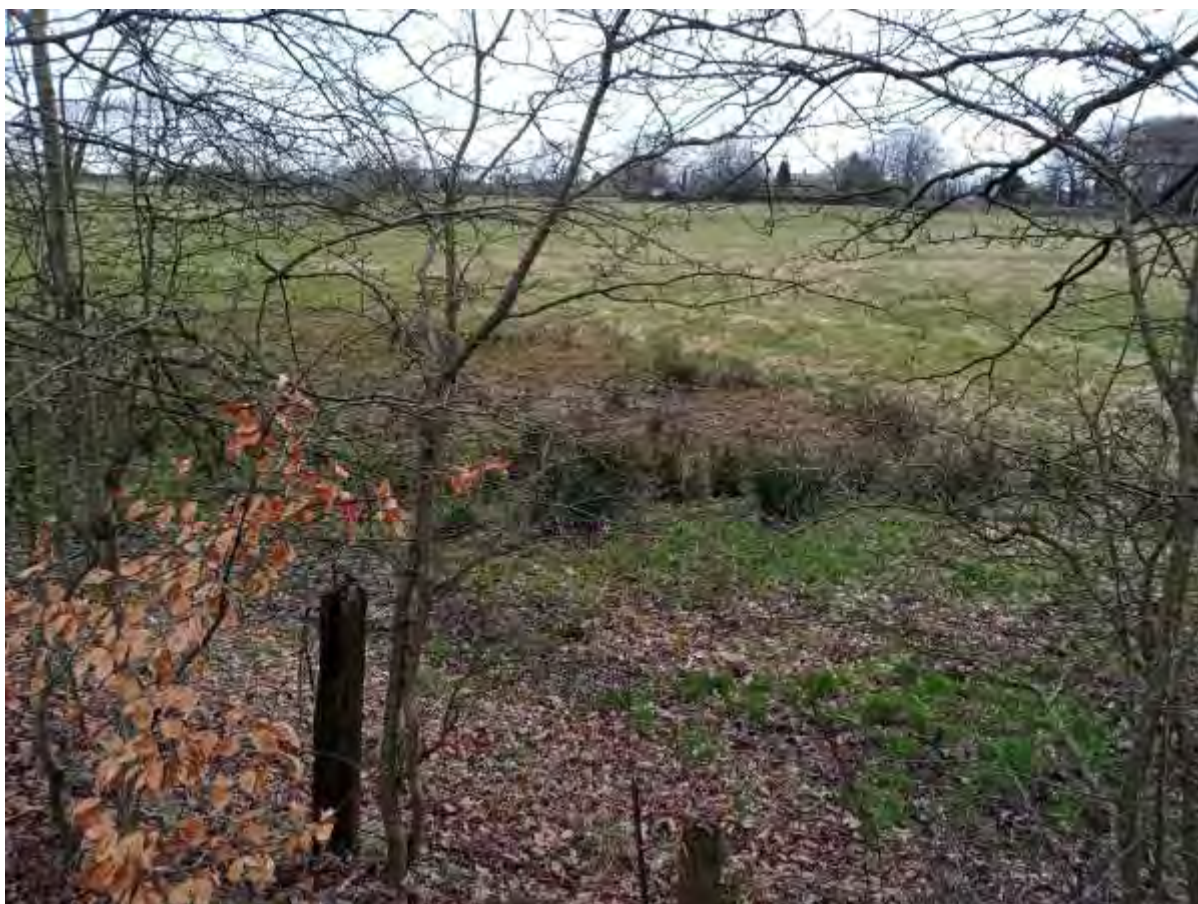
E349399:N431300

- The first site inspection was carried out during wet conditions, and it was noted that the fields were waterlogged. The second site and third inspection were undertaken in clear conditions, however the south eastern fields were noted to still have patches of surface water at E349217:N431363 and boggy ground at E349394:N431314.

Boggy Ground in south eastern field

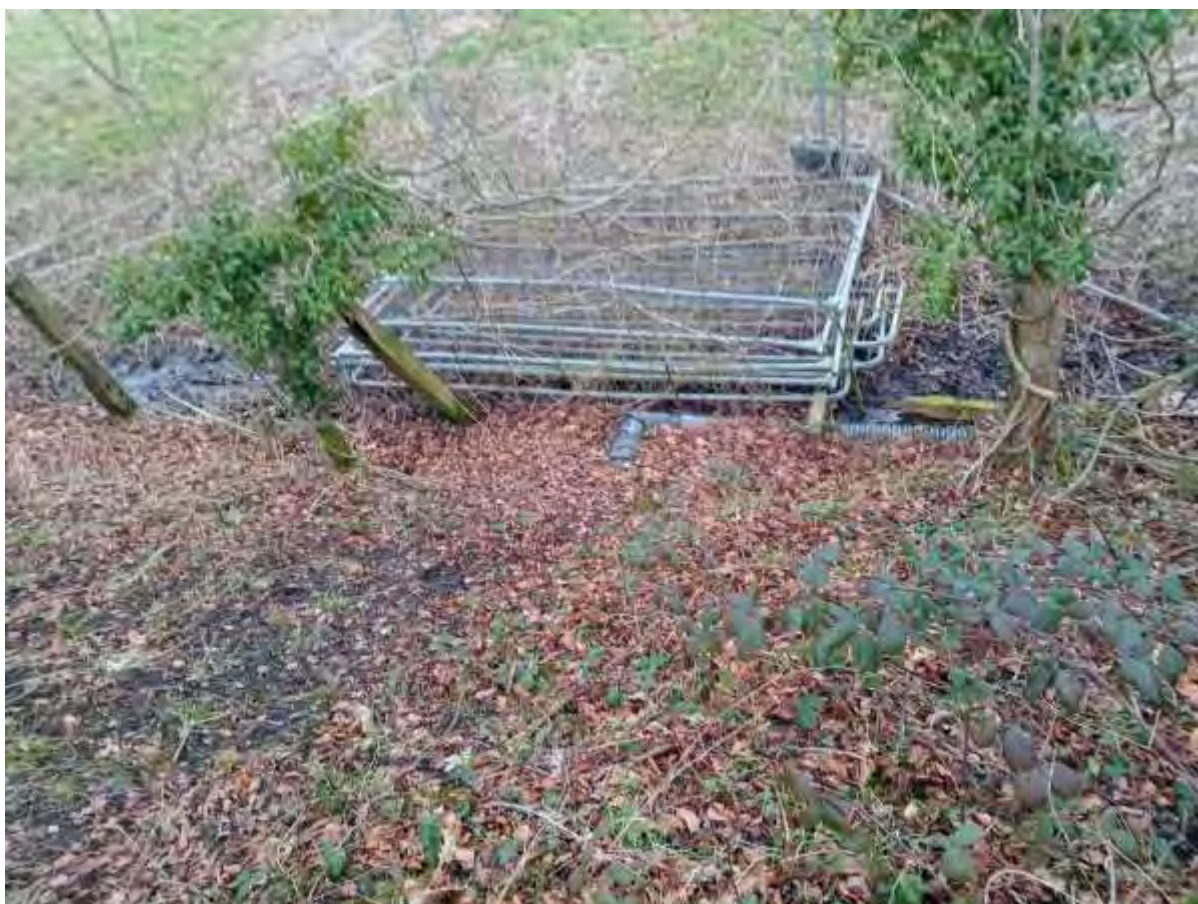
E349344:N431300

- Located in the south eastern field is a large plastic pipe that protrudes out from the railway embankment at E349346:N431304.
- An unnamed small watercourse in the eastern fields is culverted underground at E349338:N431351, directly beneath the proposed car park. Located at E349348:N431303 is a brick culvert that transports this watercourse underneath the railway. The culvert has one large crack that protrudes from the top of the archway, but otherwise looks to be in a good structural condition.

Abandoned fencing and unidentified pipe next to railway embankment.

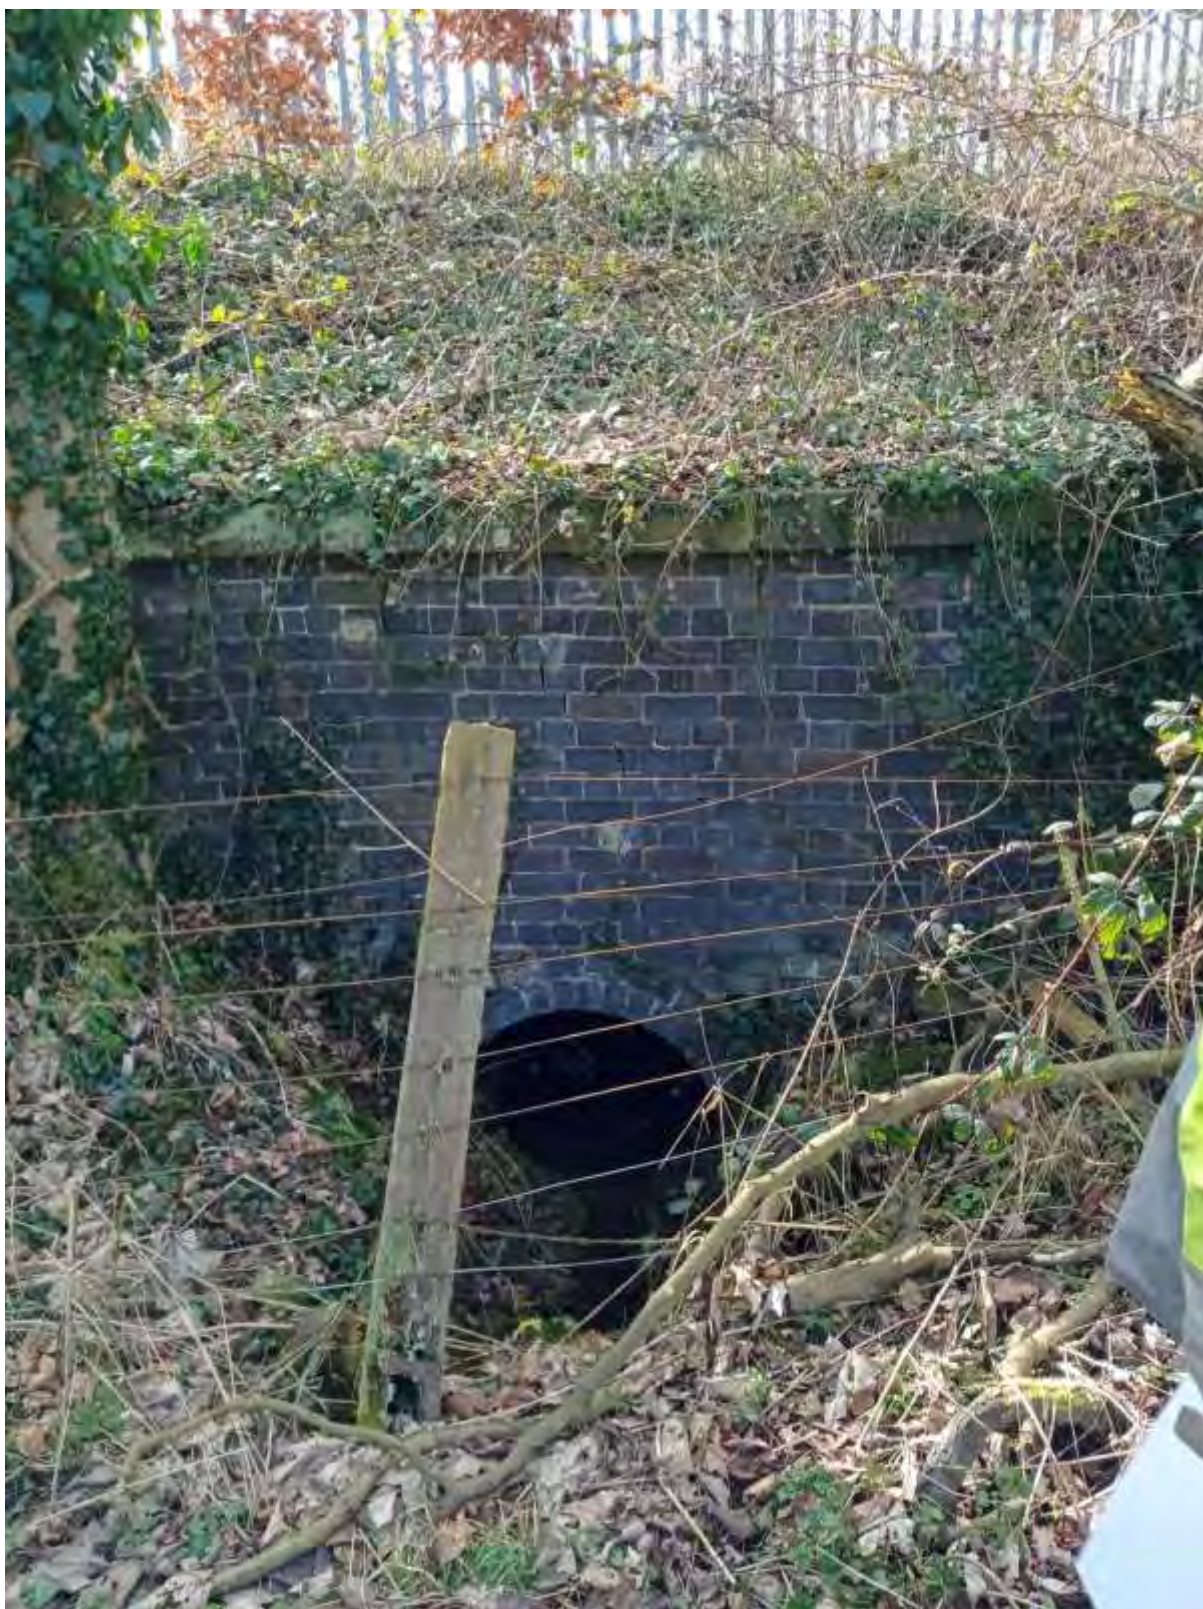
E349347:N431303

Culvert where stream runs underneath railway. One large crack is noted from the crest of the arch to the top of the bridgework.

The structural condition of the existing culvert, diverting the unnamed watercourse under the existing railway and proposed car park area, is unknown. It is therefore recommended that an assessment and survey of the culvert be undertaken by a suitably qualified engineer to inform design of the proposed car park.

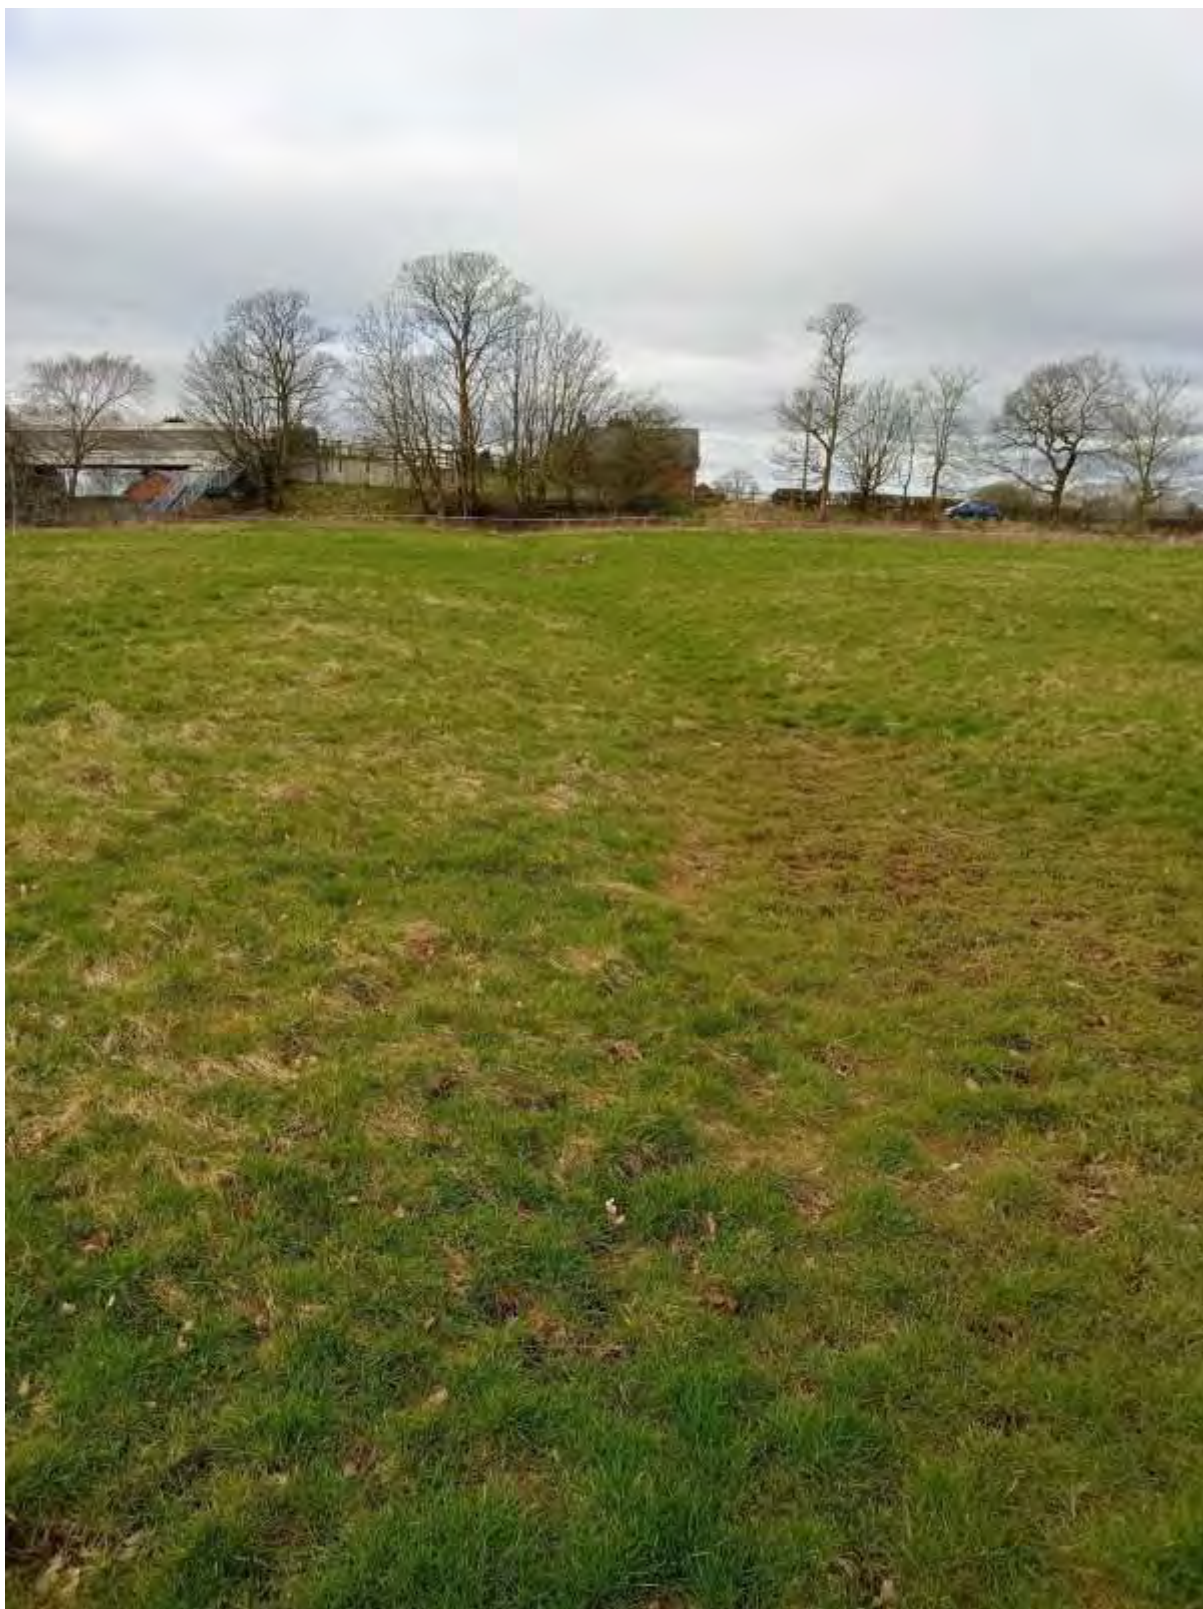
Approximately E349267:N431318

Also noted during the site walkover, several drainage ditches are located across the south eastern field, with an average depth of 0.25m. These ditches do not appear on any of the topographical maps. however, there is some correlation between them and the surface water flood maps. An approximate location map of these ditches is available in Appendix F.

Shallow ditch orientated east-west.

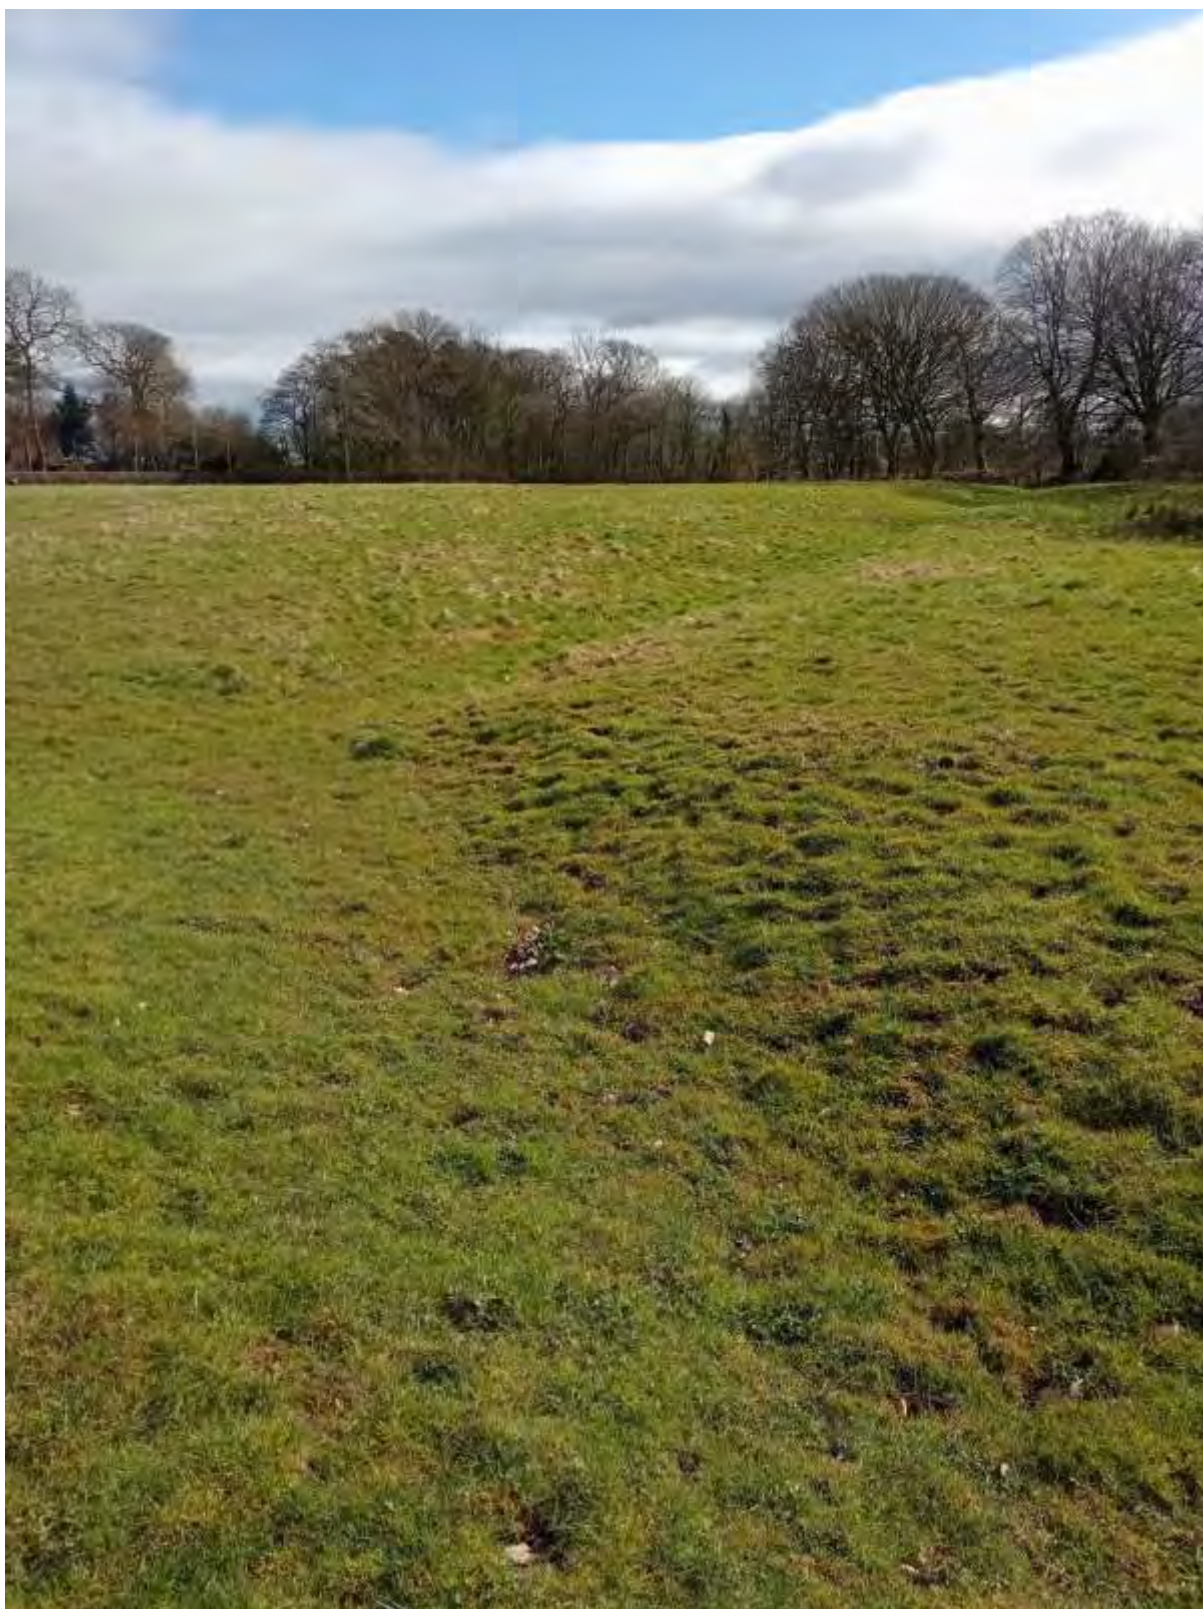
Approximately E349360:N431340

Shallow ditch initially orientated east-west however diverges south towards the railway.

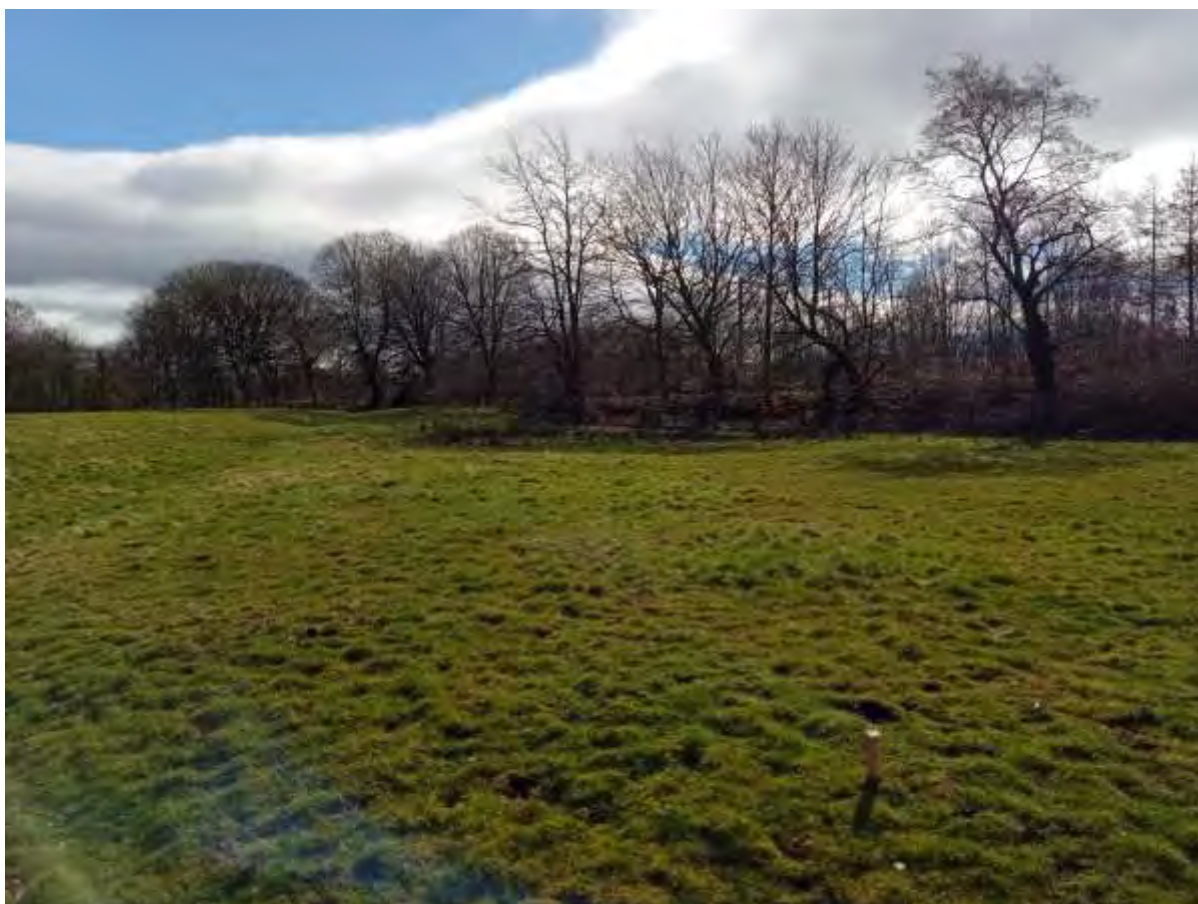
E349392:N431315

Boggy ground.

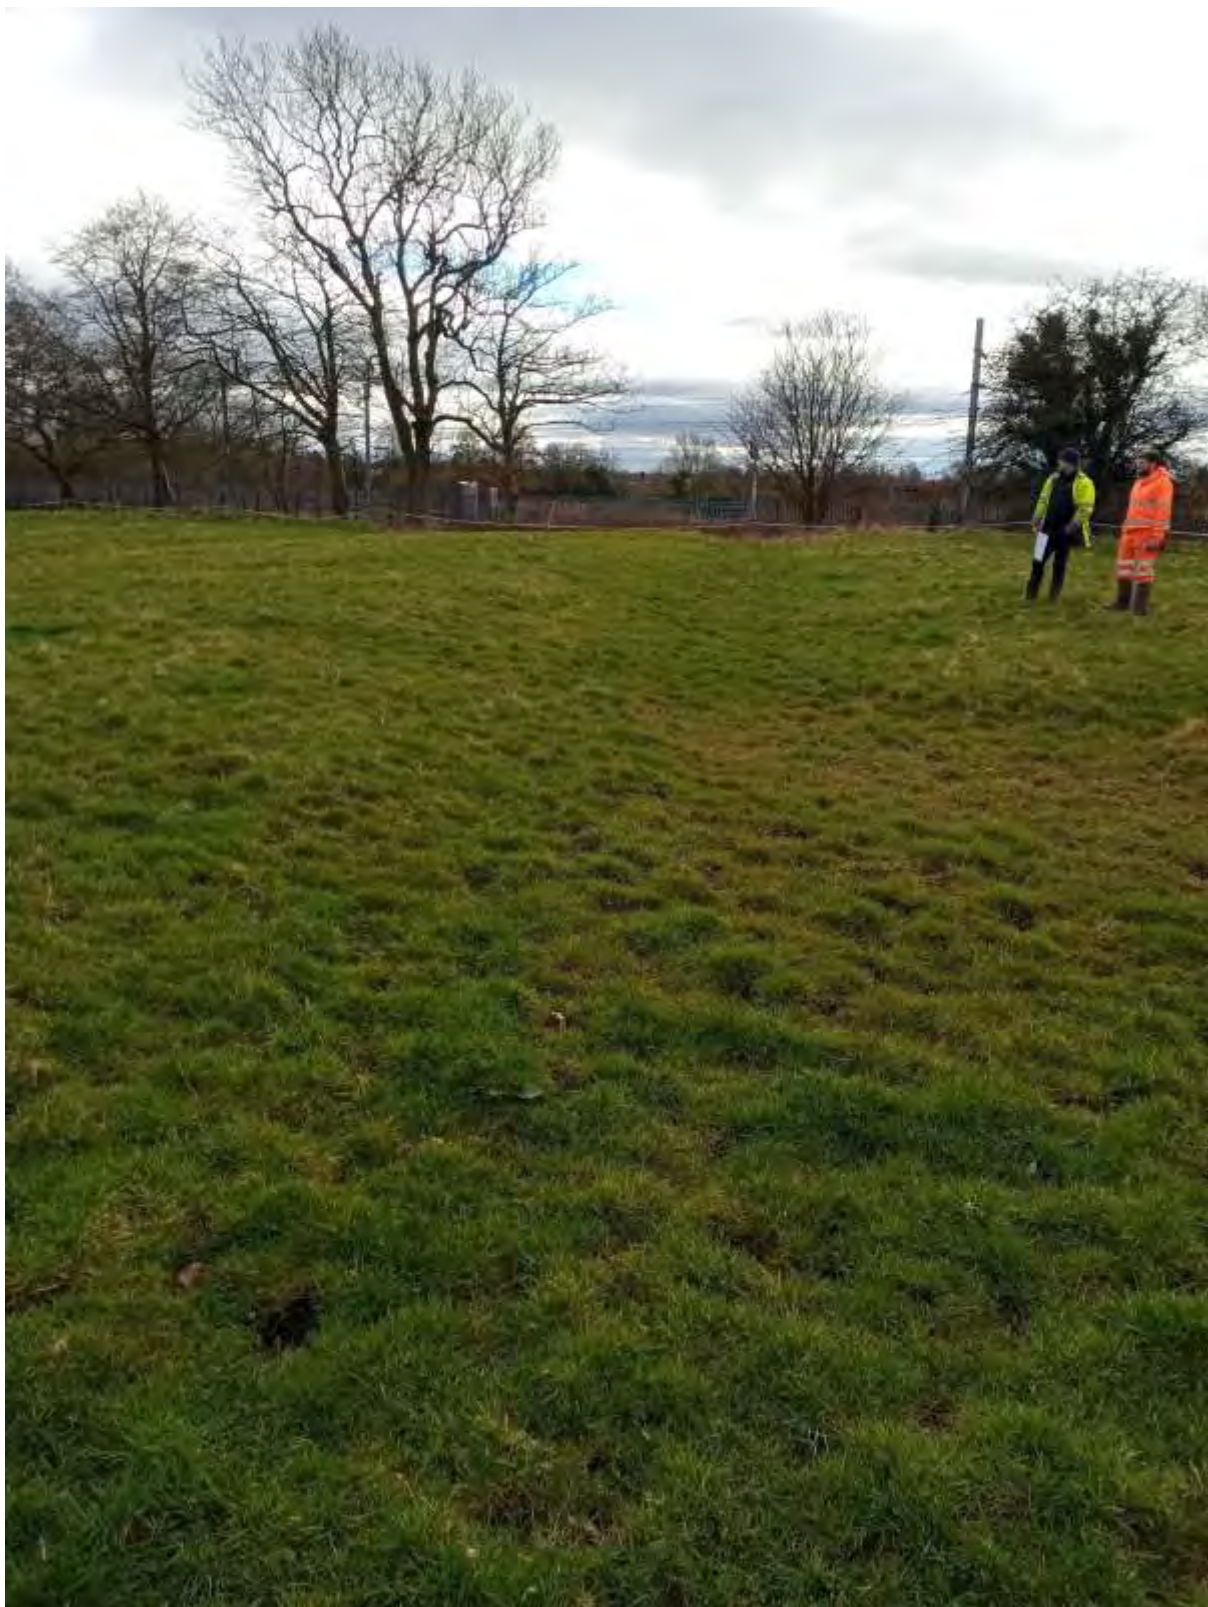
Approximately E349275:N431328

Shallow ditch orientated north-south towards railway.

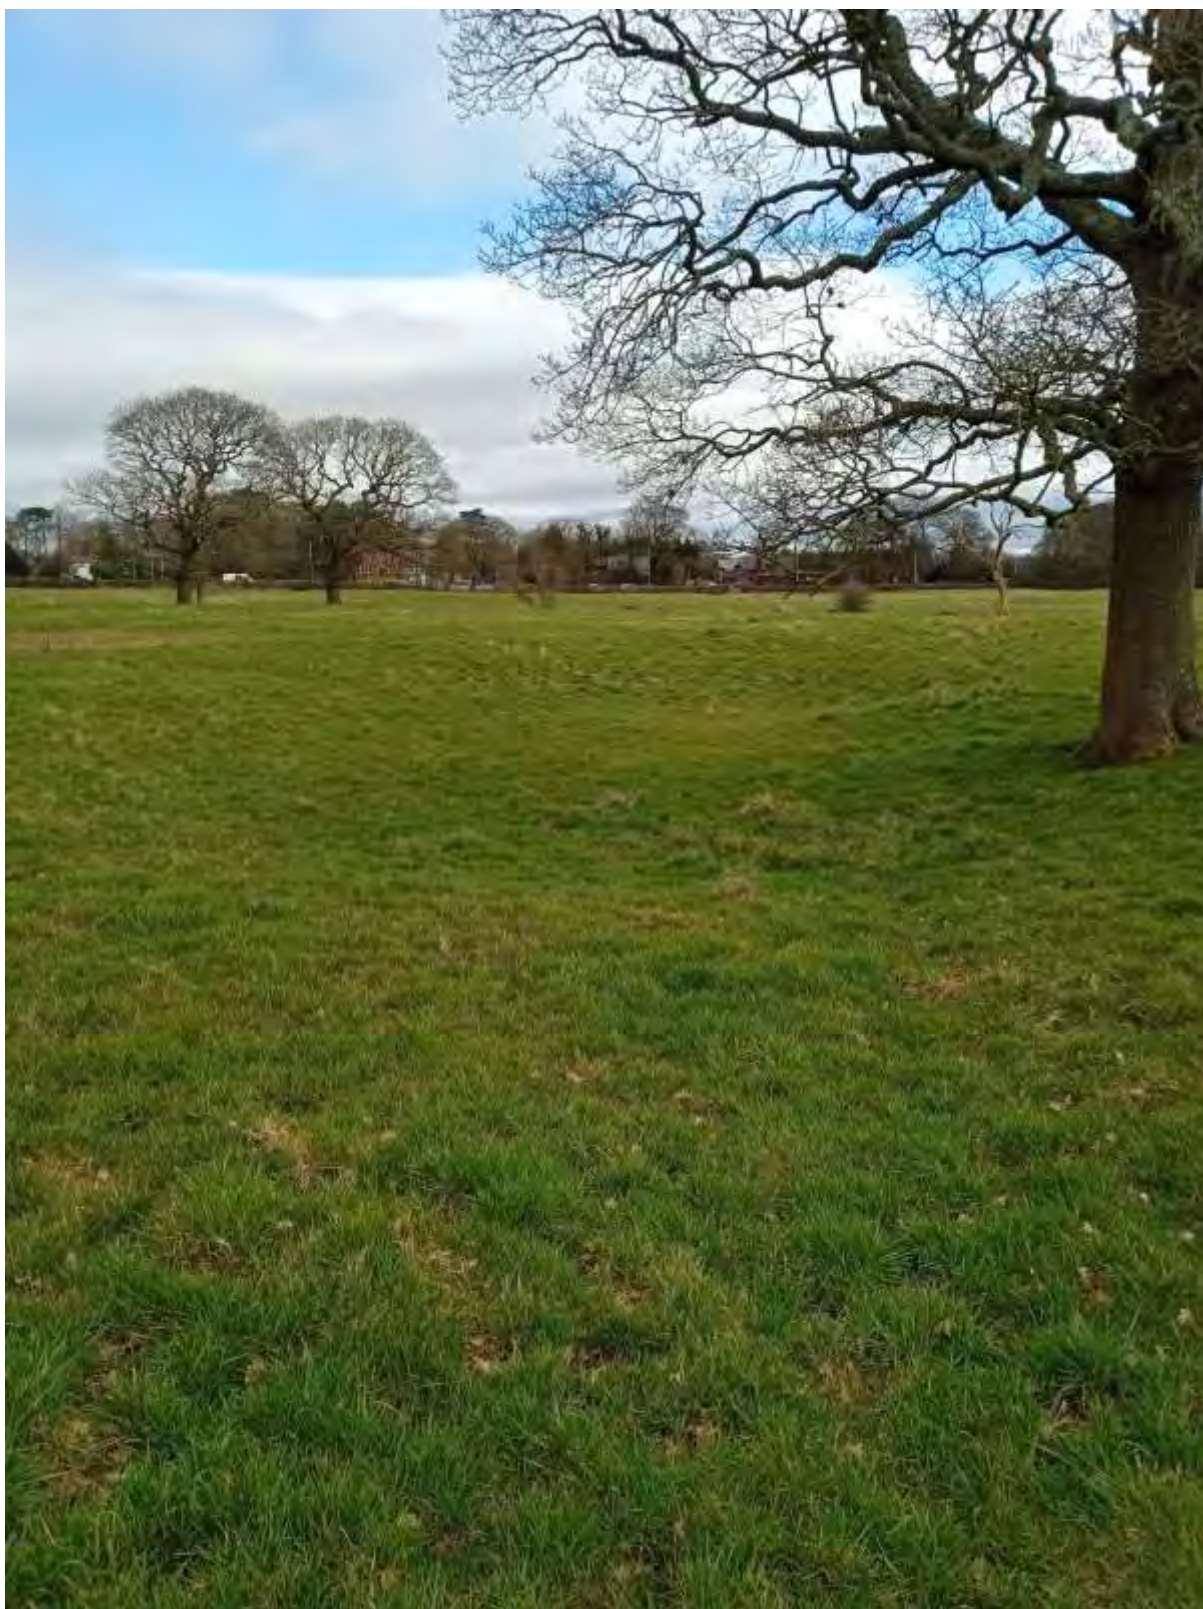
E349197:N431353

Localised depressions close to the location of an unidentified tree.

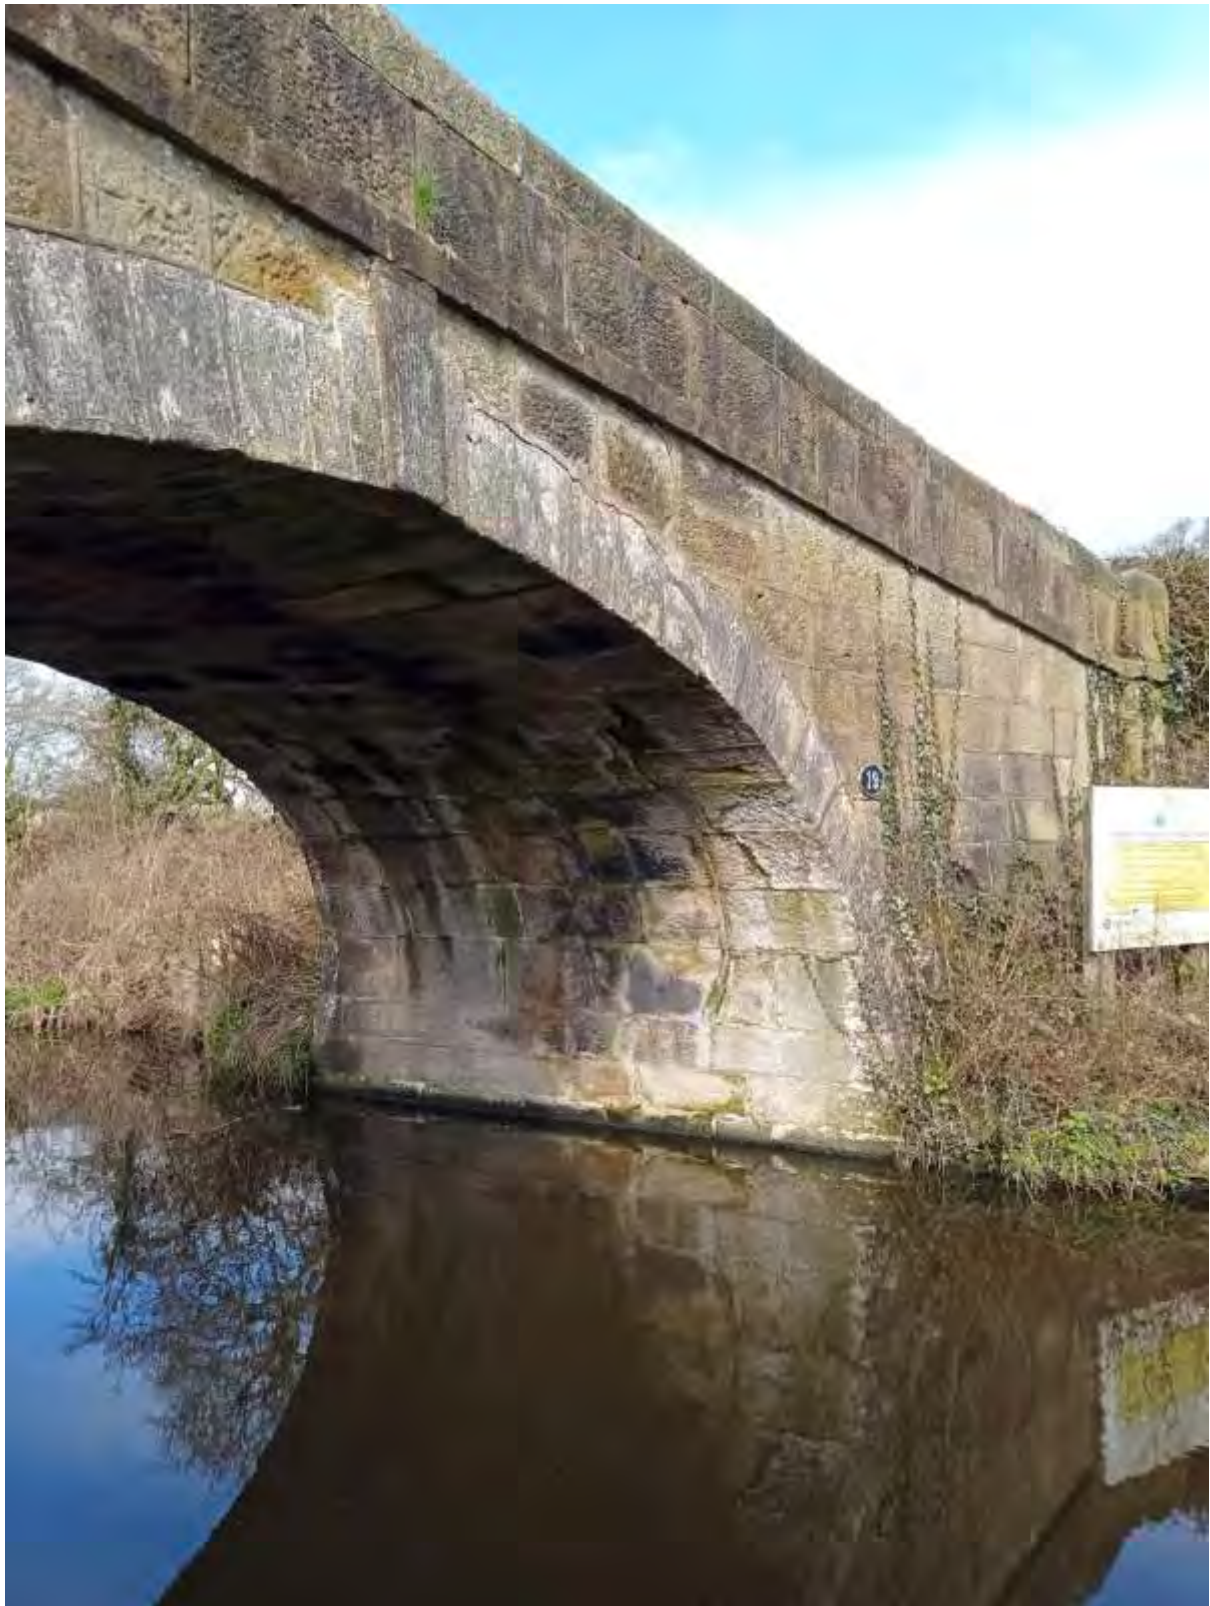
E349068:N431626

Updated and clearer defined image of crack under bridge
