# Environment Agency: Fisheries, Biodiversity & Geomorphology Preston & South Ribble FRMS Otter Survey

On 16/07/20 the Environment Agency Fisheries, Biodiversity and Geomorphology (FBG) Team set out to conduct an otter (*Lutra lutra*) survey on the river Ribble at Broadgate and Lower Penwortham for Areas 1 and 2 of the Preston and South Ribble Flood Risk Management Scheme (FRMS). It had rained every day w/c 13/07/20 although the weather conditions were dry during the survey. Prior to the survey FBG checked the river levels and they had been dropping since Saturday 11/07/20.

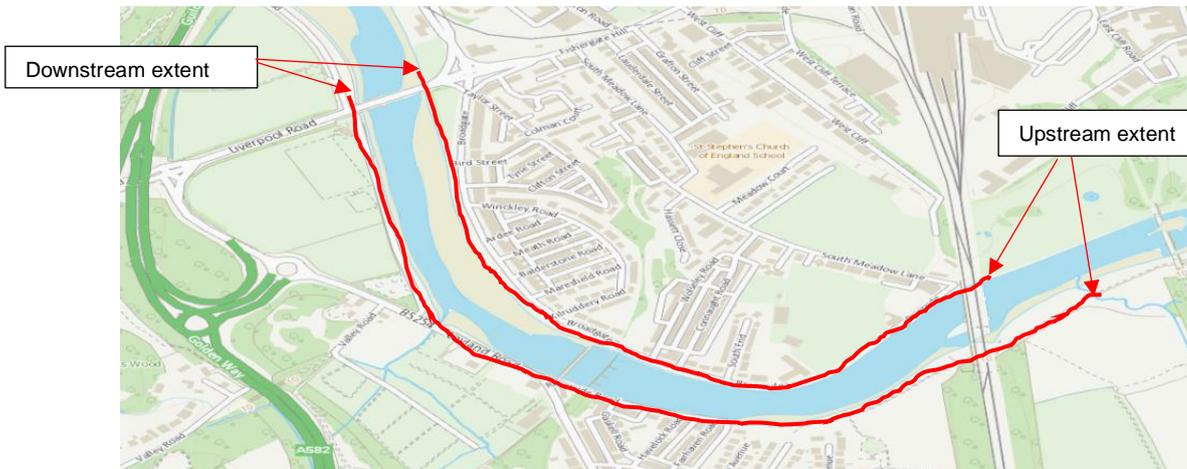
**Figure 1 – Extent of walkover / study area**

The upstream extent of the FBG walkover comprised walking 15m upstream of the West Coast Mainline to the east (SD 53554 28460) on the north bank and 155m upstream of the West Coast Mainline on the south bank, to the confluence of an unnamed tributary (SD 53660 28435). The downstream extent of the walkover was 15m beyond Liverpool Road (A5254) to the west (SD 52810 28886). Access to the river on both banks was severely compromised with the exception of one location on the south bank at SD 53519 28321. The entire length between the upstream and downstream extents on both banks were walked. The team used binoculars to assess the suitability of the opposite banks where safe access to the river was not possible. The location and extent of the survey area is shown in figure 1 below.

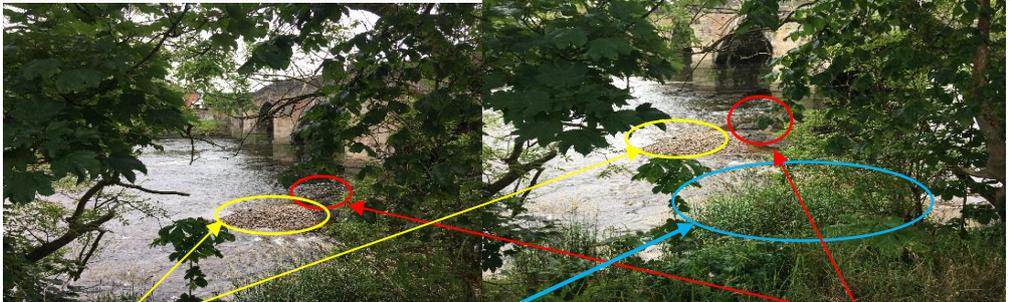
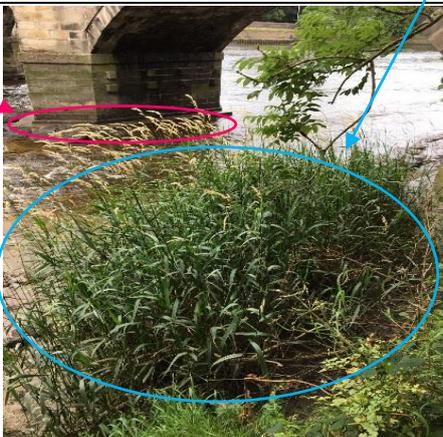
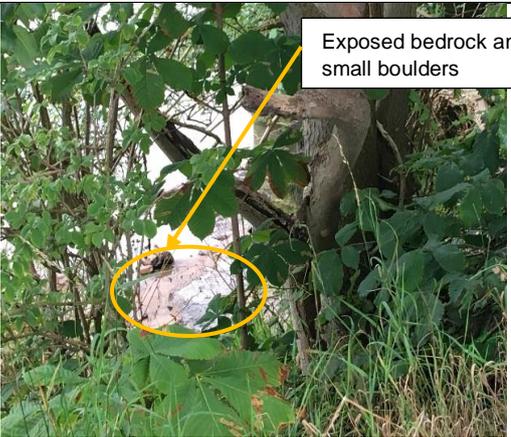
**Target Note 1**

<b>Name</b>	<b>Broadgate - Penwortham Old Bridge</b>	
<b>Grid reference</b>	<b>SD 53052 28320</b>

<div style="display: flex; justify-content: space-around; margin-top: 10px;"> <div data-bbox="395 772 646 817" style="border: 1px solid black; padding: 2px;">Exposed gravel shoal</div> <div data-bbox="694 772 997 817" style="border: 1px solid black; padding: 2px;">Phalaris bed at toe of bank</div> <div data-bbox="1145 772 1353 817" style="border: 1px solid black; padding: 2px;">Kyowa filter units</div> </div>	
<div data-bbox="204 902 347 969" style="border: 1px solid black; padding: 2px;">Ledge on bridge piers</div>

<div data-bbox="1193 846 1433 913" style="border: 1px solid black; padding: 2px;">Exposed bedrock and small boulders</div>
<b>Description of potential features used by Otters</b>	<p>Penwortham Old Bridge is listed as a Scheduled Ancient Monument built with block sandstone and incorporates 5 arches. Safe access to survey under the bridge was not possible due to steep vertical banks and deep tidal muds. The phalaris bed and immature trees could provide some vegetative cover for otters.</p>

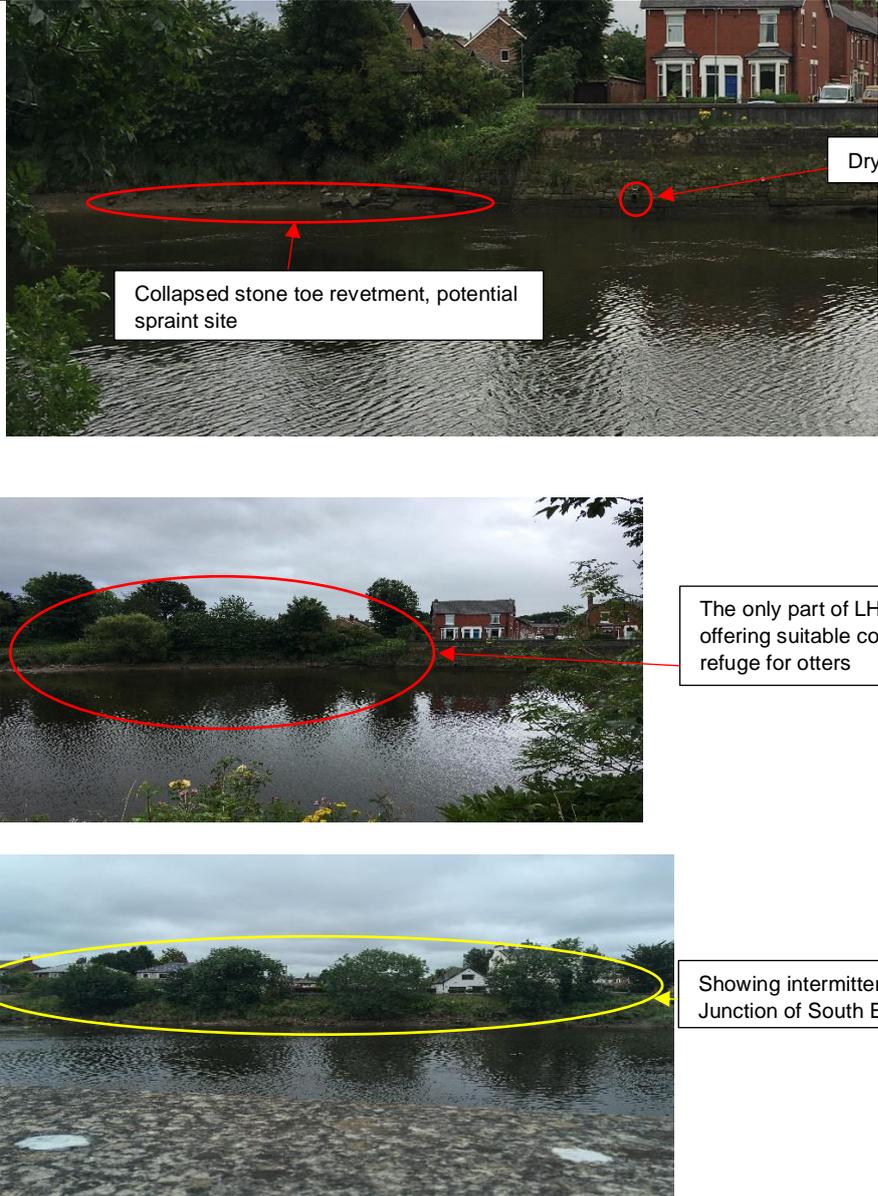
## Target Note 3

<b>Name</b>	Riverside Road and Riverside
<b>Grid reference</b>	SD 53205 28164 Plates 1 & 2 (LHB) SD 53201 28237 Plate 3
<b>Photos</b>

<p data-bbox="496 779 919 846">Collapsed stone toe revetment, potential spraint site</p> <p data-bbox="1209 651 1369 680">Dry outfall pipe</p> <p data-bbox="1058 1093 1358 1189">The only part of LHB offering suitable cover and refuge for otters</p> <p data-bbox="1058 1469 1490 1529">Showing intermittent tree cover RHB Junction of South End and Riverside</p>
<b>Description of potential features used by Otters</b>	<p data-bbox="375 1765 1390 1854">Area 2 on Riverside Road is the only location on the LHB offering suitable cover and refuge for otters within the study area. The redi-rock solution proposed in this location means that all the vegetative cover will be lost to the scheme.</p> <p data-bbox="375 1895 1390 1982">On the opposite RHB (Plate 3) we have intermittent tree canopy cover, however this is an area where there will be additional encroachment into the river due to the redi-rock solution proposed in Area 1, a potential pinch point.</p>

#### Riverside Road (LHB):

The only location on the LHB offering favourable habitat for otters is immediately upstream of the dog-leg in the existing defence where there is dense vegetation cover over ca. 70m length.

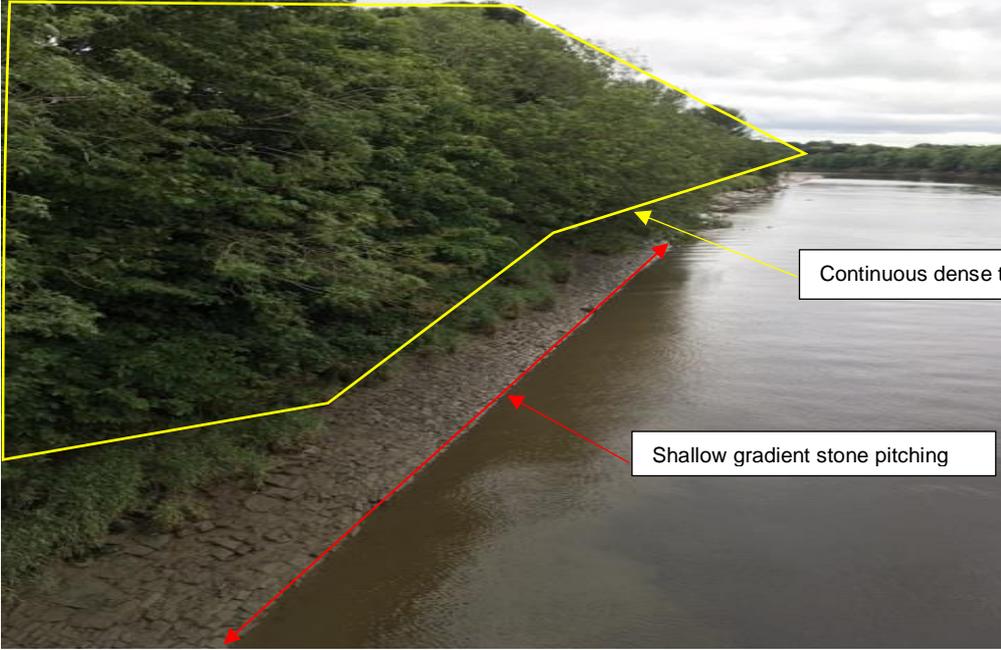
Target Note 4

Name	Liverpool Road Bridge
Grid reference	SD 52827 28798
Photos

<p data-bbox="517 1218 1177 1267">Photo taken from Liverpool Road Bridge (RHB) looking upstream</p>
Description of potential features used by Otters	<p>The area downstream of Penwortham Old Bridge on the right bank is low potential for lie up areas and little potential for holts. Downstream of Penwortham Old Bridge on the right bank (after the existing flood wall) is a line of mature trees along the reach, some on top of the walls. Some areas of scrub, mostly sparse between Penwortham Old Bridge and Liverpool Road Bridge but denser just below Liverpool Road Bridge before the vertical walls by the sea cadets.</p> <p>From the line of trees and shrub it was then sloping stone pitching to waterline, some areas were fringed by reed canary grass and then areas of exposed mud.</p> <p>The area downstream of Penwortham Old Bridge LHB is sheet piling for approx. 30m and further downstream was tree lined with stone pitching to the waterline.</p>

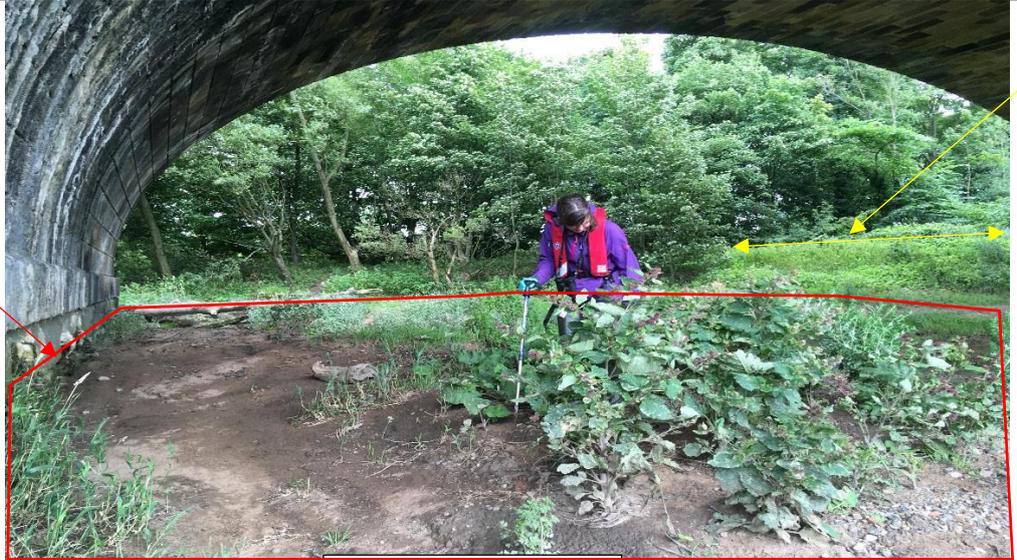
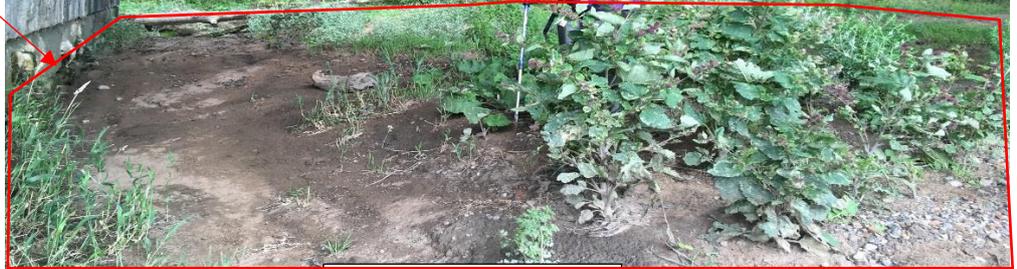
Target Note 5

Name	West Coast Mainline (WCML)
Grid reference	SD 53507 28439 Plate 1 SD 53609 28404 Plates 2 & 3 SD 53520 28307 Plates 4, 5 & 6
Photos	<p>Arch under WCML (RHB) potential resting / lie-up and spraint site for otters</p> <p>Upstream WCML looking at LHB offering good quality habitat for otters</p> <p>Only safe accessible location to survey river bank (LHB)</p>

Line of public footpath
Fine mud/silt deposits would show recent evidence of otter footprints.

<div style="border: 1px solid black; padding: 2px; width: fit-content; margin: auto;">FBG searching for field signs under WCML (LHB)</div>		
<b>Description of potential features used by Otters</b>	This was the only location that FBG could gain safe access to the river channel and banks and was an opportunistic site to spot footprints and other field signs, being dry and having fine deep silt/mud deposits. Unfortunately no positive field signs were observed in this location during our survey effort.
