**Revised Quarry Restoration Scheme Incorporating
Tunnel Arisings from the Haweswater Aqueduct
Resilience Programme (HARP) Namely the
Bowland and Marl Hill Tunnel Sections.**

Planning Application LCC/2021/0015

Waddington Fell Quarry

Supplemental Submission

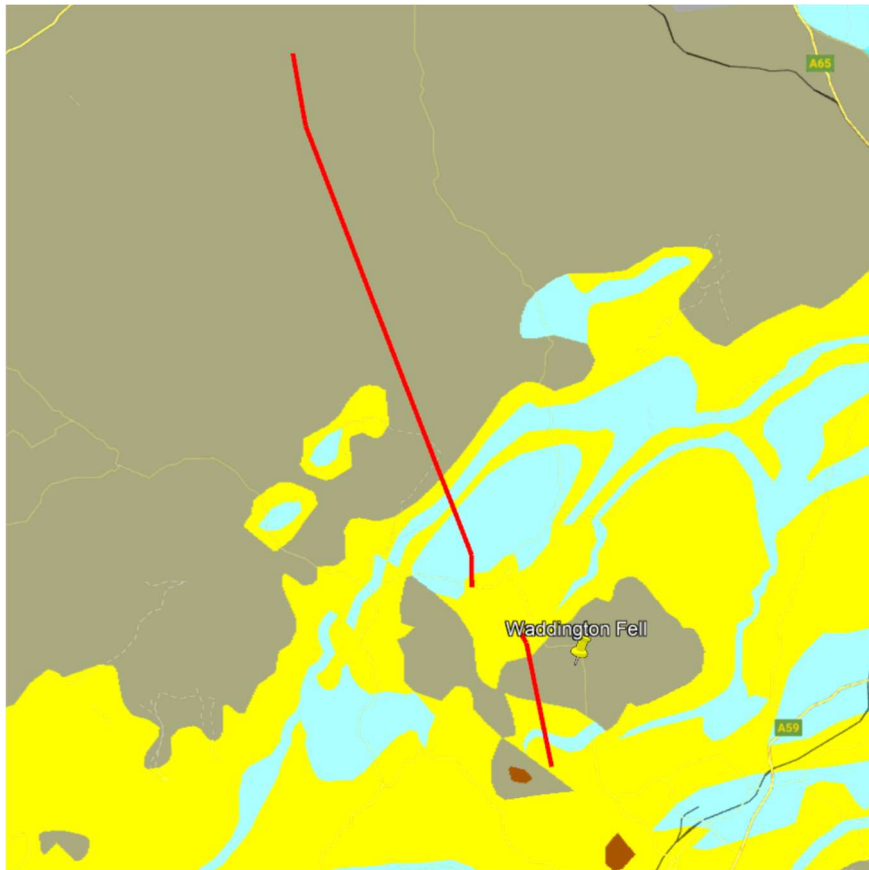
An extract from the BGS bedrock geology indicates the Millstone Grit Group in light brown, the Bowland High Group in yellow and the Craven Group in blue.

The proposed route of the Bowland section of tunnel is the longer red line to the north of Waddington Fell.

2.16 The material to be used in the restoration works will be excavated rock associated with the HARP construction. The route of the proposed Bowland and Marl Hill length of tunnel pass through bedrock comprising Millstone Grit Group (the same formation worked at Waddington Fell Quarry) comprising mudstone, siltstone and sandstone sedimentary rock, Bowland High Group and Craven Group limestone and Bowland High Group and Craven Group mudstone, siltstone and sandstone.

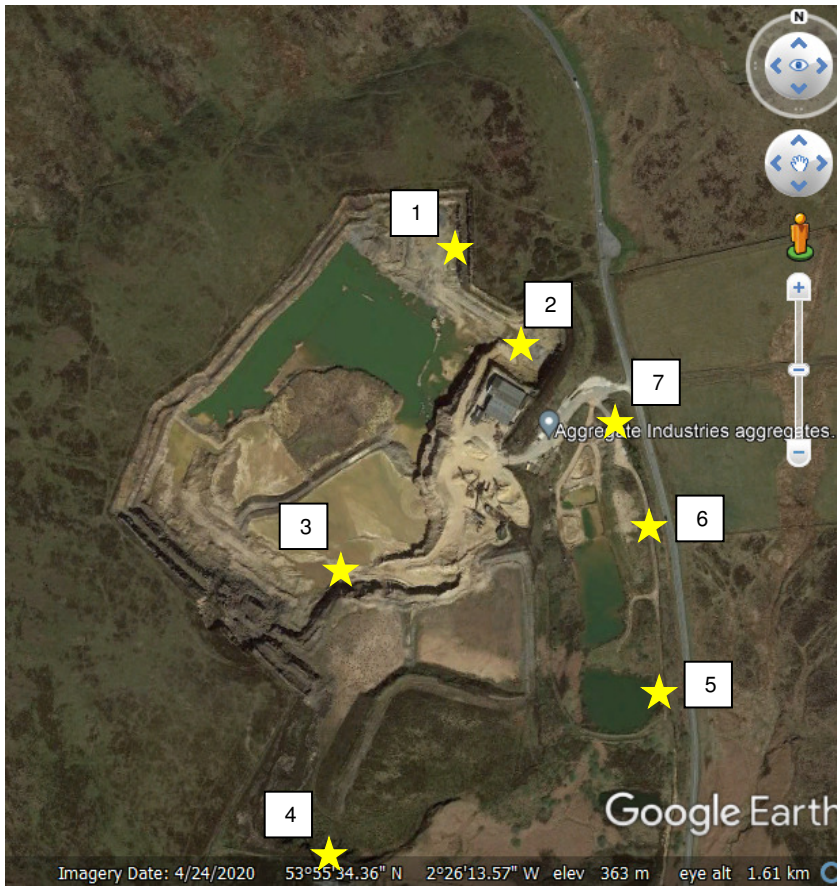
Plate 1. Location of the static bat detectors (yellow stars) during the 2020 surveys.

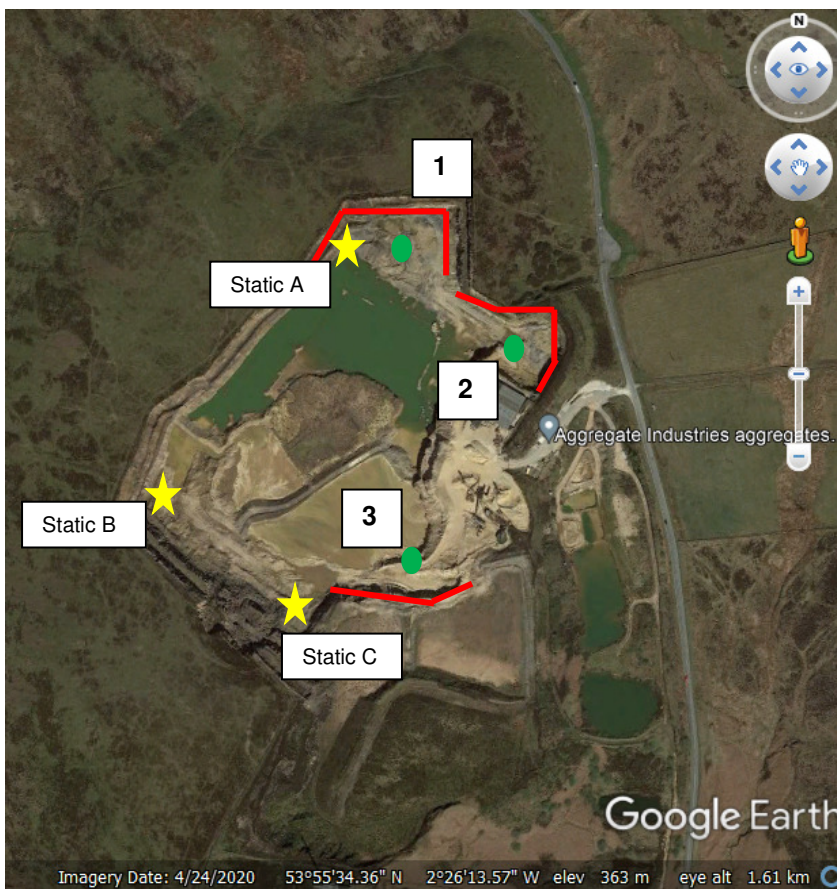
Plate 2. Quarry rock faces subject to survey (red lines) and corresponding position of surveyors (green circles 1-3) and static detectors (yellow stars A-C) during the 2021 surveys.

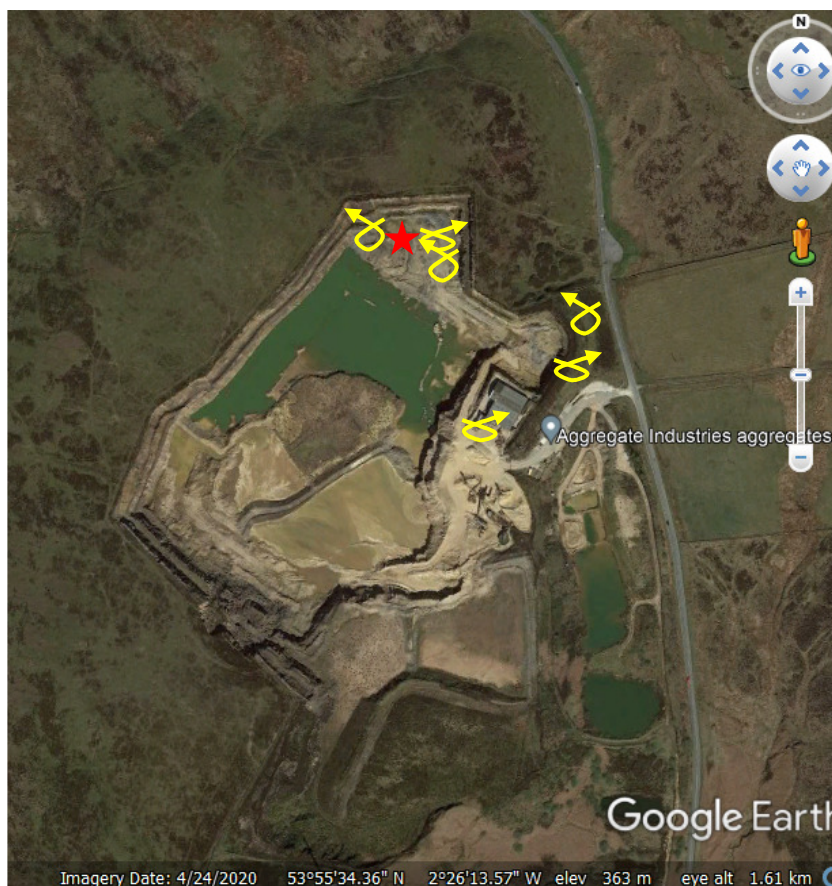
Plate 3 Locations of highest bat activity (red star) and indicative flight activity (yellow arrows).

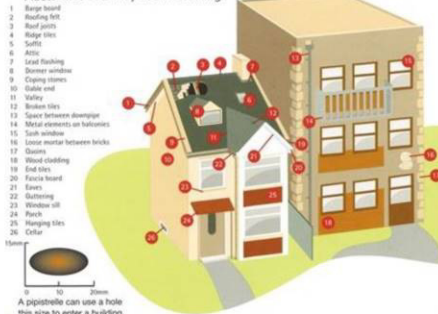
Places that bats may use in buildings

Schematic from www.bats.org.uk

- The top of gable end or dividing wall;
- The top of chimney breasts;
- Ridge and hip beams and other roof beams;
- Mortise and tension joints;
- All beams/ceilings/pipework (free hanging bats);
- The junction of roof timbers, especially where ridge and hip beams meet;
- Behind purlins;
- Between tiles and the roof lining;
- Under flat felt roofs;
- In trees (cracks/holes/ivy cladding) ;
- Under barge boards;
- In cavity walls;
- In cracks in stone or concrete;
- Behind peeling paint/wall coverings;
- Gaps behind window and door frames;
- Between window panes and timber boarding.

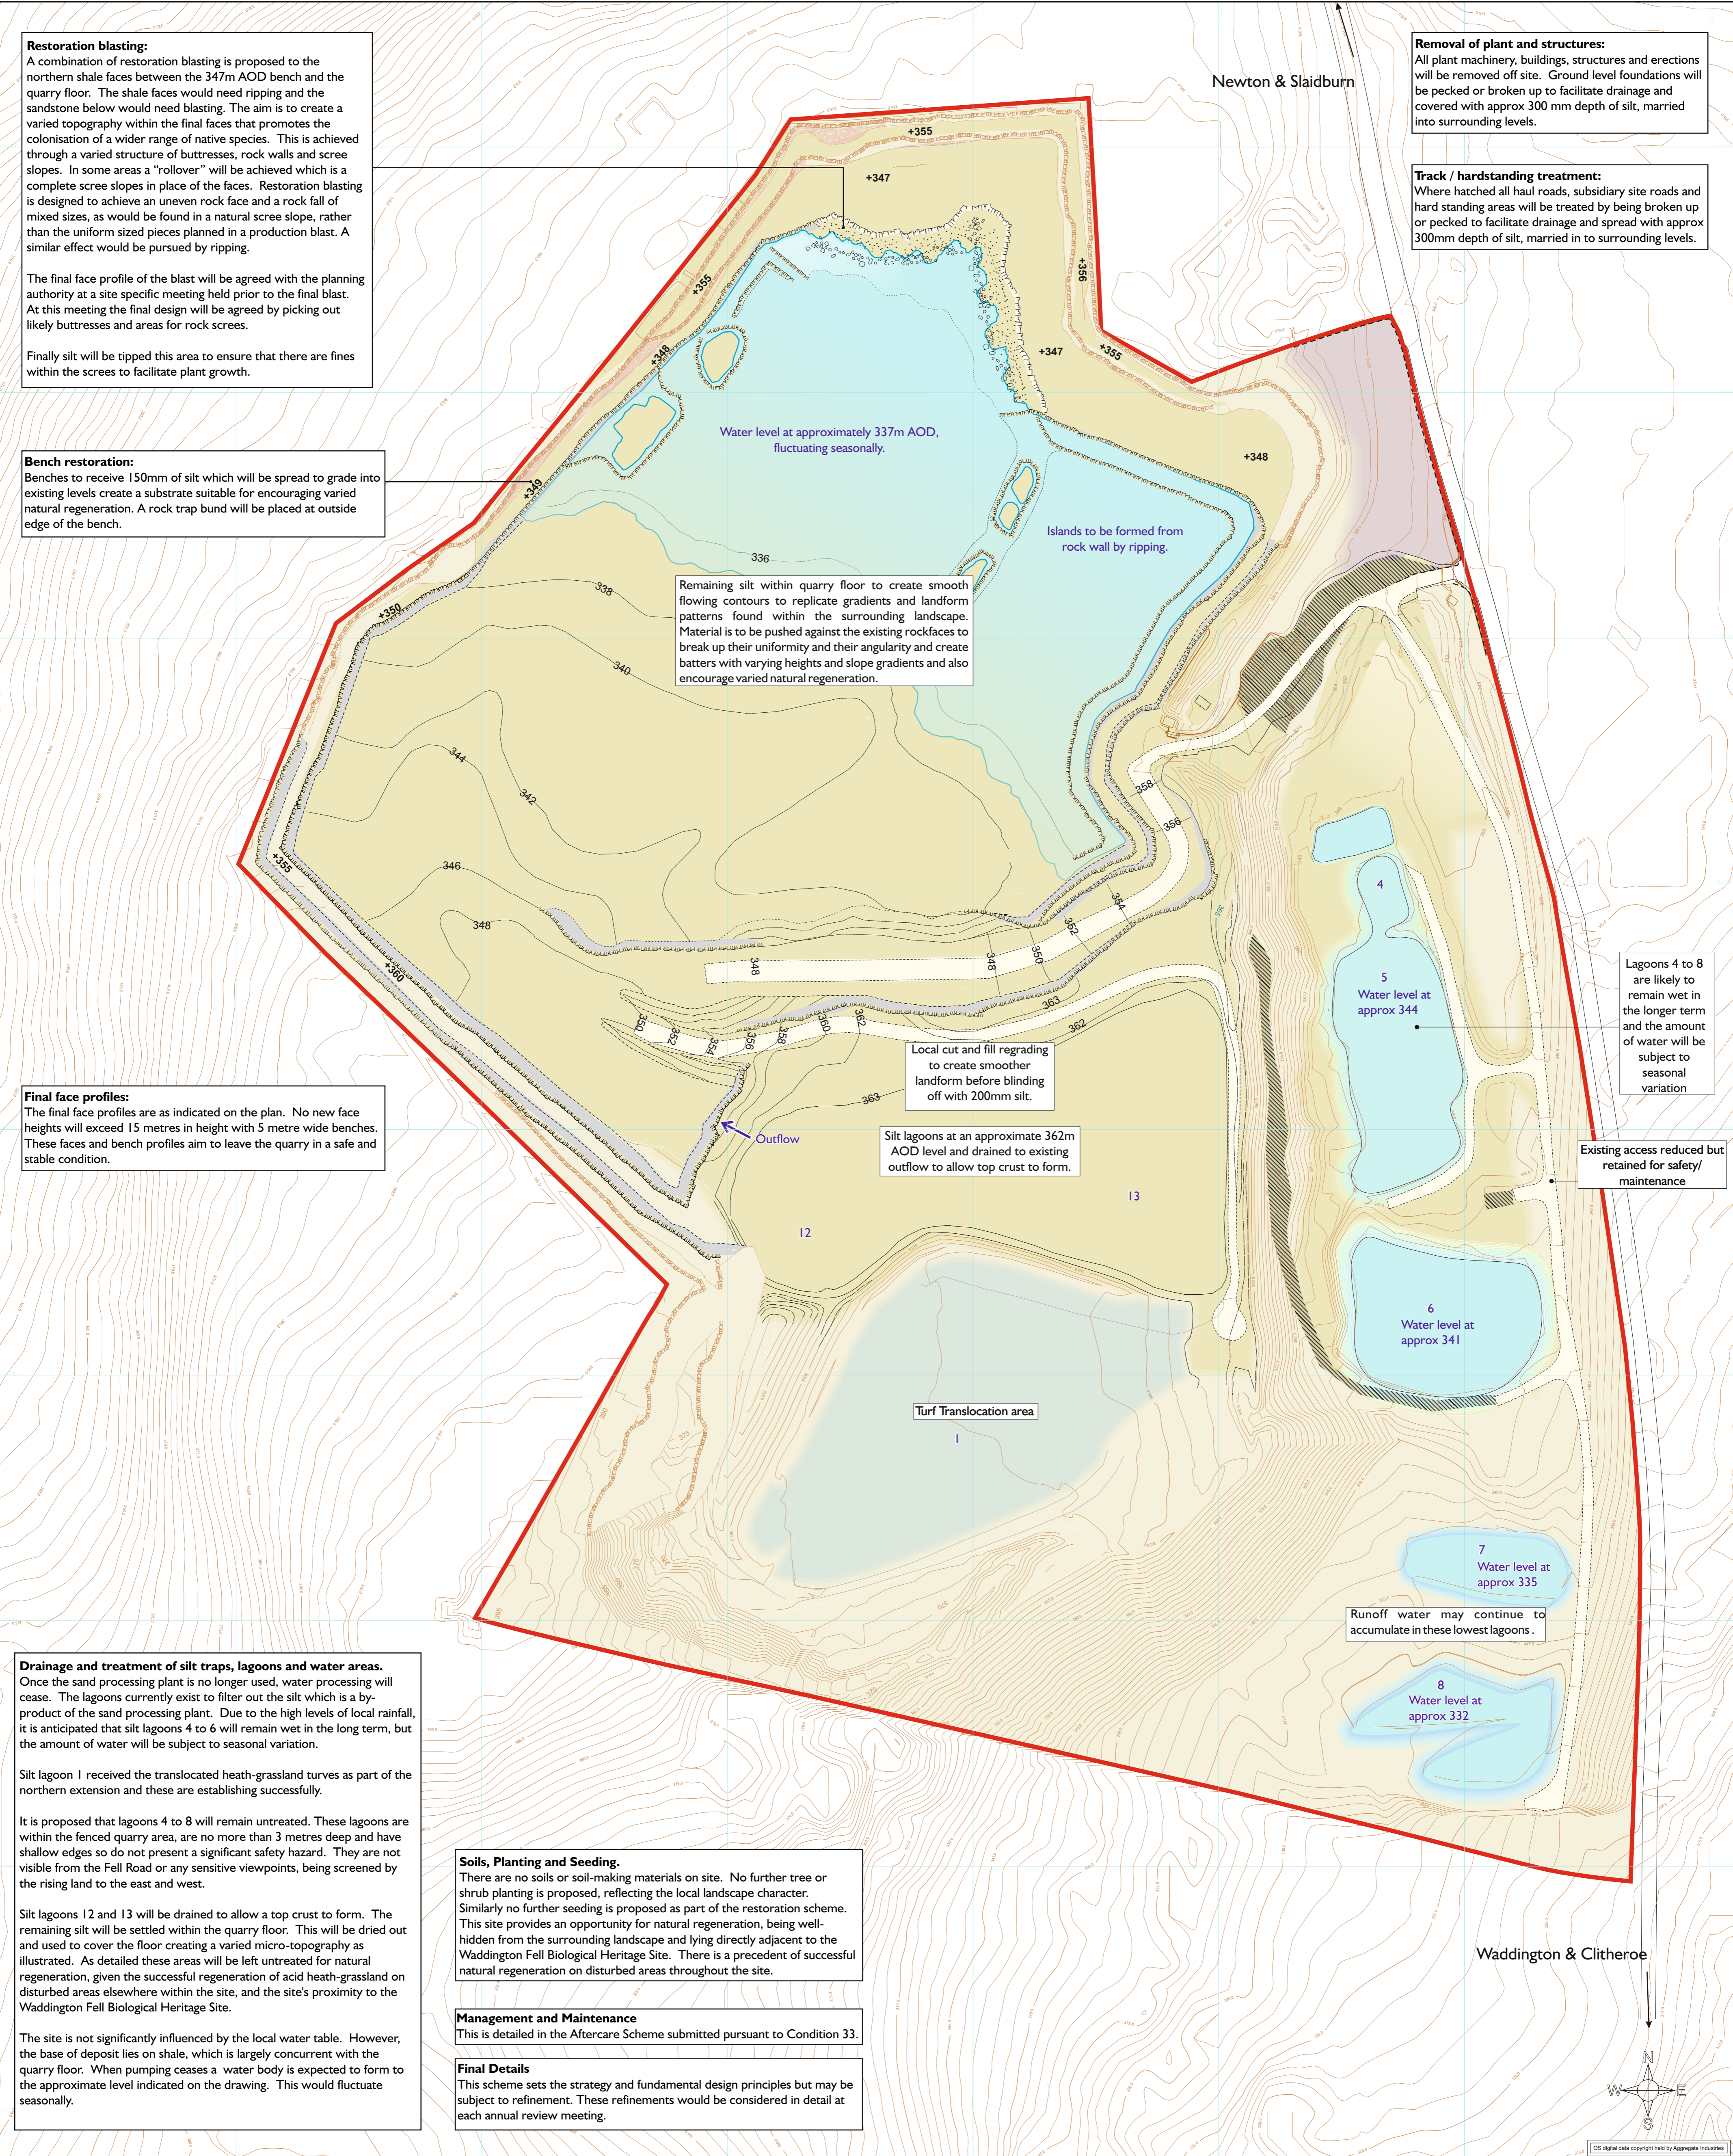
Final face profiles:
The final face profiles are as indicated on the plan. No new face heights will exceed 15 metres in height with 5 metre wide benches. These faces and bench profiles aim to leave the quarry in a safe and stable condition.

Removal of plant and structures:
All plant machinery, buildings, structures and erections will be removed off site. Ground level foundations will be pecked or broken up to facilitate drainage and covered with approx 300 mm depth of silt, married into surrounding levels.

Track / hardstanding treatment:
Where hatched all haul roads, subsidiary site roads and hard standing areas will be treated by being broken up or pecked to facilitate drainage and spread with approx 300mm depth of silt, married in to surrounding levels.

Remaining silt within quarry floor to create smooth flowing contours to replicate gradients and landform patterns found within the surrounding landscape. Material is to be pushed against the existing rockfaces to break up their uniformity and their angularity and create batters with varying heights and slope gradients and also encourage varied natural regeneration.

Existing access reduced but retained for safety/maintenance

Runoff water may continue to accumulate in these lowest lagoons.

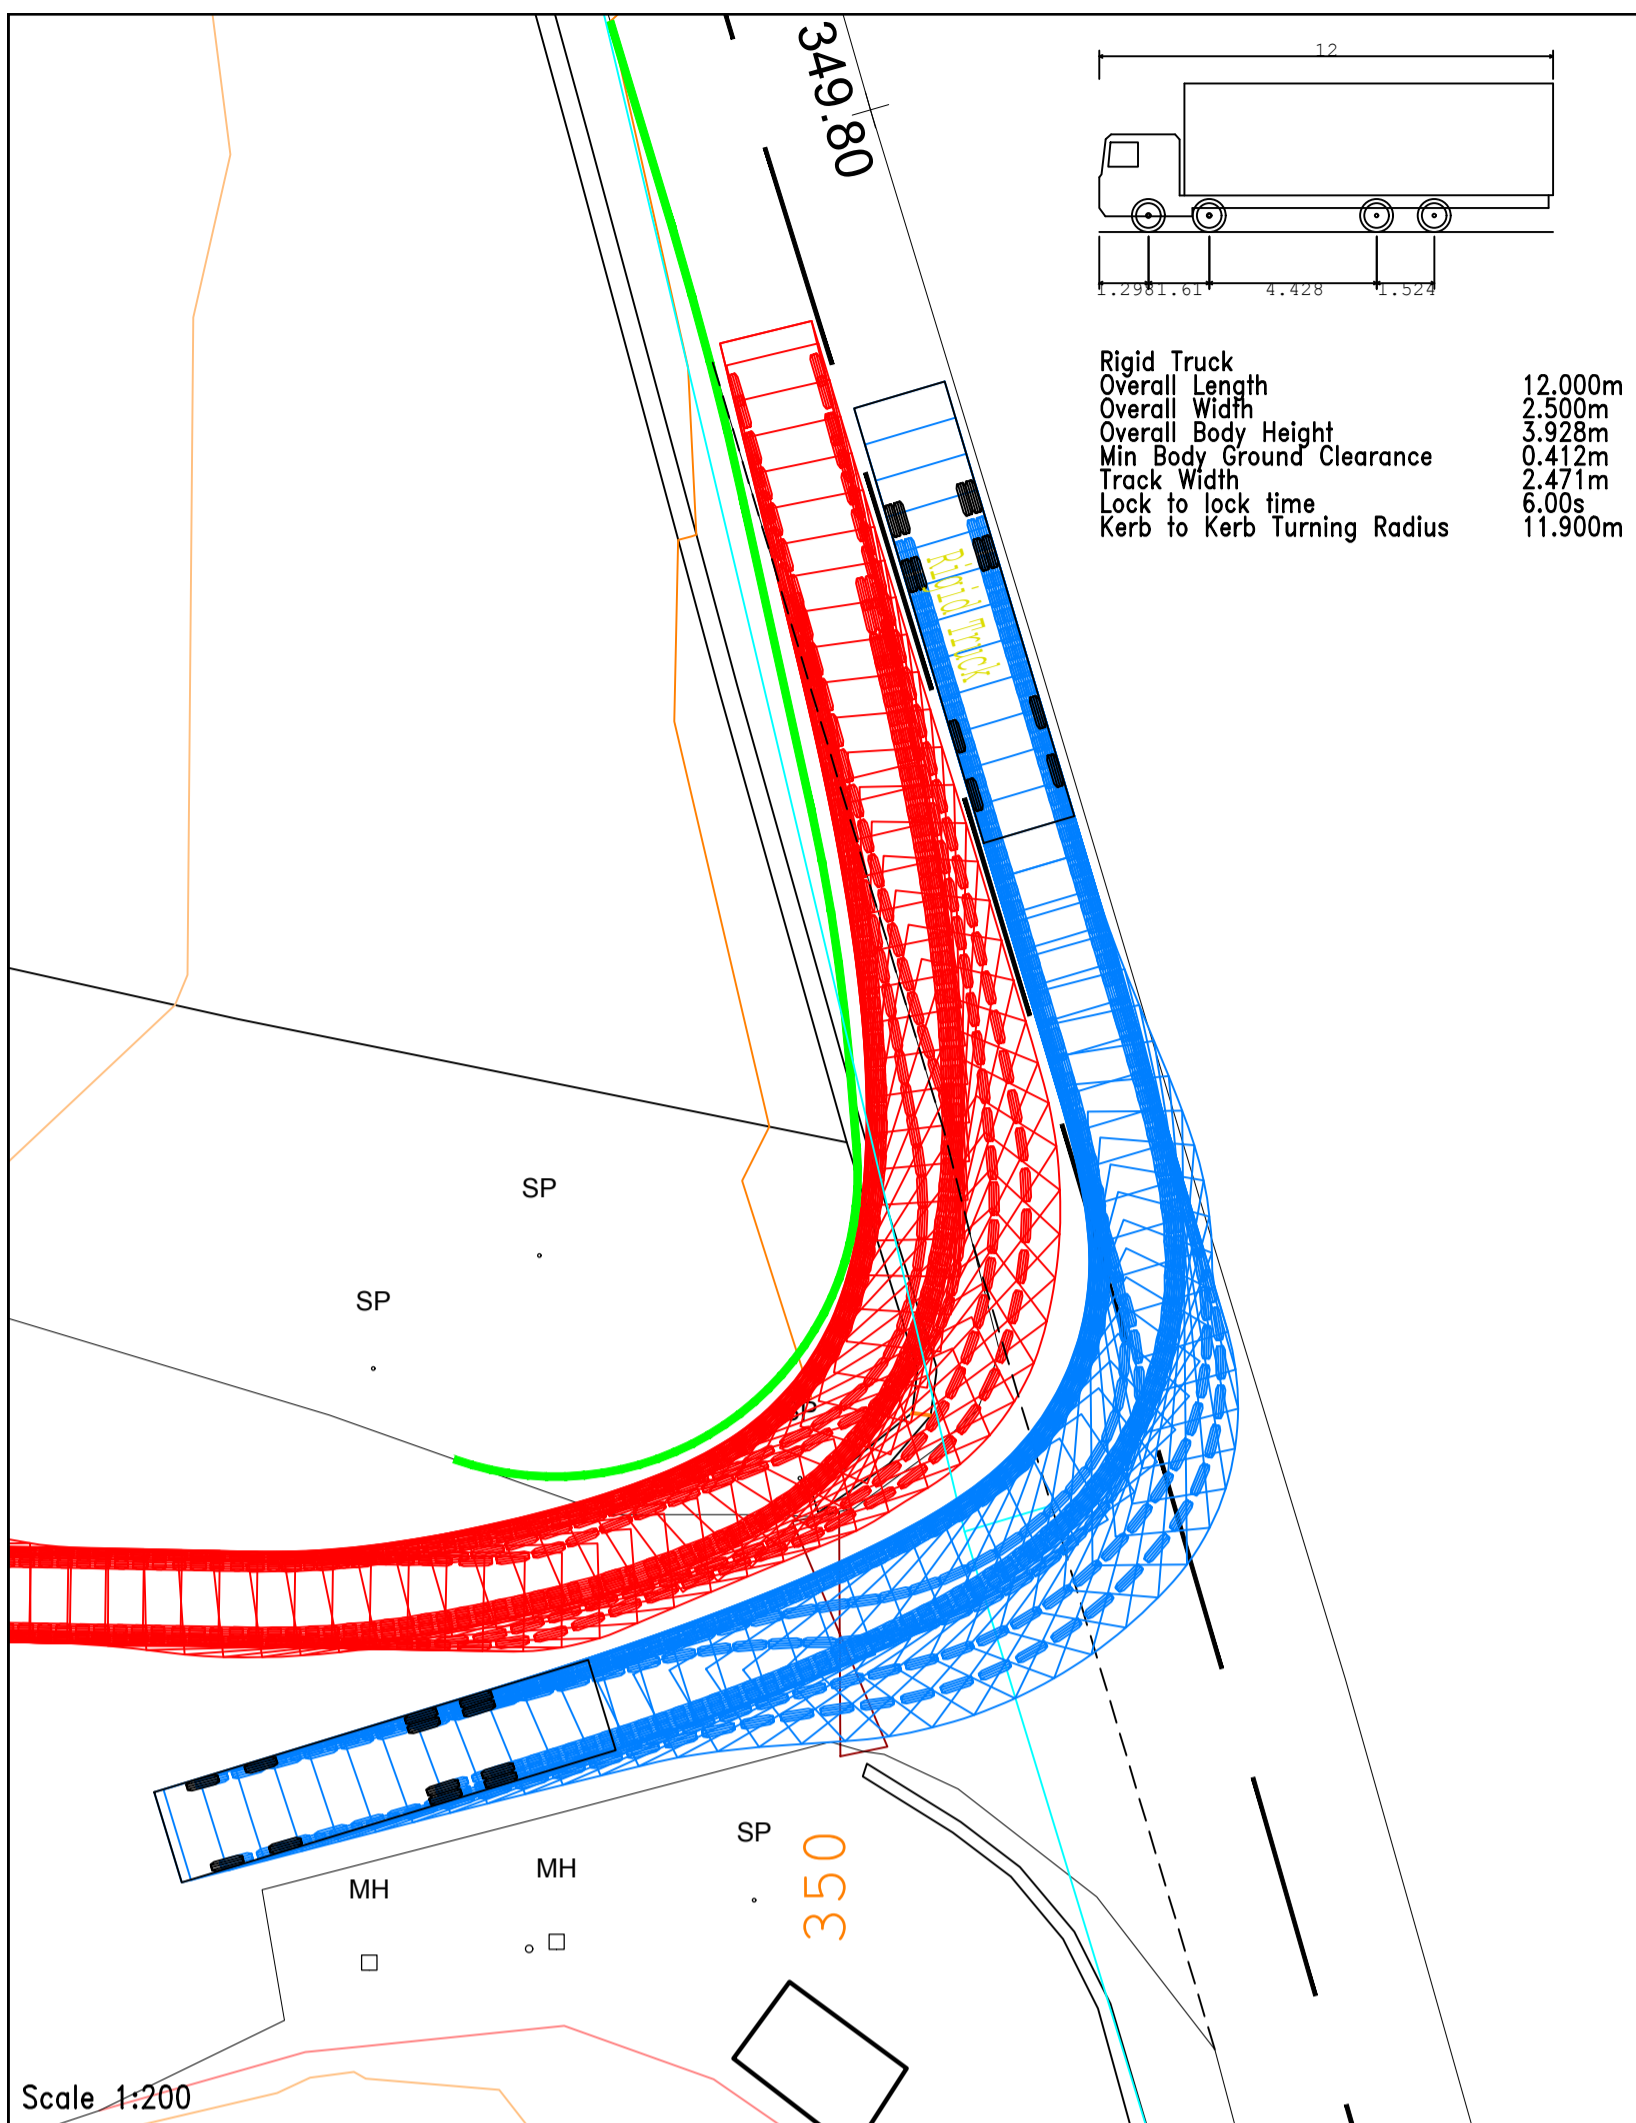
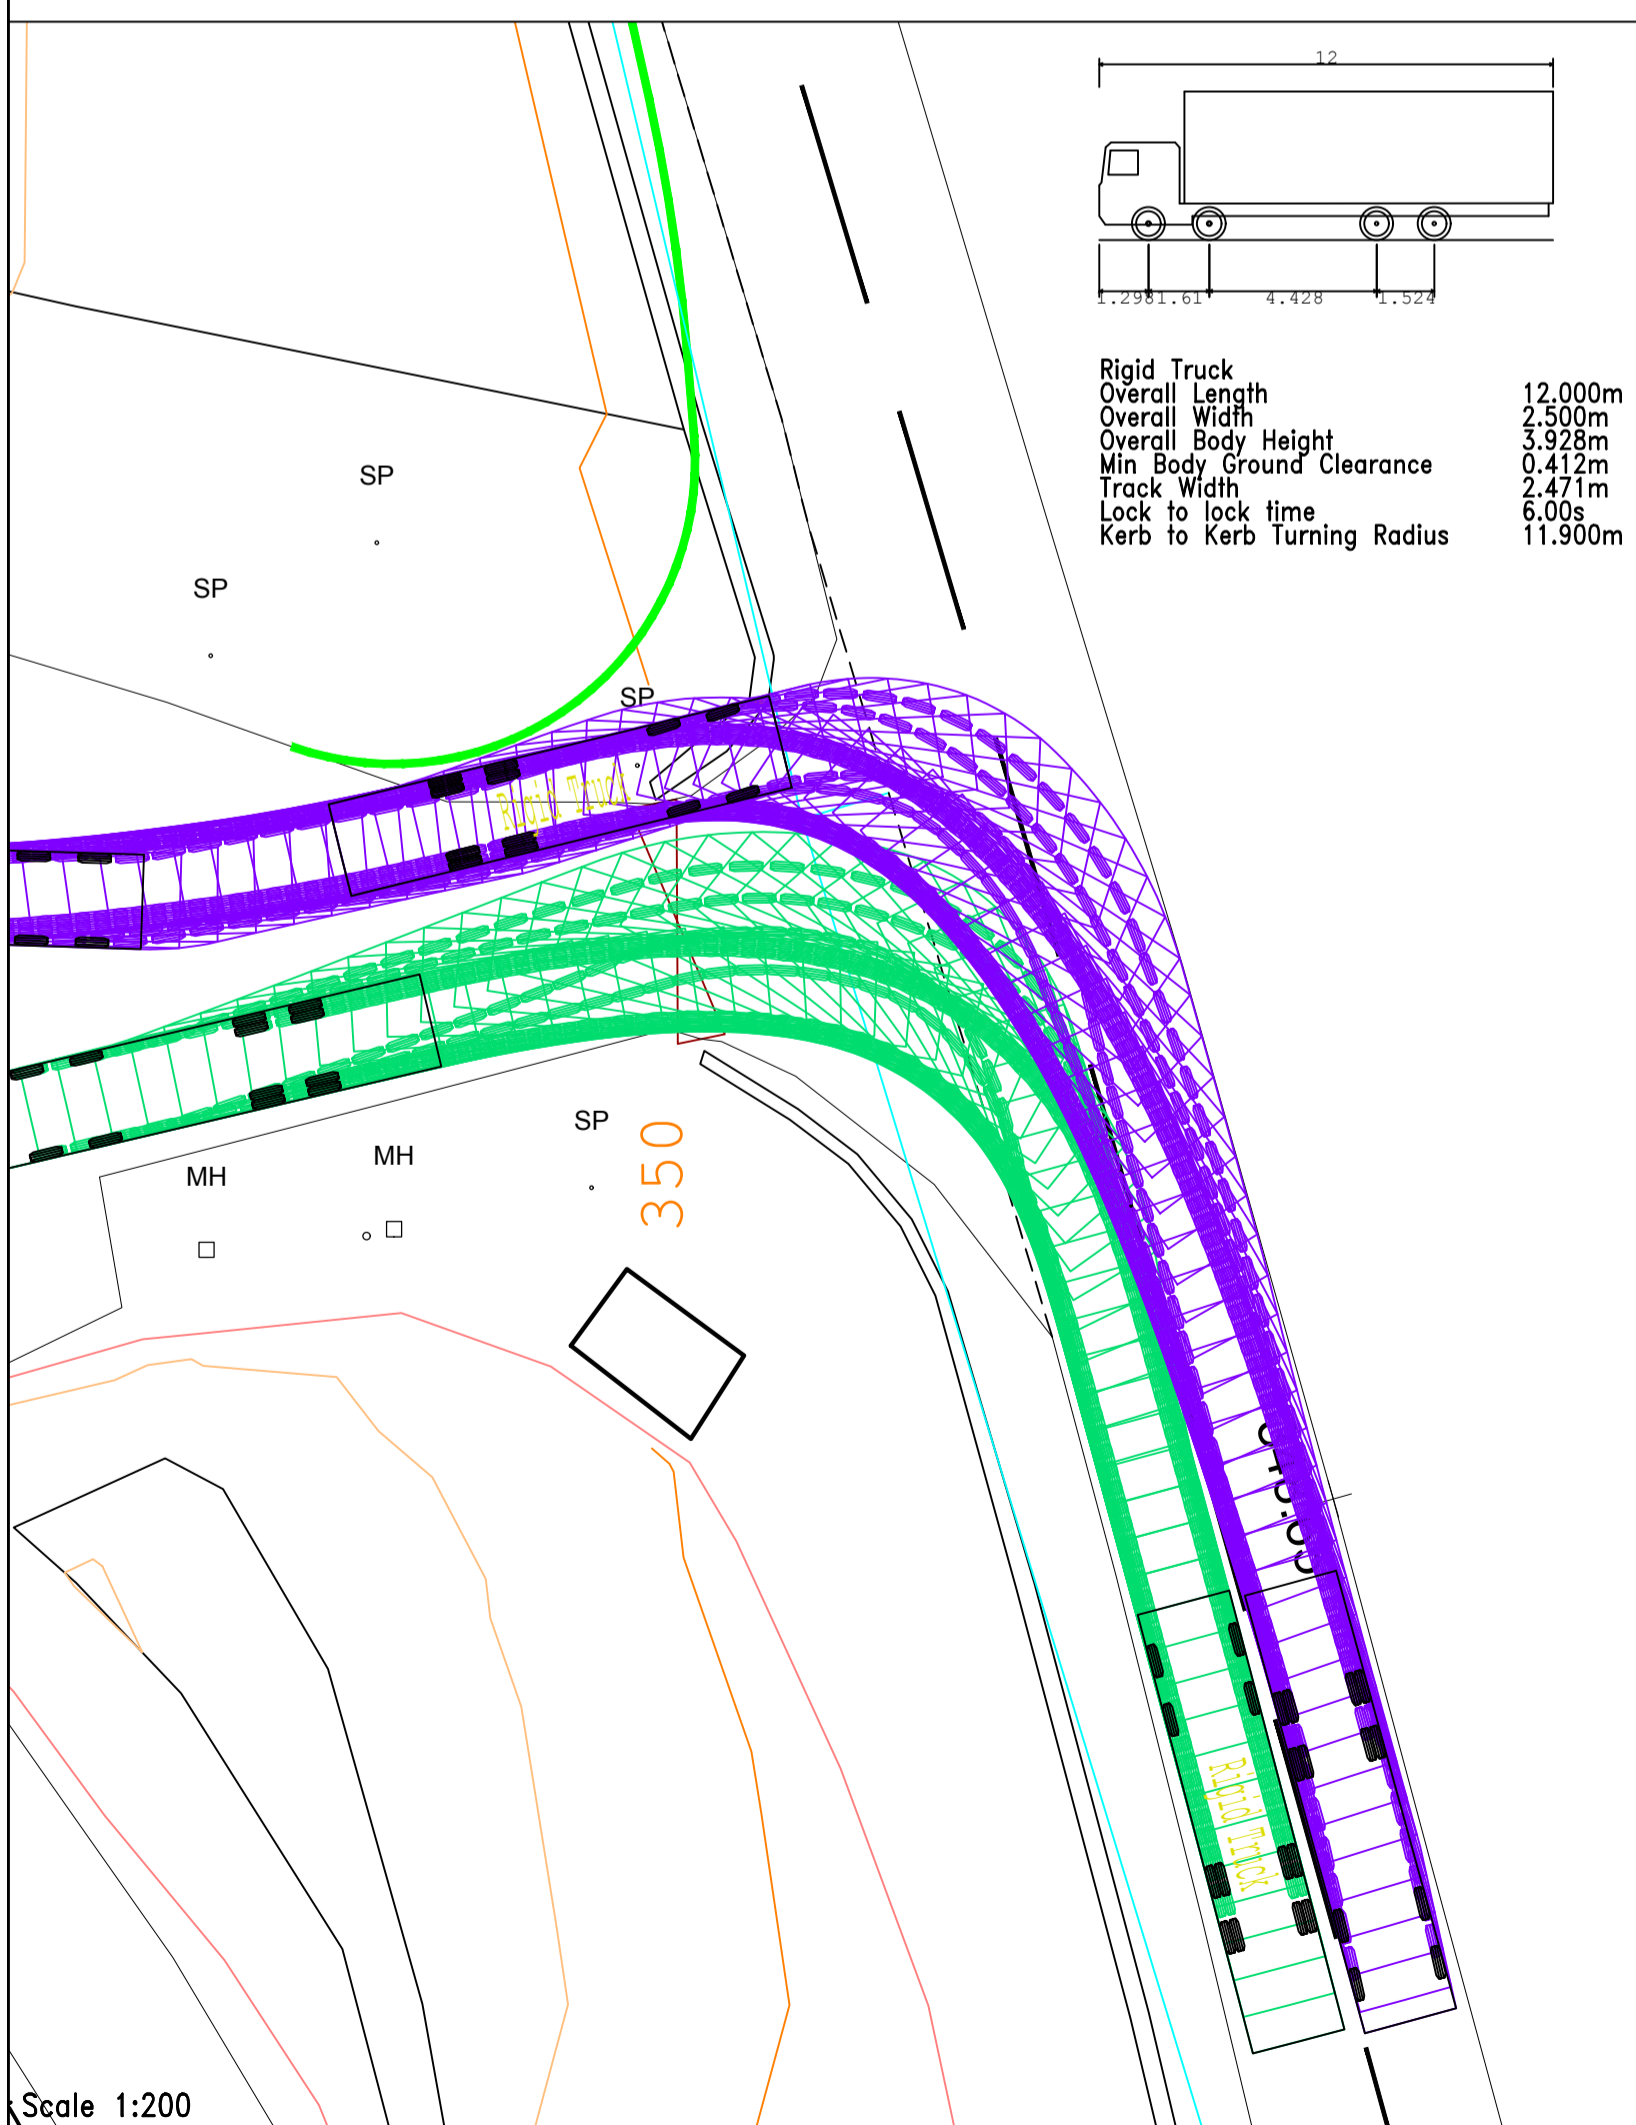
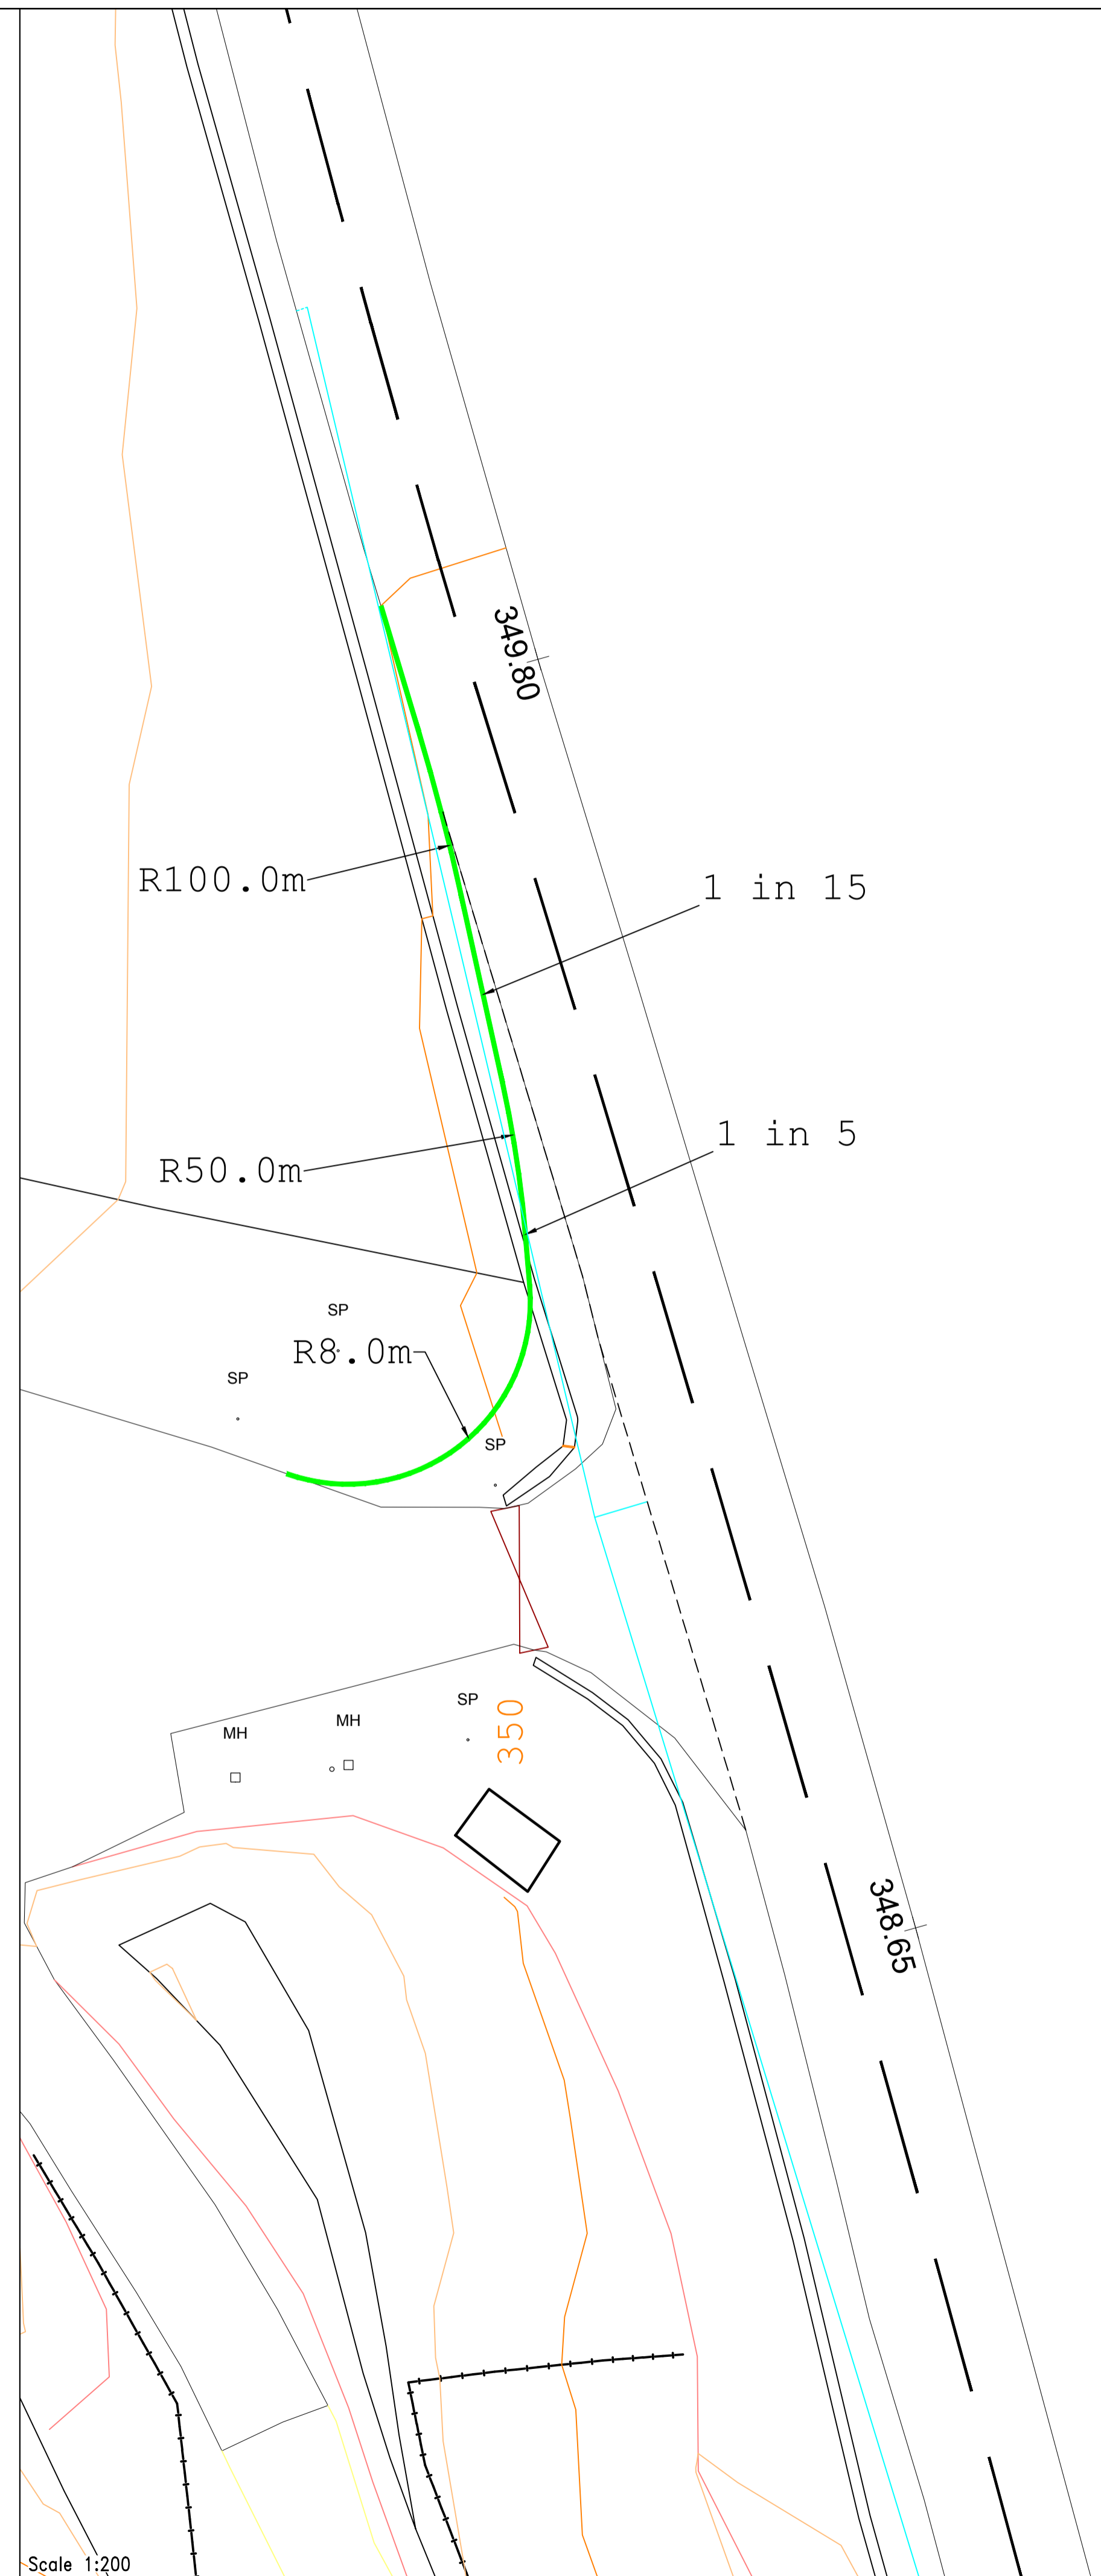
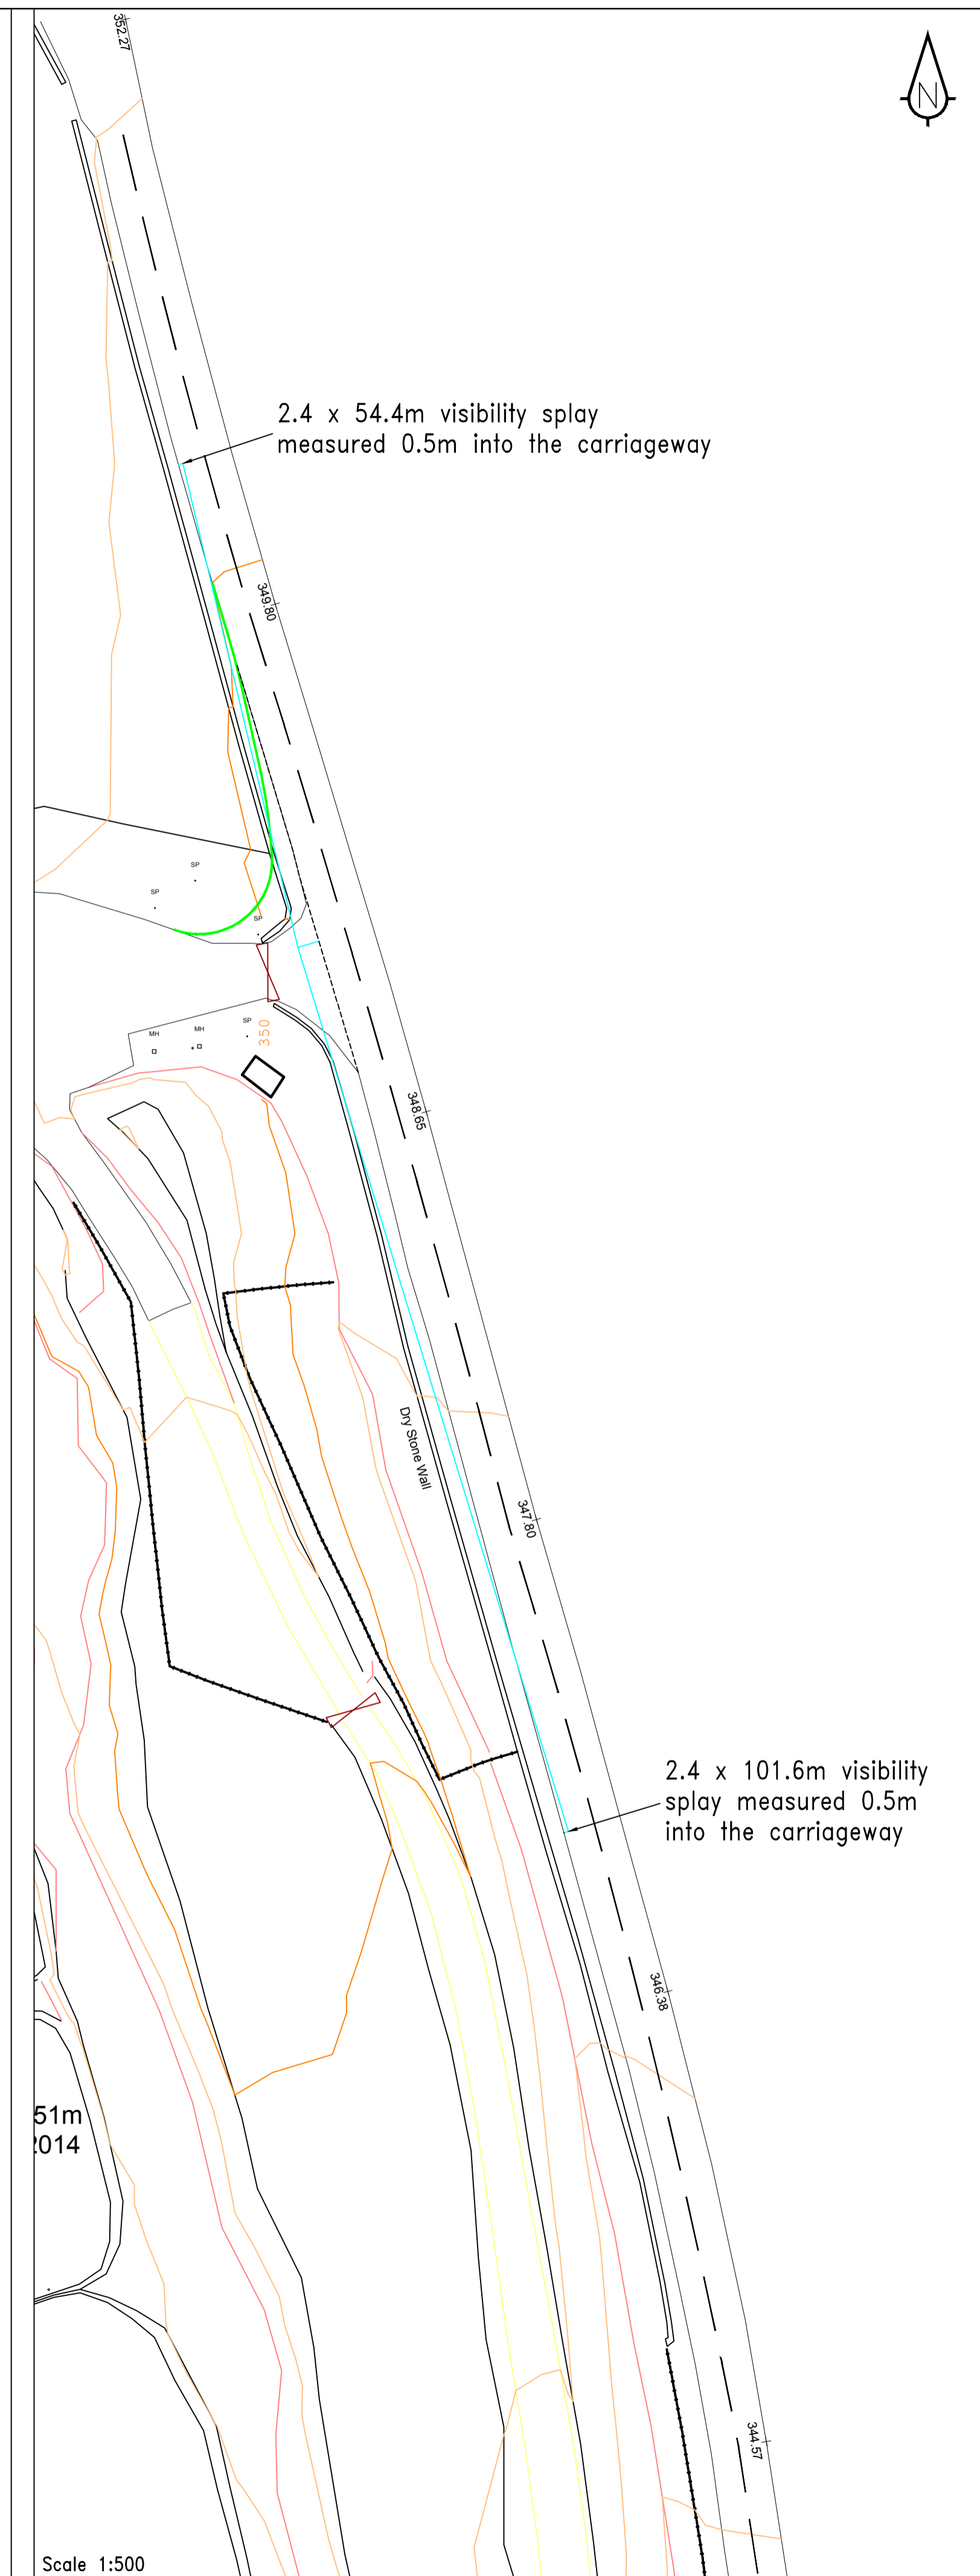
Drawing 300461-001 Rev A

| A | Revised Access Arrangement | BL | 11.10.21 | AA |
