M6 JUNCTION 29 SOUTH

Signalisation of Approach Arm
Stage 1 Road Safety Audit

PROJECT NO. 70084465

OUR REF. NO. 70084465-RS1

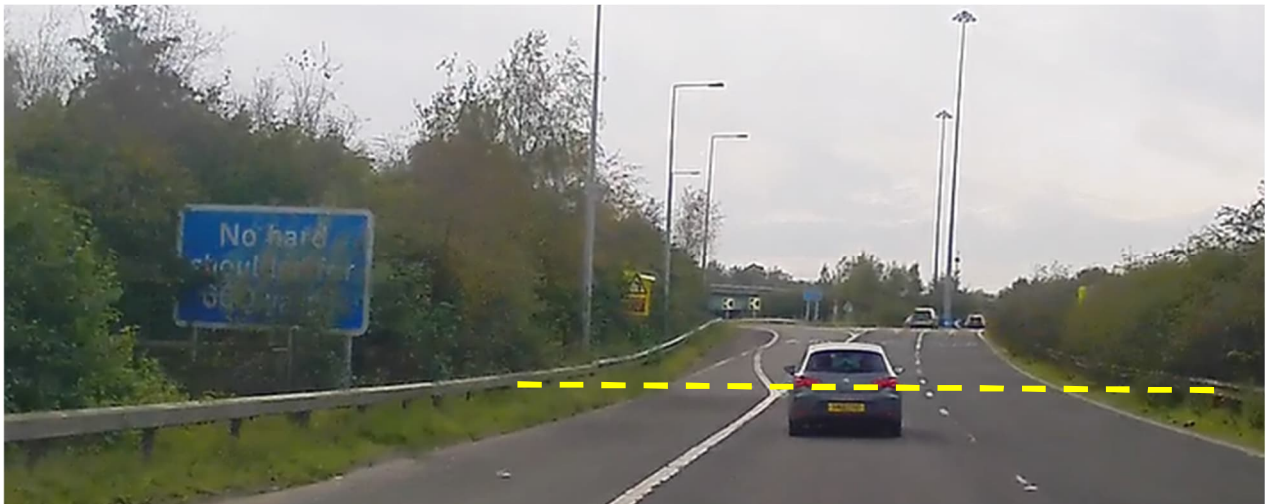
Location: Southbound connector road approach to traffic signals.

Summary: Vegetation and other sign obscuring traffic signals and warning signs.

During the site visit it was noted that foliage adjacent to both lanes of the connector road and existing signs located on the nearside of the carriageway, have the potential to obscure visibility to the primary signal heads and the advance warning signs. The advance warning signs for the traffic signals could also make it more difficult to see the roundabout and bend warning signs that are also currently obscured by vegetation. This could result in sudden sharp braking, resulting in shunts on the approach to the traffic signals.

Figure 4-1 - Approximate distance of signals warning signs indicated, where they may be obscured by vegetation or by the “no hard shoulder” sign, and may obscure the bend and roundabout warning signs.

It is recommended that vegetation is removed and maintained, and a double height traffic signal is provided at both primary signal locations to improve visibility.

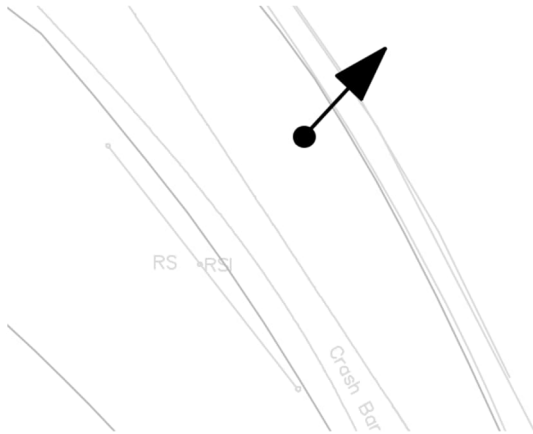
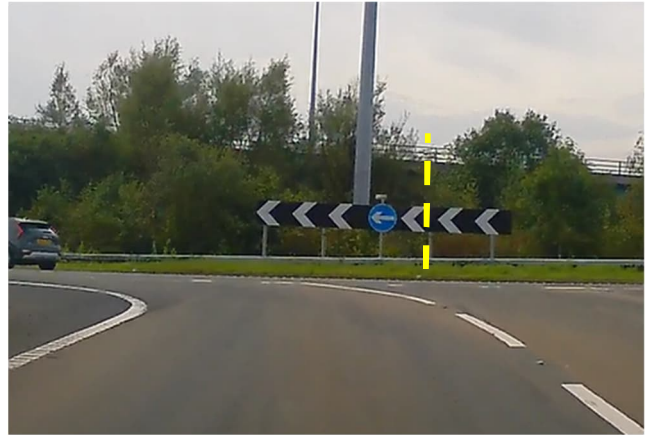
Location: Southbound connector road secondary traffic signal location.

Summary: Proposed signal head / pole to be located in front of VRS and Chevron signs.

The proposed location of the secondary signal for the southbound connector road approach is located in front of the roundabout Chevron signs and in front of the existing Vehicle Restraint System (VRS). This may result in increased severity of injury should any vehicle fail to stop at the traffic signals and strikes the pole.

Figure 4-2 -Illustration of proposed secondary signal location

It is recommended that the secondary traffic signal is located where it will not be in front of the Chevron sign, and behind the VRS. If it is necessary to relocate the VRS it is noted that, as a continuation of the parapet, the VRS may need to be upgraded to meet current standards.

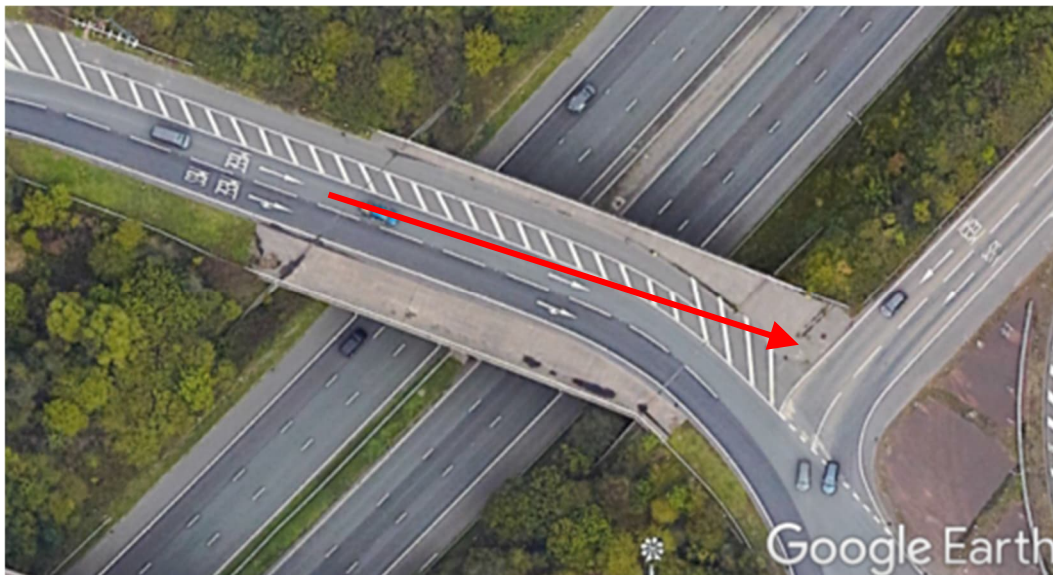
Location: Proposed traffic signal buildout, circulatory carriage way approach.

Summary: Proposed build out places traffic signal at a vulnerable location where vehicles losing control may strike the traffic signal.

The design proposes a build out across the width of the hatched area to the near side of the circulatory carriageway. Vehicles losing control within the roundabout and veering towards the near side, would hit the traffic signal or any VRS in front of the traffic signal head-on. The designer has confirmed the intention of the build out is to place the traffic signal closer to the line of sight of drivers in lane 1. However, the curvature of the circulatory carriage way would allow a direct line of sight from lane 1 to a signal placed on the existing kerbed area at the side of the hatching.

Figure 4-3 - Illustration of visibility angle from nearside lane to nearside primary signal.

It is recommended that the build out is omitted from the design or extended along the length of the hatching so that any vehicles losing control would hit the VRS at a shallow angle.

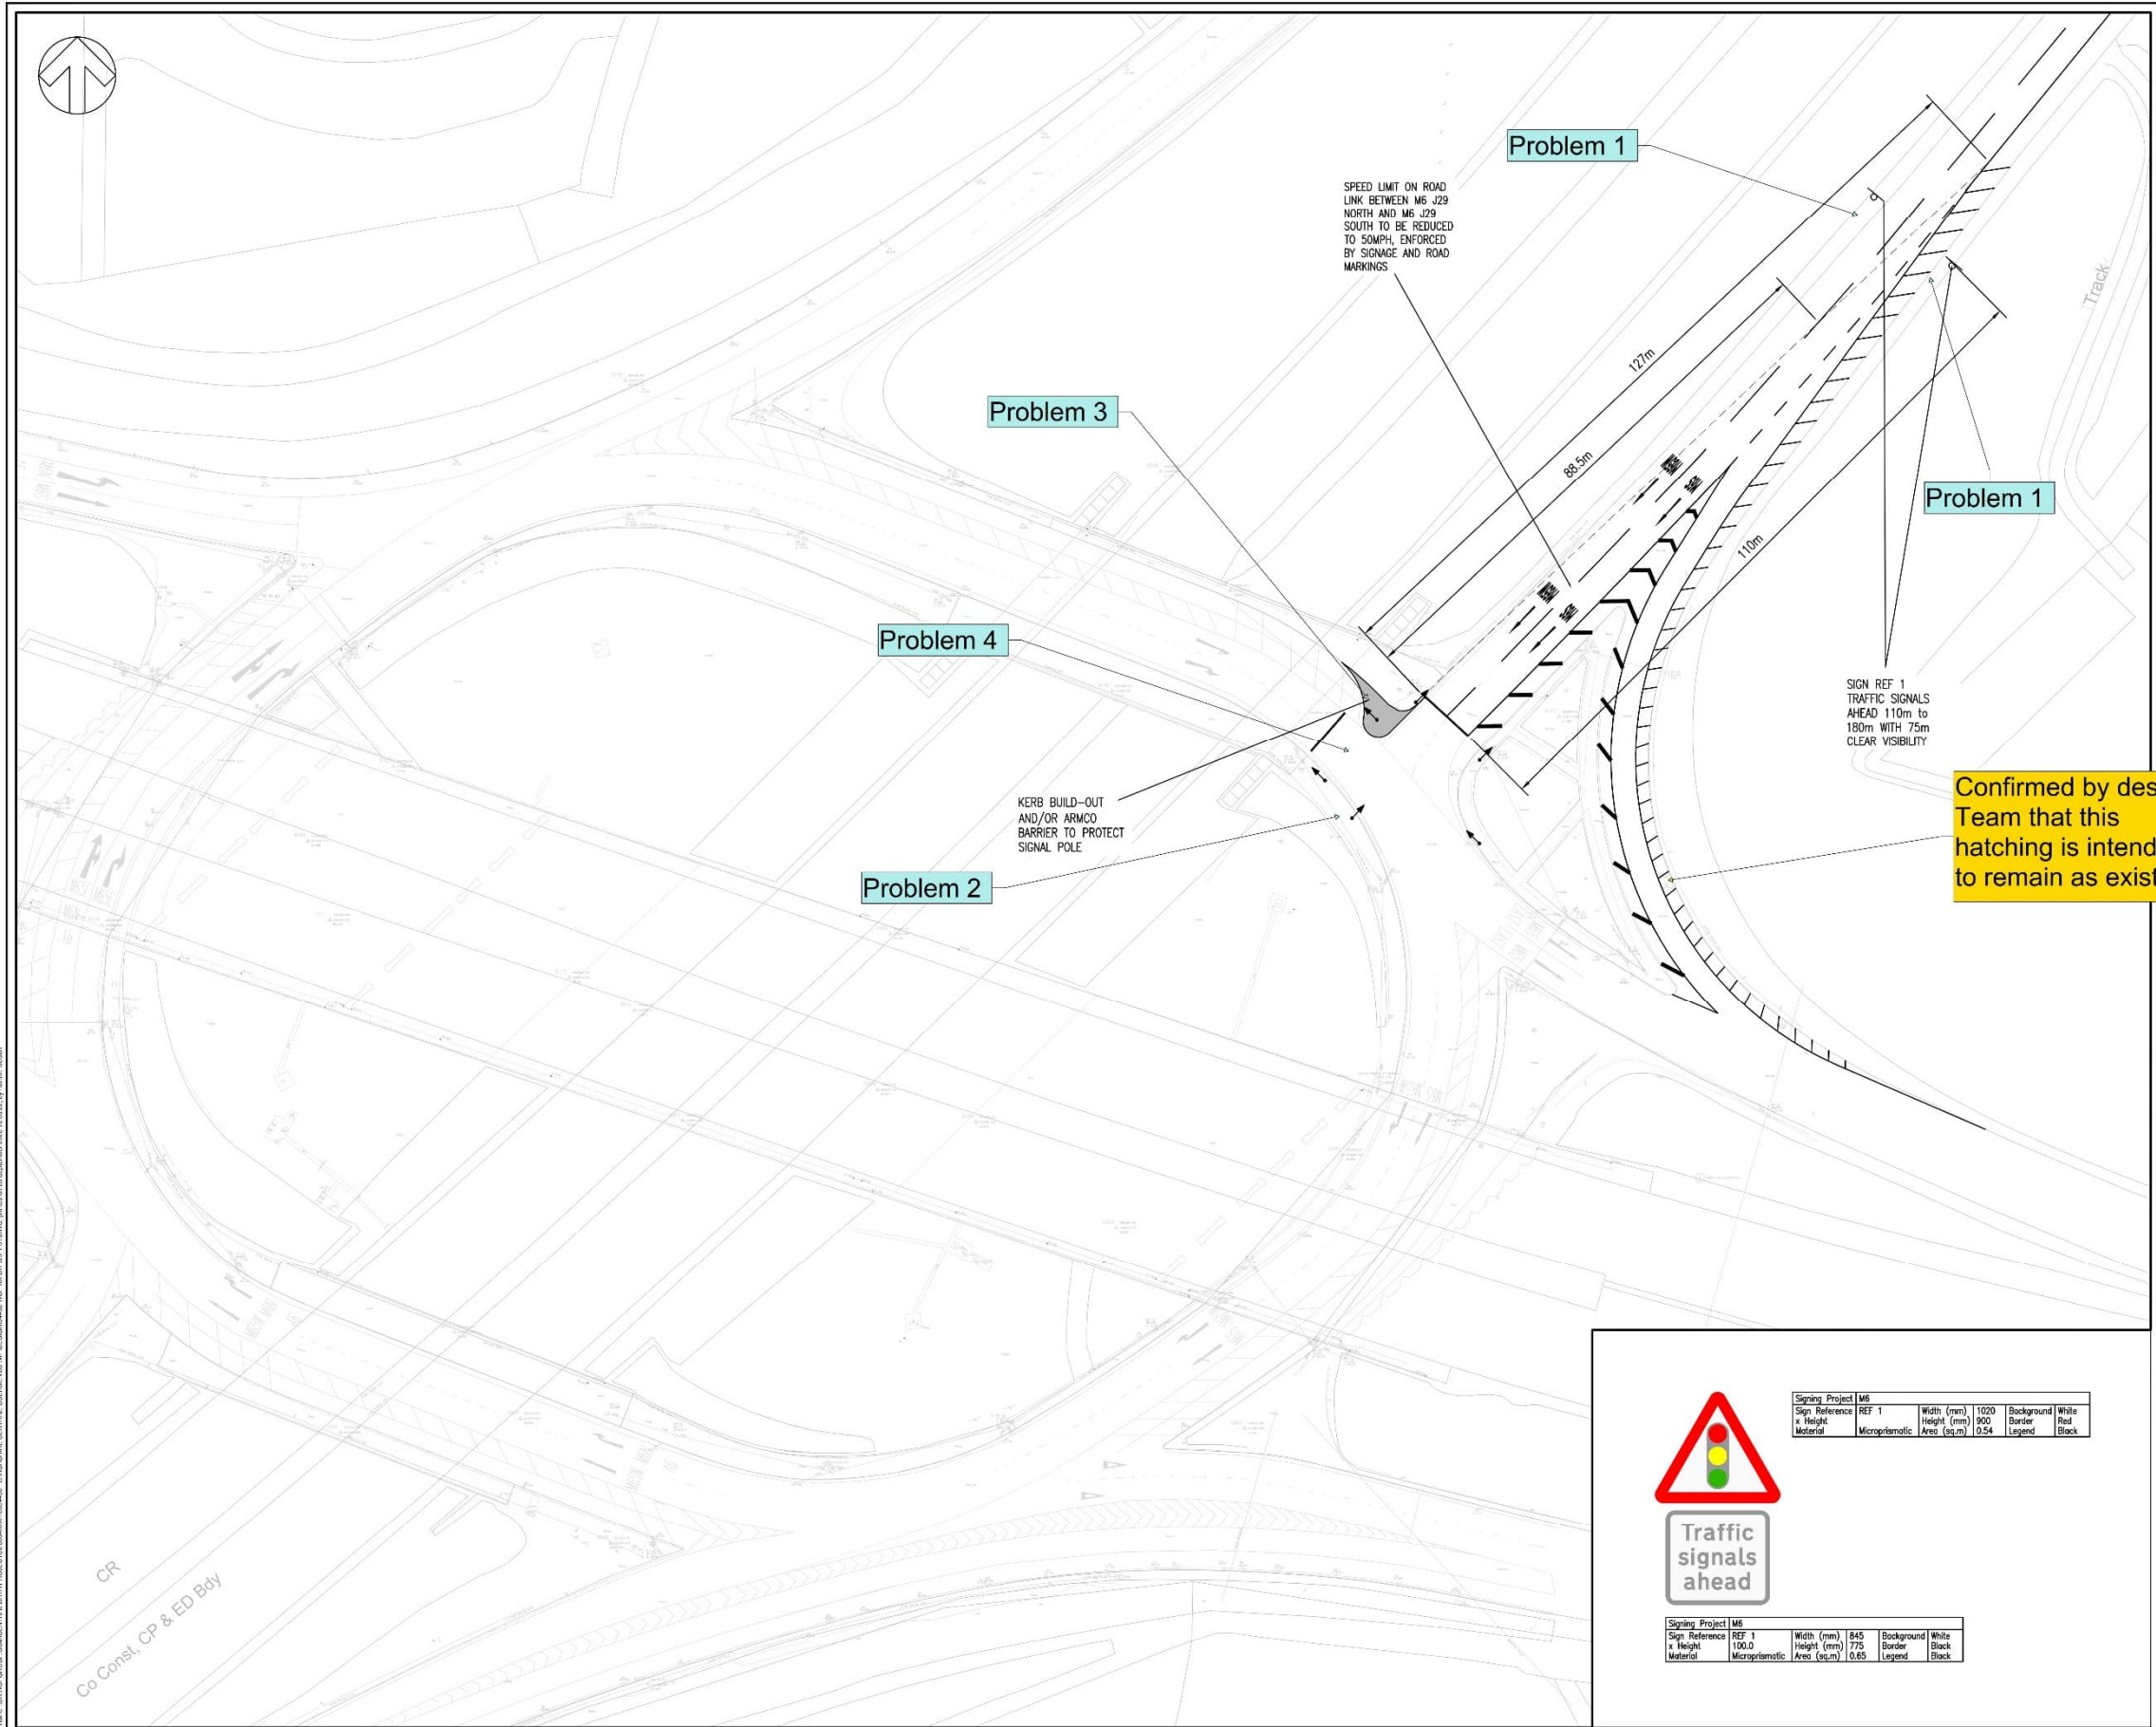
PROBLEM LOCATION PLAN

Confirmed by design Team that this hatching is intended to remain as existing
