Phase I Geoenvironmental Site Assessment
Woodcock Estate, Leyland, Preston
Reference:14-866-R1-RevA
Date: March 2022

PHASE I GEOENVIRONMENTAL SITE ASSESSMENT

Woodcock Estate
Stanifield Lane
Lostock Hall
Leyland
Preston
PR5 5XT

Report Ref: 14-866-R1-RevA
Date Issued: March 2022

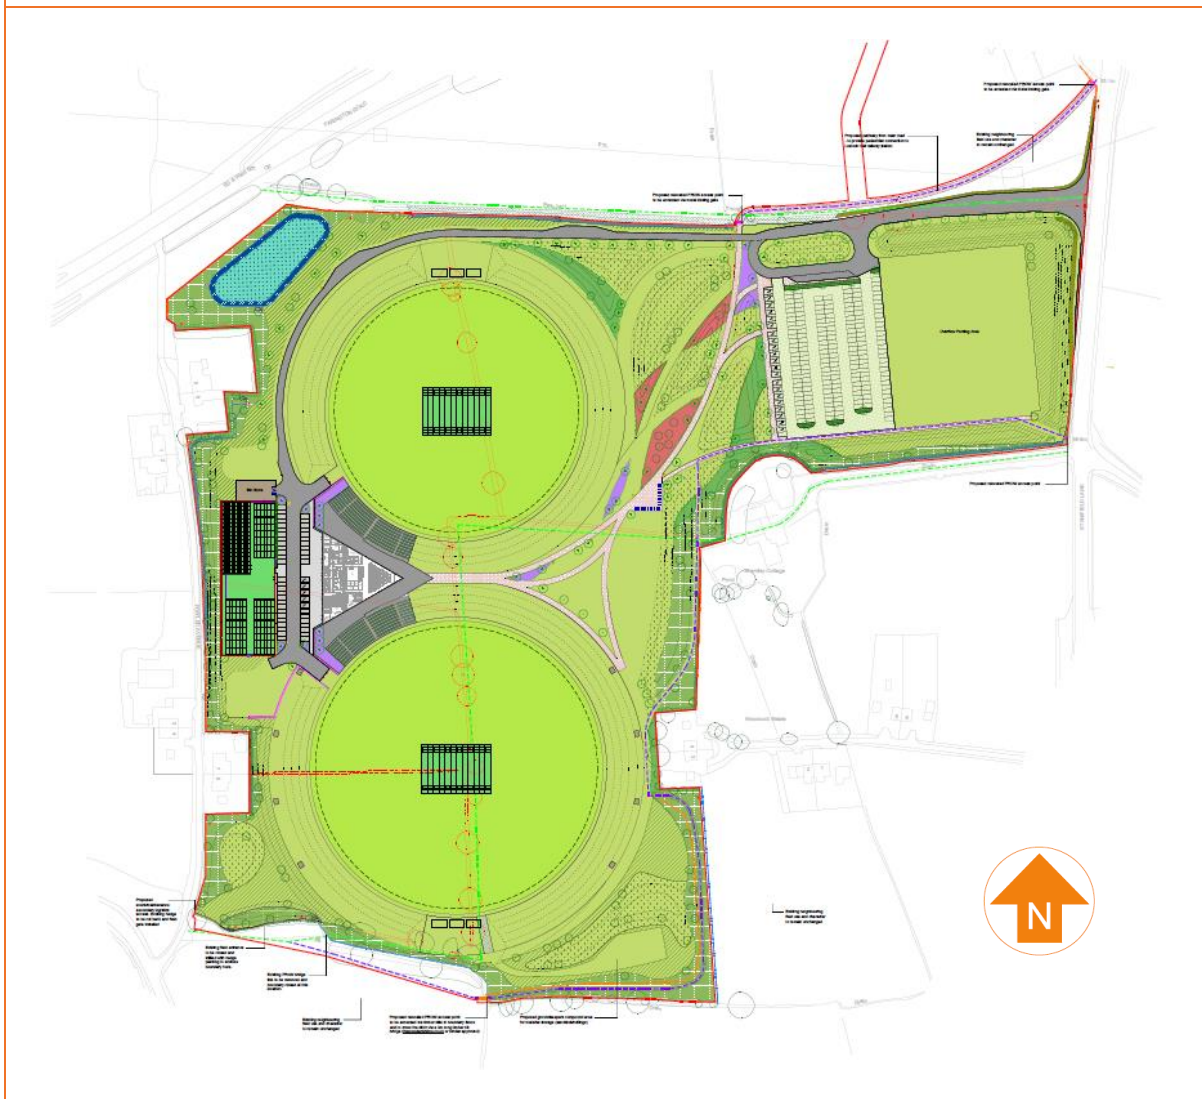
FIGURE 1.1 SNAPSHOT OF PROPOSED DEVELOPMENT

A snapshot of the proposed development layout is indicated in Figure 1.1.

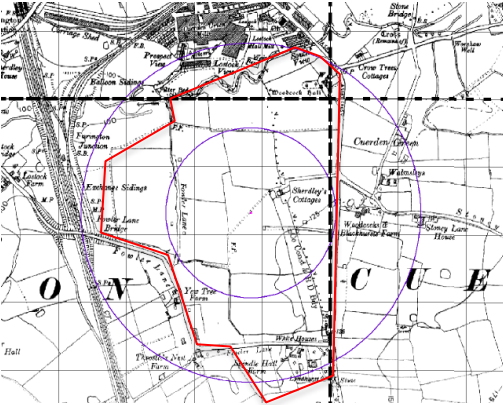
MAP EDITION	HISTORICAL LAND USE	HISTORICAL MAP EXCERPT
<p>Pre 1883 – Pre 1912 1:10,560</p>	<p>The site is largely undeveloped. Mature trees are sporadically present throughout the site and along fence lines. The site is divided into multiple agricultural fields. Several footpaths are shown to extend across the site and around the site boundary. A track is recorded midway on the eastern boundary leading to Sherdley's Cottages. An unnamed feature is also present adjacent to Sherdley's Cottage. Woodcock Hall is recorded in the north east corner of the site and appears to comprise 4no. buildings.</p>

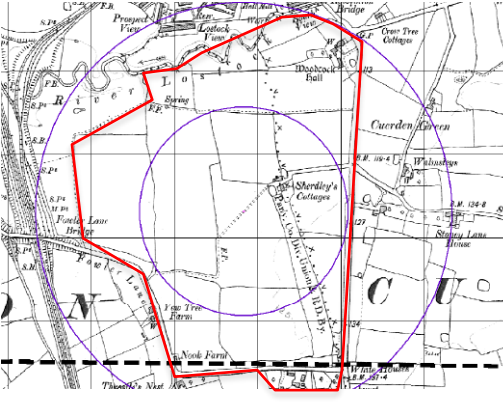
<p>Pre 1912 – Pre 1938 1:10,560</p>	<p>A spring is recorded on the northern boundary. Woodcock Hall appears to have been refigured/extended. Agricultural fields appear to have been reconfigured.</p>

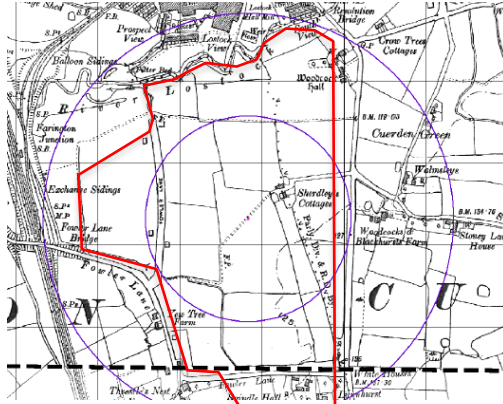
<p>Pre 1938 – Pre 1962 1:10,560</p>	<p>Fowler lane now extends north - south in the western section of the site.</p>

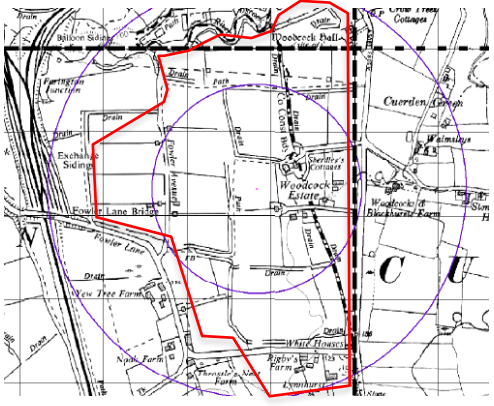
<p>Pre-1962 – Pre-1983 1:10,560</p>	<p>Exchange sidings are now present within the western sector of the site. There are now 6no. buildings along Fowler Lane to the west. There are several drains extending in north south and east west orientations throughout the site. Woodcock Hall is now one building, and Woodcock Estate is now shown in the centre of the eastern boundary and comprises an access road and 5no. buildings. Overhead cables with associated pylons are present in the northern section of the site. The feature adjacent to Sherdley's Cottage is now noted as a pond.</p>

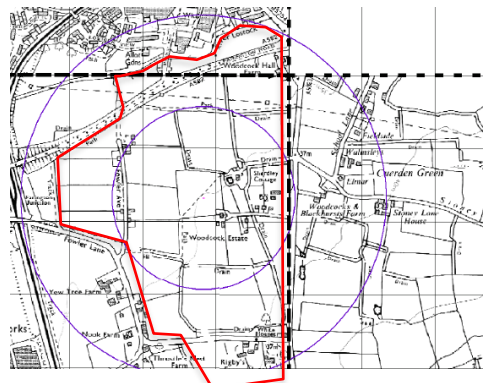
<p>Pre-1983- Pre 2001 1:10,560</p>	<p>Fowler Lane is now identified as Fowler Avenue. There are now 10no. buildings part of Woodcock Estate and associated access road.</p>

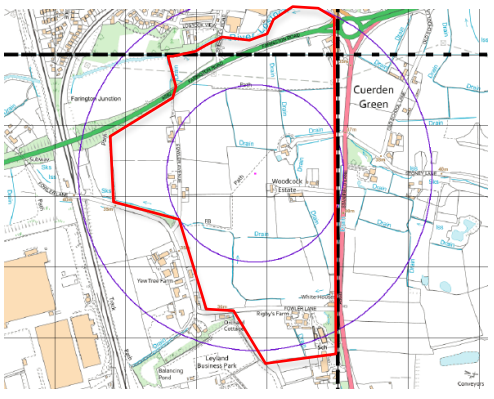
<p>Pre 2001- Pre 2021 1:10,000</p>	<p>Woodstock Hall farm is now labelled in the north eastern corner of the site and comprises 2no. buildings. Woodcock Estate now consists of 6no. buildings.</p>

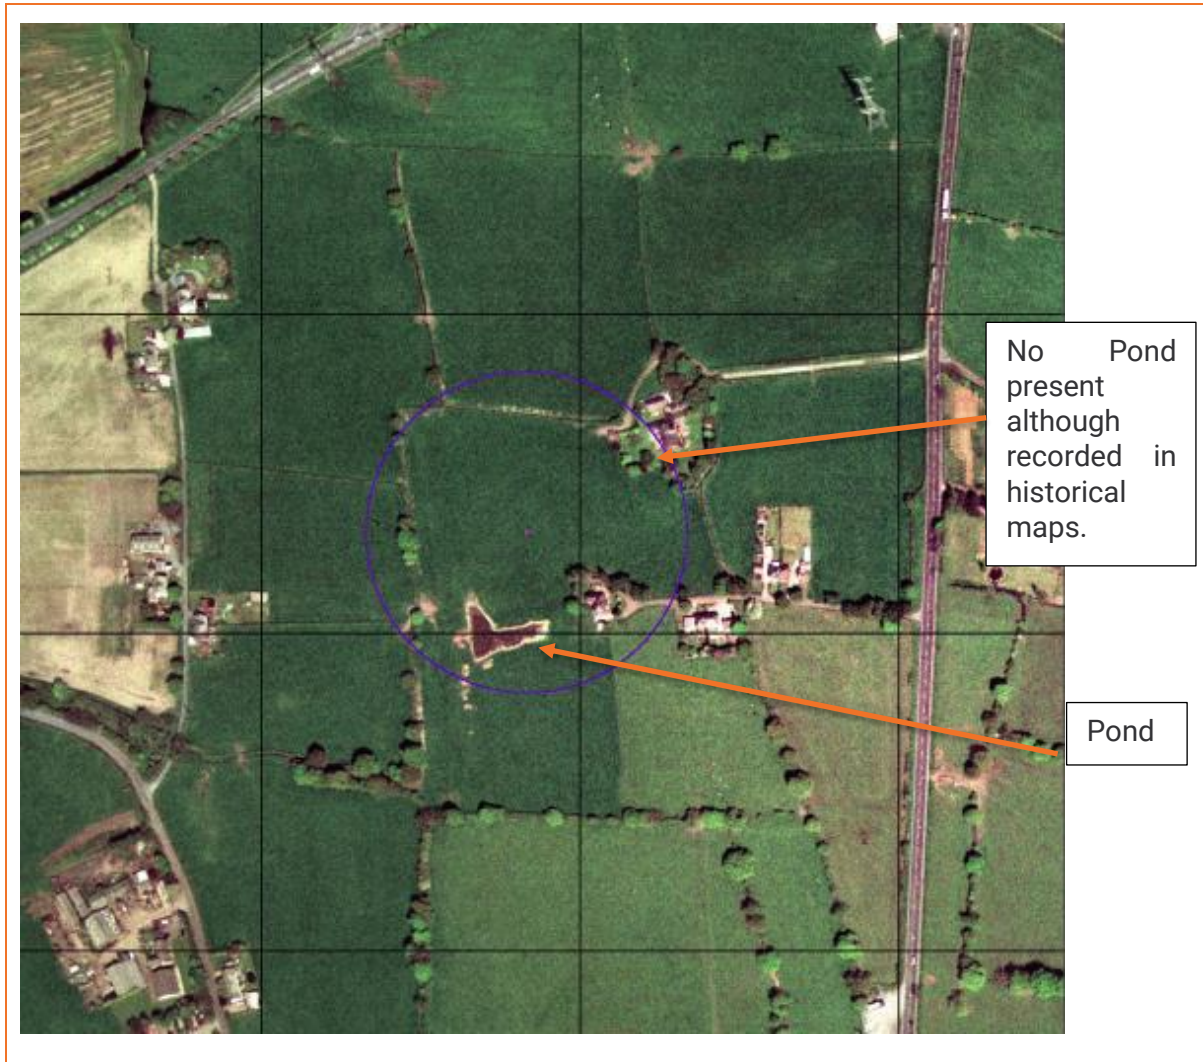
FIGURE 3.1 HISTORIC PHOTOGRAPH OF THE SUBJECT SITE DATED 2001

A historic photo (Figure 3.1) dated 2001 indicates the presence of a pond in the centre of the subject site which is not indicated on any historical maps obtained. The pond appears to have since dried up and has left a depression in the land. The photograph also indicates that the pond present on the historic map is redundant at this time.
