Design and Construction

Ground Investigation Report (GIR)

Cottam Parkway: Access Bridge and Embankment

Geotechnical Report No. CLM07b-LCC-RP-600-0001

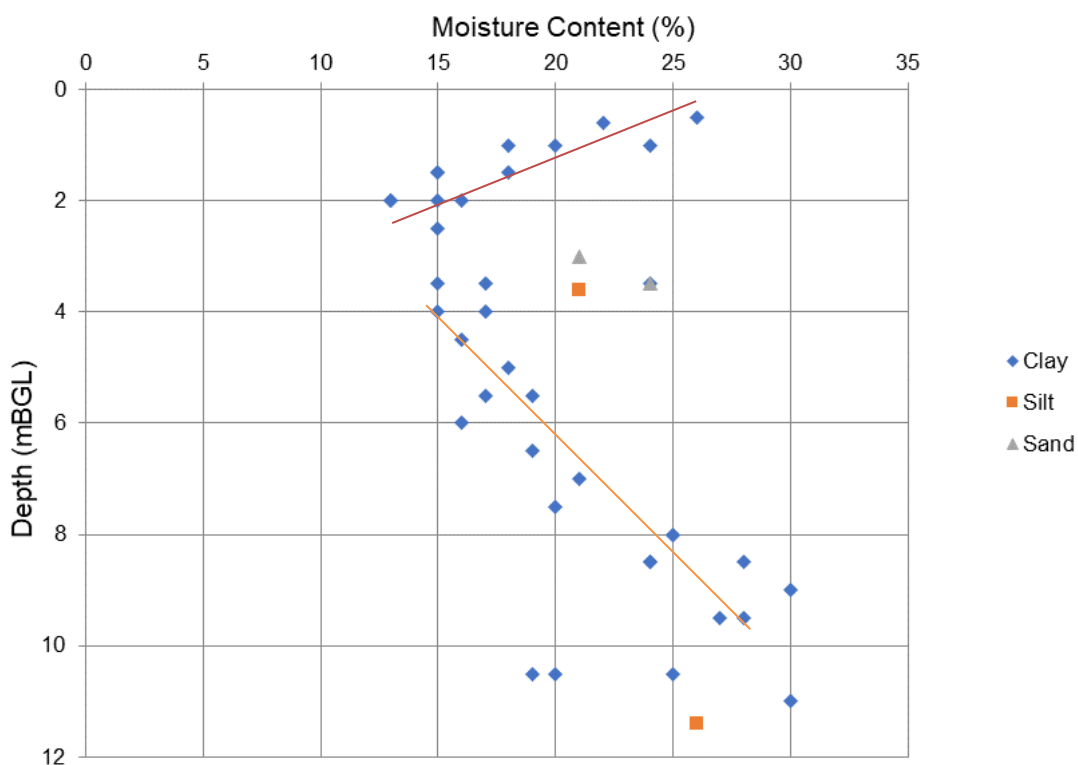
Atterburg testing indicates the clay to be a low to intermediate plasticity with moisture contents ranging between 13% and 30%. There is no clear link between plasticity index, moisture content and depth. However, moisture content does appear to decrease from surface level to 2mbgl and then increase with depth towards the base of the Upper Glacial Till, as shown in Figure 3. This may be due to naturally higher levels of moisture content at the surface due to rainwater saturation, which becomes drier with depth. Below circa 2.50mbgl, pockets of perched groundwater are located (see Section 5.1) and the moisture content of the soil will gradually increase with depth as it becomes more saturated.

Figure 3: Moisture content values with depth (trend lines are indicative and not for design purposes)

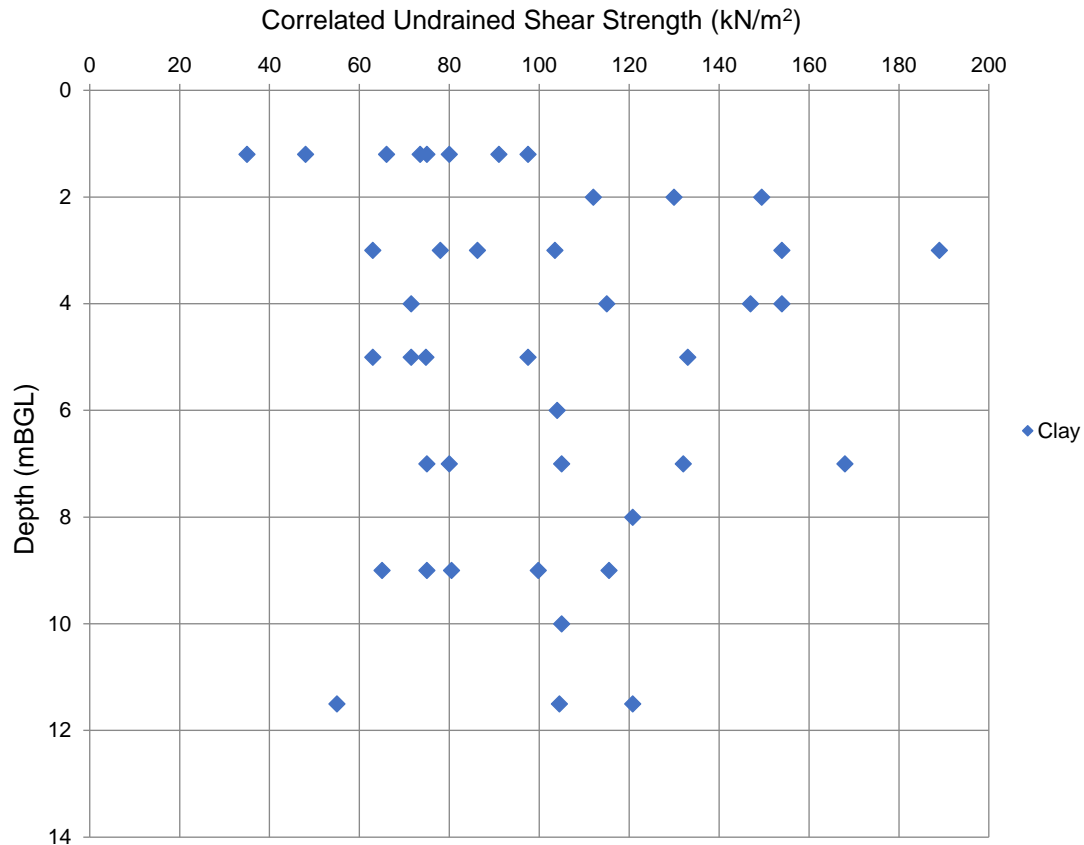
A summary of the correlated shear strengths for the Upper Glacial Till is provided in Figure 5 below and generally shows no clear correlation between shear strength and depth.

Figure 5: Correlated shear strength with depth (trend line is indicative and not for design purposes)

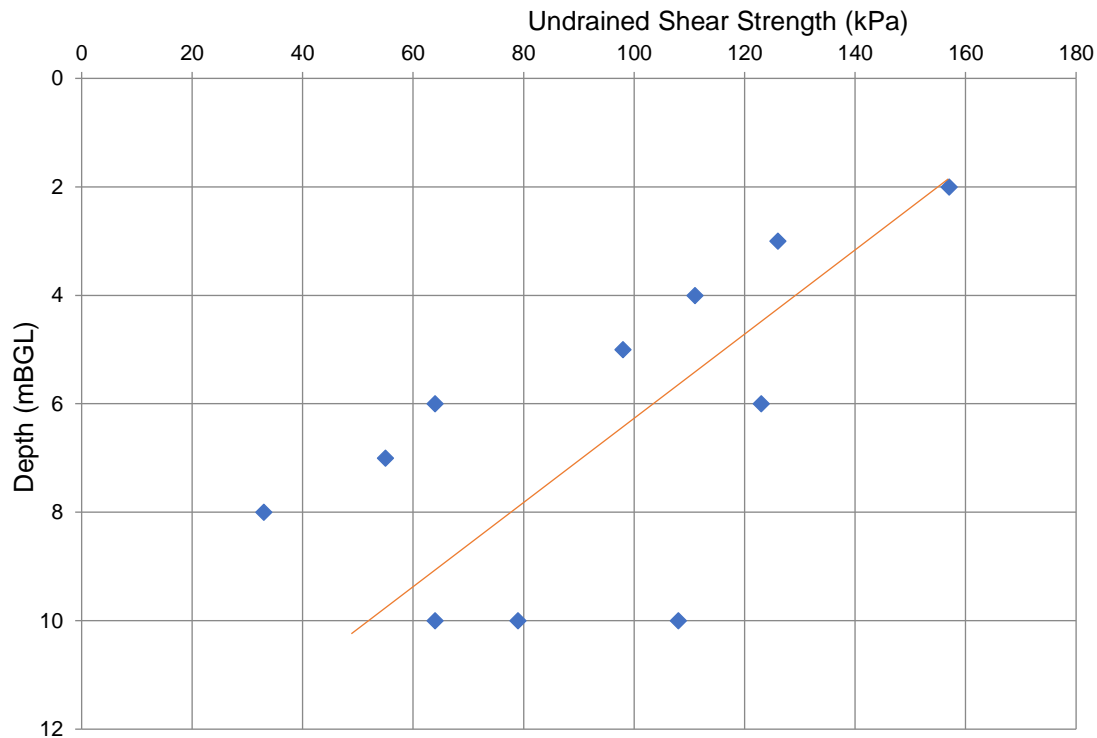
Figure 6 shows undrained strength reducing with depth in the upper glacial till. This seems to correspond with the general trend of increasing moisture content with depth.

Figure 6: Undrained shear strength with depth (trend line is indicative and not for design purposes)

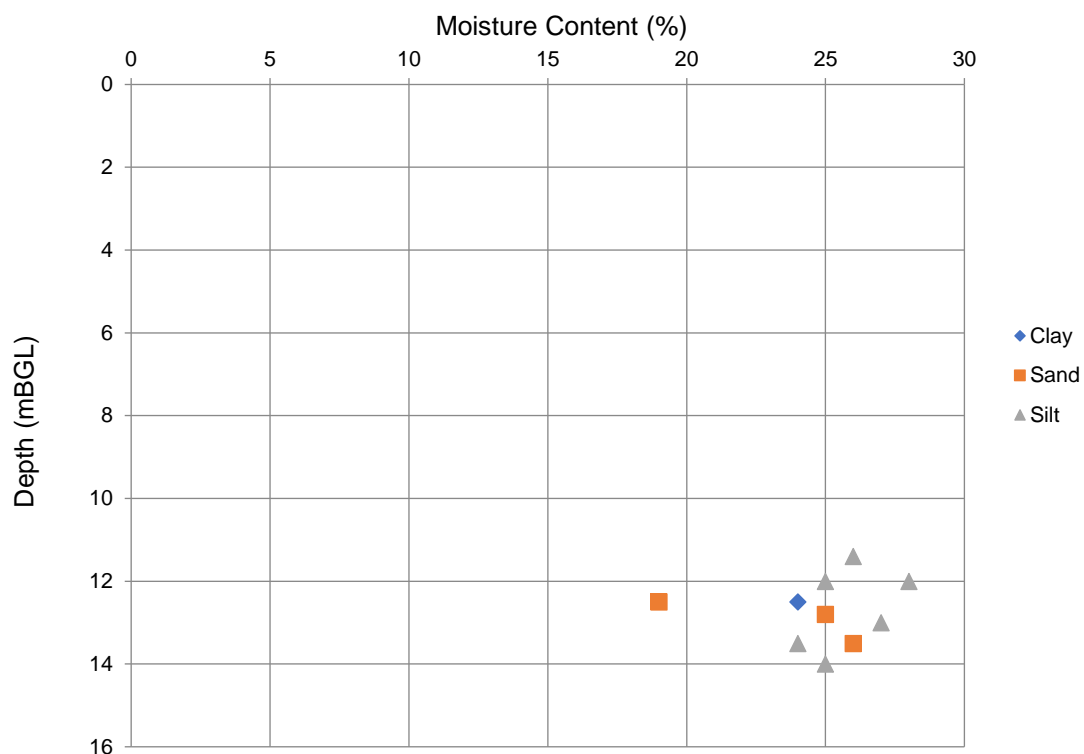
Atterburg testing indicates the clay layers within the Upper Glaciofluvial Deposits to be of intermediate plasticity. Moisture contents range between 19% and 27% and appear to be within the same range as the deepest part of the Upper Glacial Till, continuing the trend of increasing moisture content with depth (see Figure 7). The higher moisture contents in the Upper Glaciofluvial Deposits are likely due to the perched groundwater encountered at this depth (See Section 5.1).

Figure 7: Moisture content values with depth
