04th December 2023

Bat Building Inspection: County Hall, Fishergate, Preston, Lancashire PR1 8RL

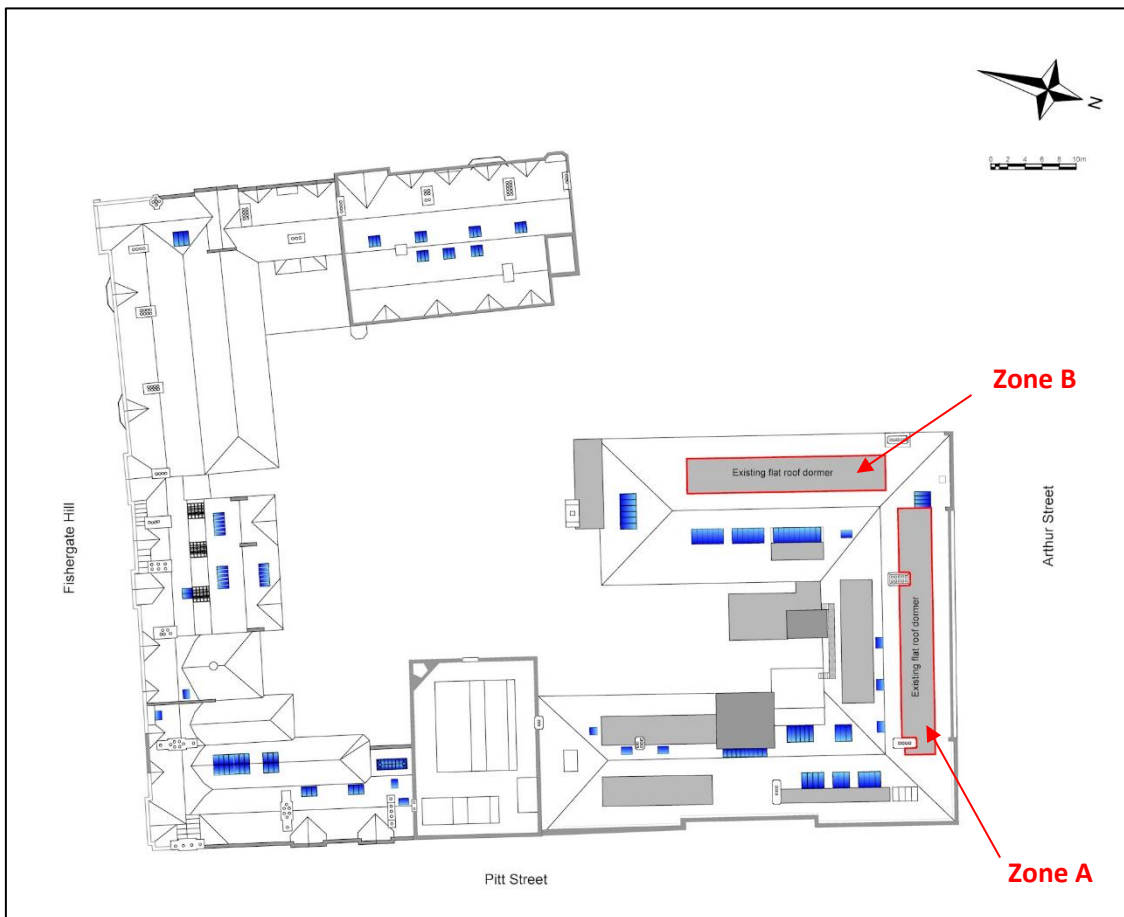
Plan 3: Existing Roof Plan.

Examination of the external aspects of the building found the roof to be pitched and hipped with slate tiles throughout. The dormer windows were on north (Zone A) and west (Zone B) facing pitches of the roof (see Plan 3) and were found to be flat roofed with roofing felt covering and ends that were timber clad.
