B. Drainage Survey Details

Project Name: B5254 Lostock Hall 2021_12_06
Project Description: WinCan Import in Miraculix WRc4 Standard
Project Date: 07/12/2021
Inspection Standard: MSCC4 Sewers & Drainage GB (SRM4 Scoring)

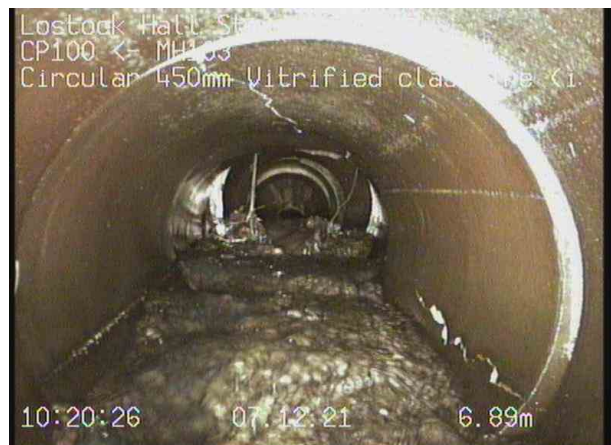
<table><tr> <td style="text-align: right;">0.00</td> <td>MH</td> <td>Start node type, manhole, reference number: MH103</td> <td>00:00:02</td> <td></td> <td></td> </tr><tr> <td style="text-align: right;">6.92</td> <td>CLJ</td> <td>Crack, longitudinal at joint at 11 o'clock</td> <td>00:01:14</td> <td>CP100X_d 7148160-d f8a-465f-b</td> <td>2</td> </tr></table>

CP100X_d7148160-df8a-465f-bacd-fba022c64dea_20211207_092413_981.jpg, 00:01:14, 6.92 m
 Crack, longitudinal at joint at 11 o'clock

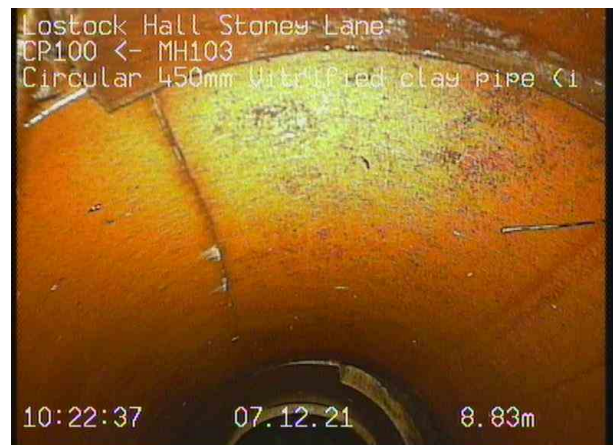
<table><tr> <td style="text-align: right;">0.00</td> <td>MH</td> <td>Start node type, manhole, reference number: MH103</td> <td>00:00:02</td> <td></td> <td></td> </tr><tr> <td style="text-align: right;">8.84</td> <td>CLJ</td> <td>Crack, longitudinal at joint at 11 o'clock</td> <td>00:02:35</td> <td>CP100X_1 e224d9e-4 05b-47da-</td> <td>2</td> </tr></table>

CP100X_1e224d9e-405b-47da-9010-a4eba253f7df_20211207_092624_848.jpg, 00:02:35, 8.84 m
Crack, longitudinal at joint at 11 o'clock

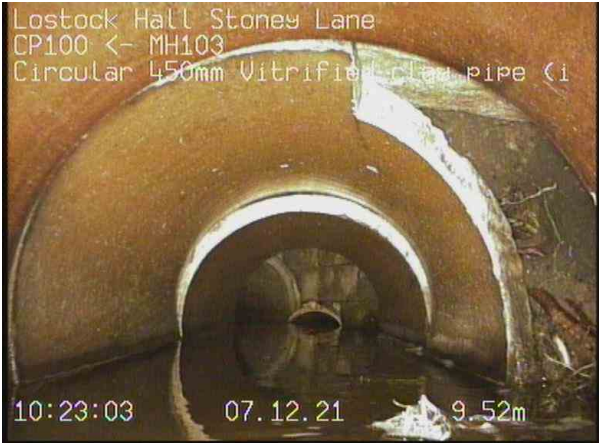
CP100X_df3e1c8c-c9c4-48ad-8804-7f15afaf9e4d_20211207_092650_656.jpg, 00:02:51, 9.52 m
 Hole in drain or sewer at a joint from 12 o'clock to 5 o'clock

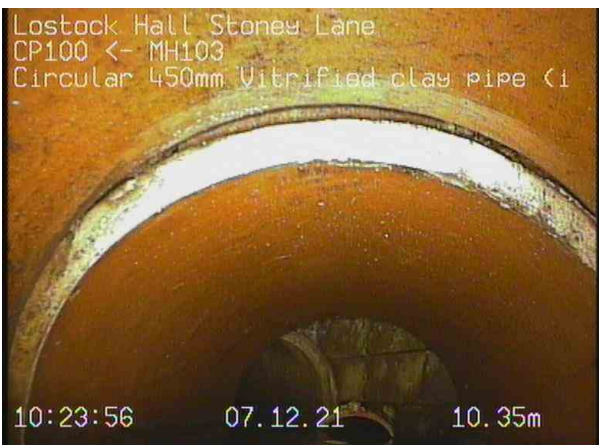
CP100X_0b6959cb-bf47-4b35-be67-4c037a8aafa6_20211207_092744_477.jpg, 00:03:38, 10.34 m
 Joint displaced, medium

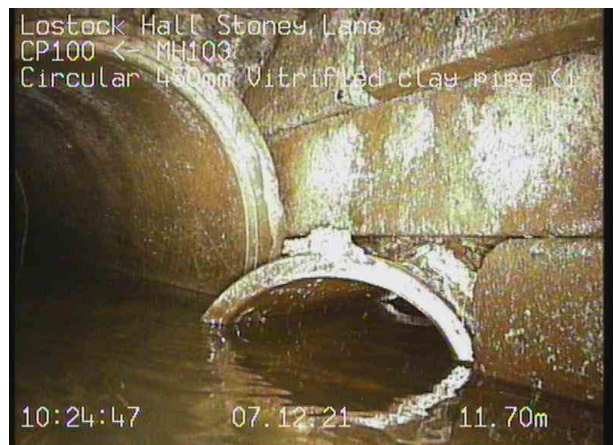
CP100X_562dccc1-b2f1-4f6c-9112-ebdc9effc733_20211207_092834_668.jpg, 00:04:00, 11.70 m
 General remark, Connecting pipe you can see in the catchpit is coming from Ditch1.

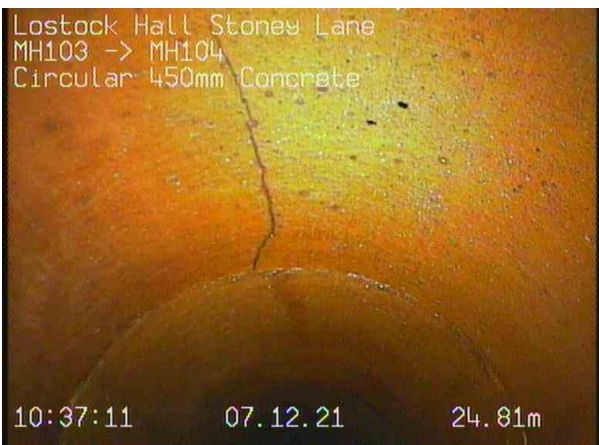
<table><tr> <td style="width: 10%;">Depth: 1.30 m</td> <td colspan="7"></td> </tr><tr> <td></td> <td>24.81</td> <td>CLJ</td> <td>Crack, longitudinal at joint at 12 o'clock</td> <td>00:03:56</td> <td>MH103X_f7c38e15-932b-42d6-</td> <td></td> <td>2</td> </tr></table>

MH103X_f7c38e15-932b-42d6-95a7-6f00c36d977e_20211207_094059_279.jpg, 00:03:56, 24.81 m
 Crack, longitudinal at joint at 12 o'clock

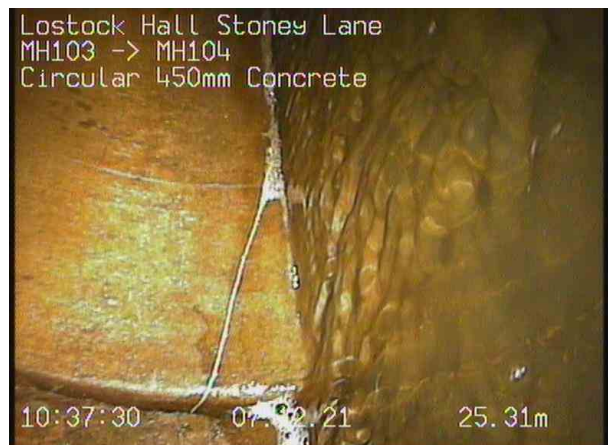
<table><tr> <td style="width: 10%;">Depth: 1.30 m</td> <td colspan="7"></td> </tr><tr> <td></td> <td>25.31</td> <td>CLJ</td> <td>Crack, longitudinal at joint at 7 o'clock</td> <td>00:04:10</td> <td>MH103X_62b509ee-8da6-429a</td> <td></td> <td>2</td> </tr></table>

MH103X_62b509ee-8da6-429a-a5f8-ef328ec179a6_20211207_094118_056.jpg, 00:04:10, 25.31 m
 Crack, longitudinal at joint at 7 o'clock

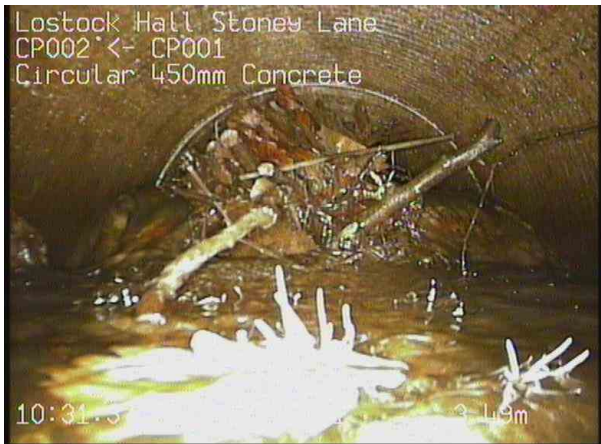
CP002X_0658fe4e-c858-4465-9642-e41be5d5b39a_20211207_103610_514.jpg, 00:00:27, 3.49 m
Roots, mass, 90% cross-sectional area loss, Before Root-Cutting/Warthog

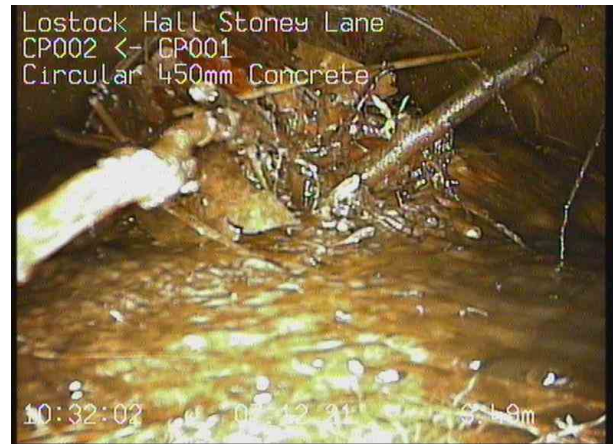
CP002X_7c92932e-6bc4-45c9-a487-1ee05fd42271_20211207_103634_647.jpg, 00:00:45, 3.49 m
Survey abandoned, Unable to pass debris

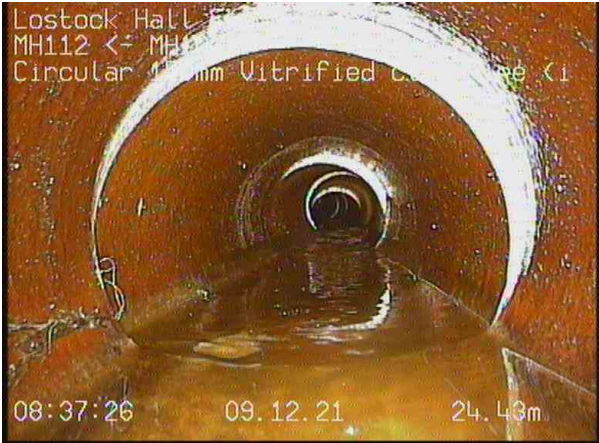
MH112X_f79f7a9b-4cf2-4bcb-8a14-13bd8f1be70c_20211209_084157_386.jpg, 00:04:09, 24.43 m
Roots, fine at joint

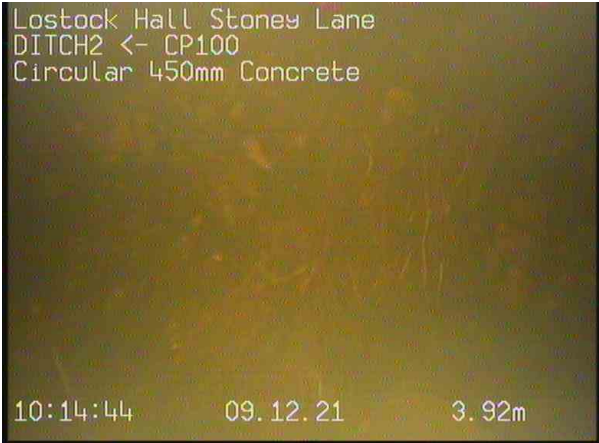
DITCH2X_d0e641f9-1ac0-4818-897b-d3a3cd028c56_20211209_101915_093.jpg, 00:00:55, 3.92 m
 Roots, mass, 30% cross-sectional area loss

DITCH2X_bf3123d7-9d7b-42f2-92e0-6a9b0563fc02_20211209_101943_168.jpg, 00:00:55, 3.92 m
 Roots, mass, 30% cross-sectional area loss

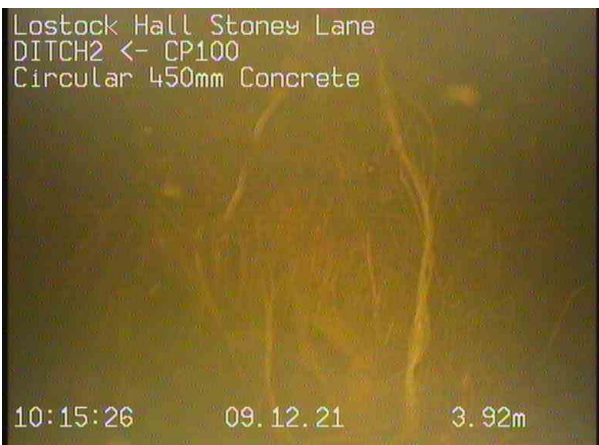
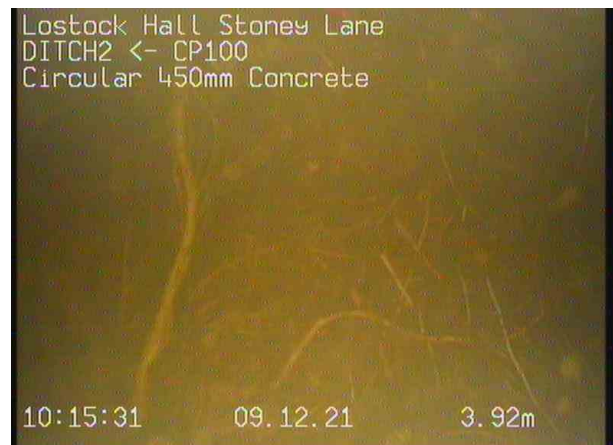
DITCH2X_82ea87bd-8f82-42f0-ae60-59e618eb32d9_20211209_101957_683.jpg, 00:01:32, 3.92 m
 Roots, tap

DITCH2X_893ca743-d2f4-4384-ab6f-36db9748845d_20211209_102002_264.jpg, 00:01:32, 3.92 m
 Roots, tap

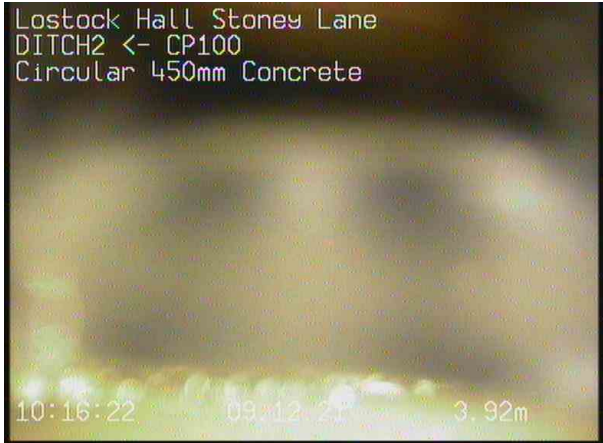
DITCH2X_b0d974d4-ab85-4ca4-95ce-bd05c55802fc_20211209_102053_454.jpg, 00:01:55, 3.92 m
 Survey abandoned, Unable to pass mass roots. Robotic cutter needed. Unable to remove with Warthog. Survey Overlapped.

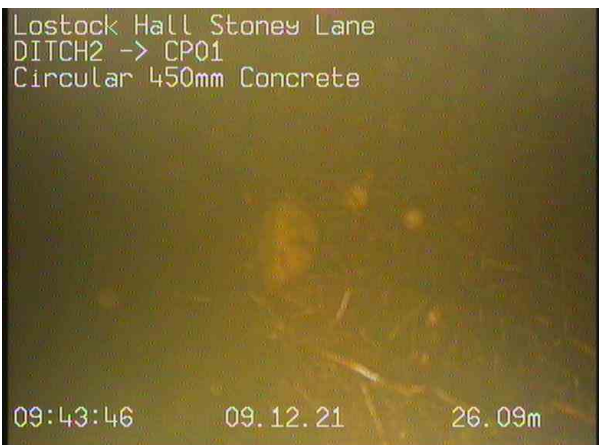
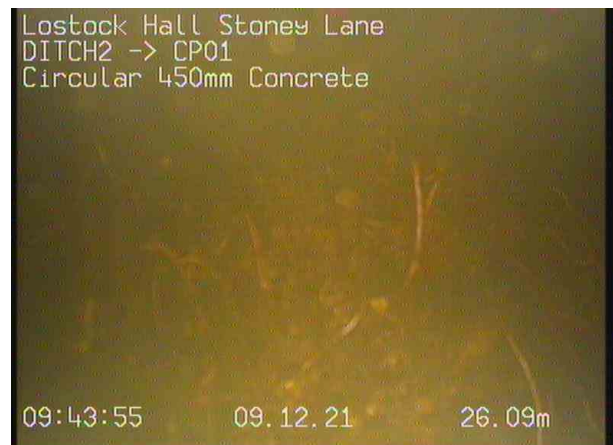
DITCH2X_d6608d2e-1516-4496-8d62-d7c5bf3b1b75_20211209_094817_724.jpg, 00:05:29, 26.09 m
 Roots, mass, 30% cross-sectional area loss

DITCH2X_652f154b-e4d7-4485-9329-7ac427e47d08_20211209_094826_618.jpg, 00:05:29, 26.09 m
 Roots, mass, 30% cross-sectional area loss

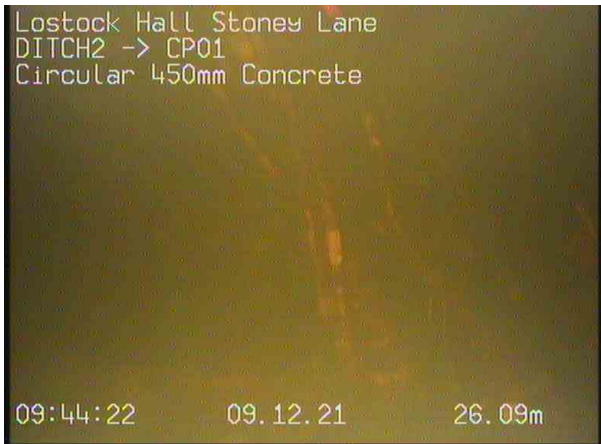
DITCH2X_91dc0210-5a83-4af4-ba15-f31d7ec9e9b7_20211209_094853_573.jpg, 00:06:01, 26.09 m
Roots, tap at joint

DITCH2X_43823a0b-87df-4c4f-9ff0-09c72dc82cfc_20211209_094903_373.jpg, 00:06:01, 26.09 m
Roots, tap at joint

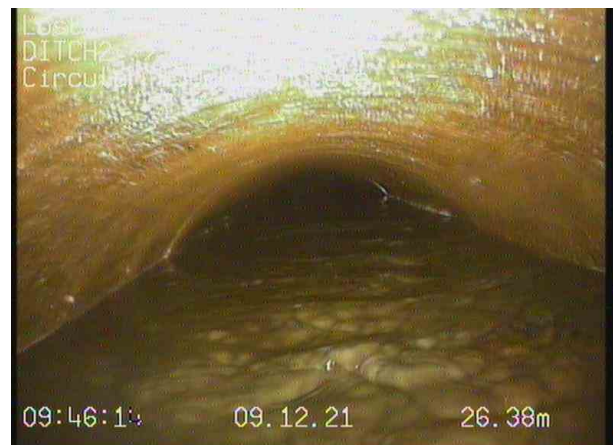
DITCH2X_af5a118b-9635-4d59-94f7-40bb4923ea76_20211209_095044_894.jpg, 00:07:05, 26.37 m
Survey abandoned, Unable to remove mass roots with warthog. Needs a robotic cutter. Survey Overlapped from CP01

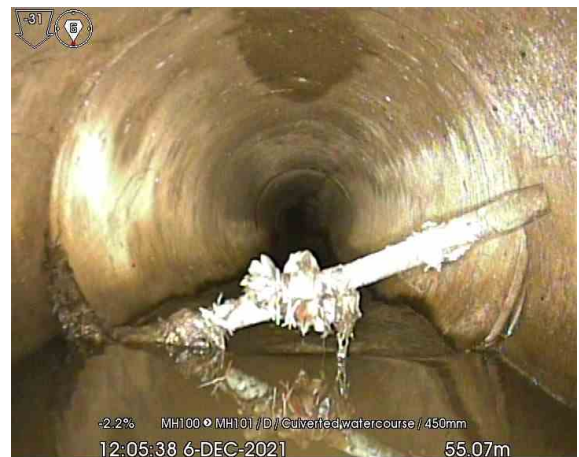
MH100X_55-07m_120519.jpg, 00:06:28, 55.07 m
 Other obstacles from 2 o'clock to 8 o'clock, 10%
 cross-sectional area loss, Bar or branch stuck in the joint

MH100X_55-07m_120538.jpg, 00:06:30, 55.07 m
 Survey abandoned, Unable to pass bar or branch with the
 crawler. Line needs jetting. TM needed.

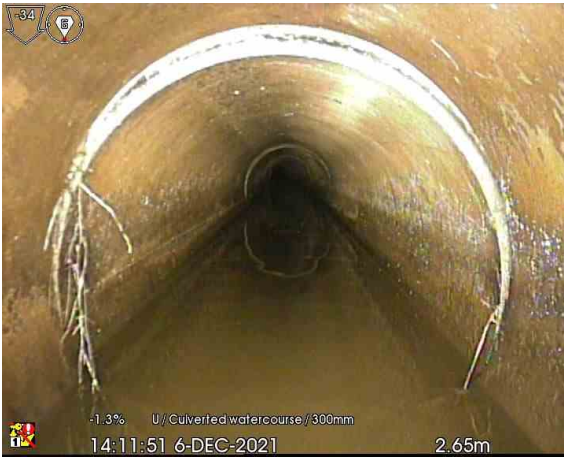
MH102X_2-65m_141151.jpg, 00:00:26, 2.65 m
 Roots, fine at joint

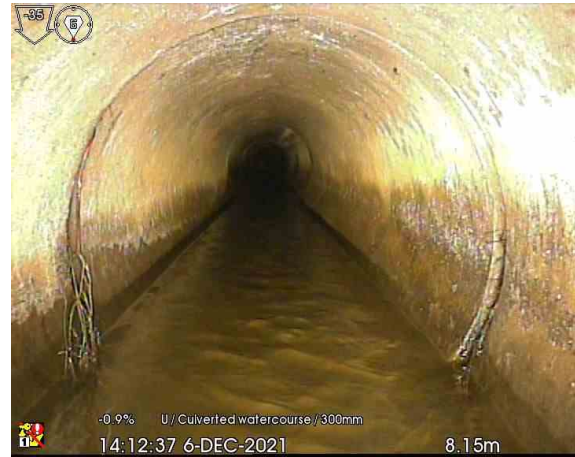
MH102X_8-15m_141237.jpg, 00:01:06, 8.15 m
 Roots, fine at joint

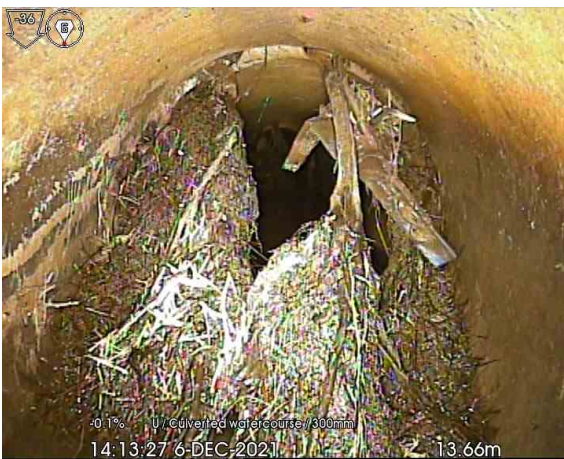
MH102X_13-66m_141327.jpg, 00:01:46, 13.66 m
 Roots, mass at joint, 90% % cross-sectional area loss

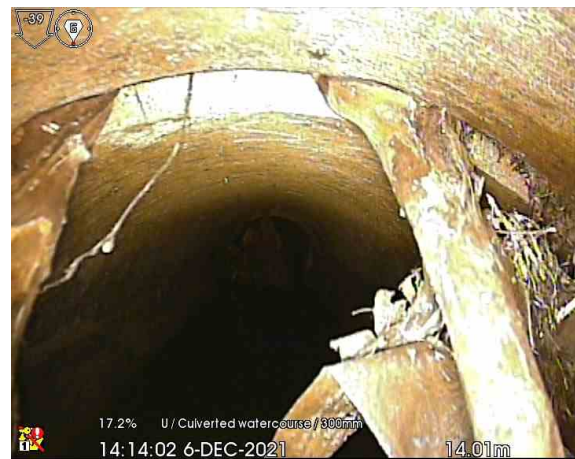
MH102X_14-01m_141402.jpg, 00:02:07, 14.01 m
 Survey abandoned, Unable to pass mass roots. Line needs root cutting. TM Needed.

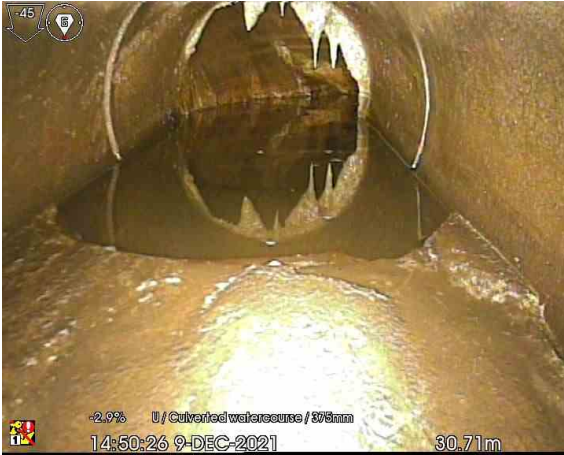
DITCH6 PIPE A_30-71m_145026.jpg, 00:02:27, 30.71 m
 Survey abandoned, Unable to drive over concrete

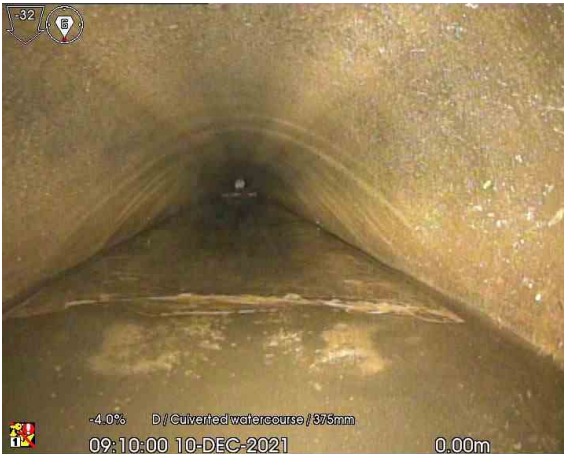
MH113X_0-00m_091000.jpg, 00:00:06, 0.00 m
 Attached deposits, other from 4 o'clock to 8 o'clock, 30% cross-sectional area loss, Concrete in line

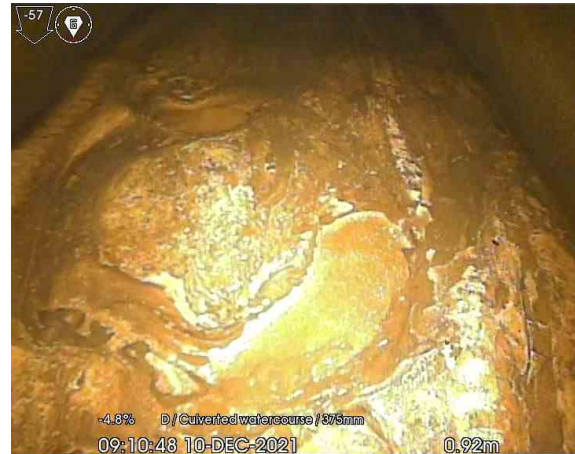
MH113X_0-92m_091048.jpg, 00:00:31, 0.92 m
 Attached deposits, other from 4 o'clock to 8 o'clock, 30% cross-sectional area loss, Unable to remove remaining Concrete

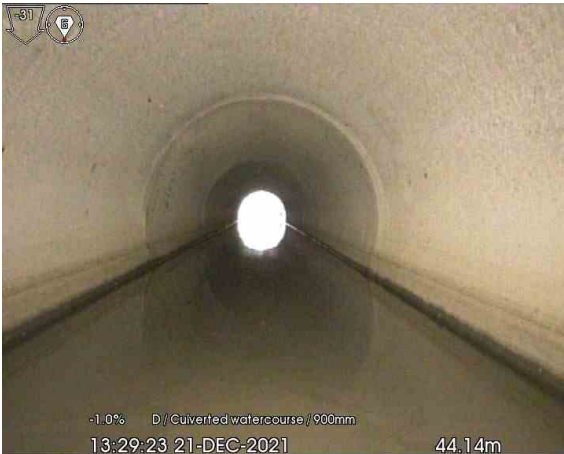
DITCH7X_44-14m_132923.jpg, 00:02:47, 44.14 m
 Settled deposits, fine, 20% % cross-sectional area loss

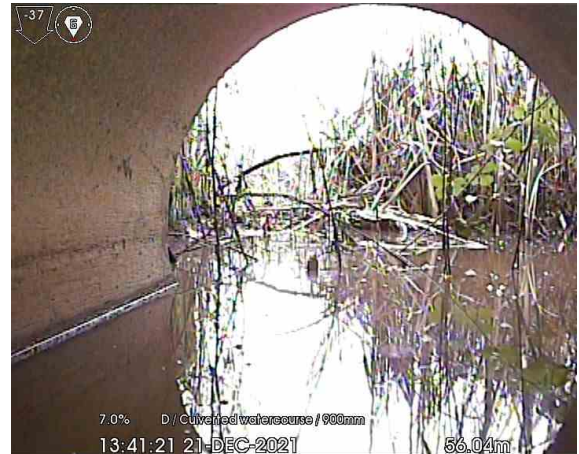
DITCH7X_56-04m_134121.jpg, 00:13:47, 56.04 m
 Finish node type, outfall, reference number: DITCH3, Ditch needs devegetation to drop the water level

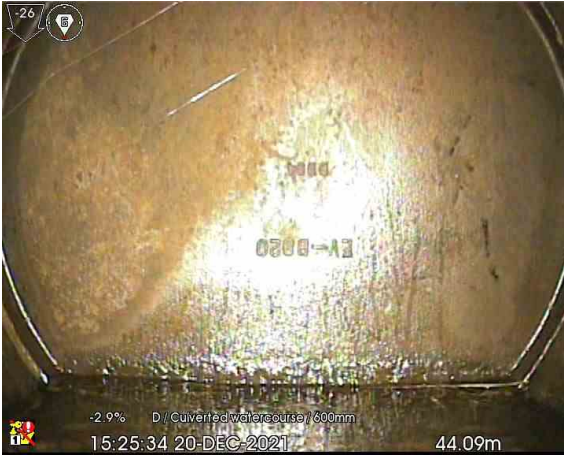
MH116Y_44-09m_152534.jpg, 00:03:08, 44.09 m
 Finish node type, outfall, reference number: OUTFALL, Flap valve on the outfall. Outfalls into the River Lostock.

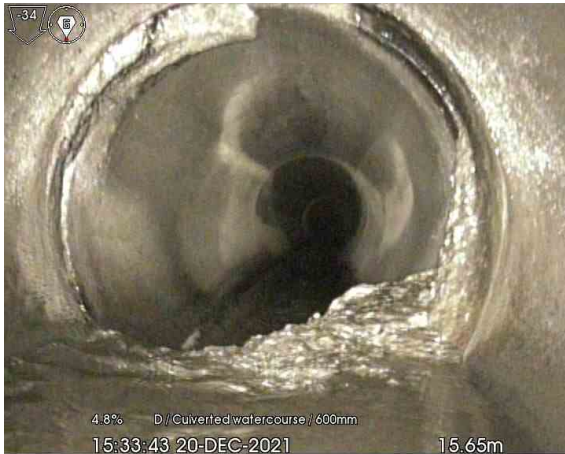
MH115X_15-65m_153343.jpg, 00:01:27, 15.65 m
 Attached deposits, encrustation at joint, from 03 to 07 o'clock,
 15% % cross-sectional area loss

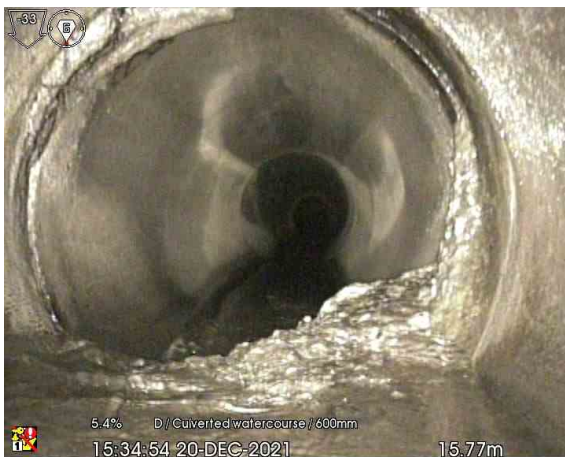
MH115X_15-77m_153454.jpg, 00:02:01, 15.77 m
 Survey abandoned, Risk to equipment. Survey overlapped
 from downstream manhole

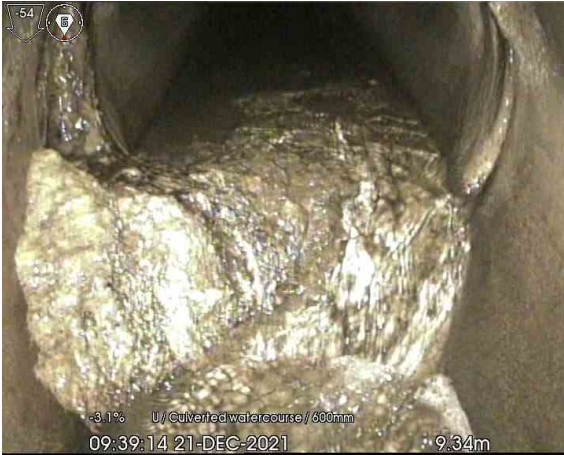
MH115X Overlap_9-34m_093914.jpg, 00:00:56, 9.34 m
 Attached deposits, encrustation at joint, from 04 to 08 o'clock,
 20% % cross-sectional area loss

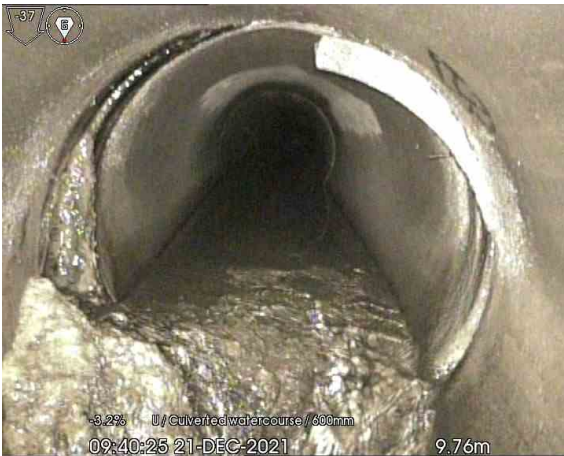
MH115X Overlap_9-76m_094025.jpg, 00:01:45, 9.76 m
 Survey abandoned, Survey overlapped from upstream
 manhole

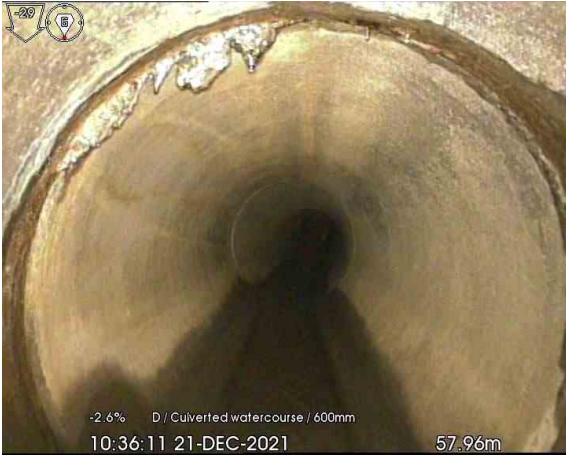
MH117X_57-96m_103611.jpg, 00:04:56, 57.96 m
 Attached deposits, encrustation at joint, from 10 to 12 o'clock,
 5% % cross-sectional area loss

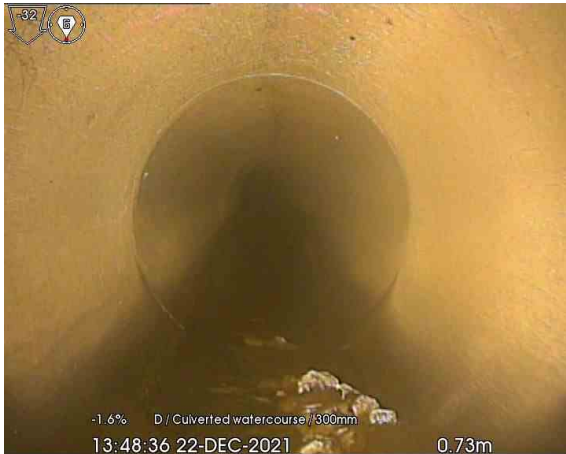
MH6X_0-73m_134836.jpg, 00:00:11, 0.73 m
 Material changes to concrete

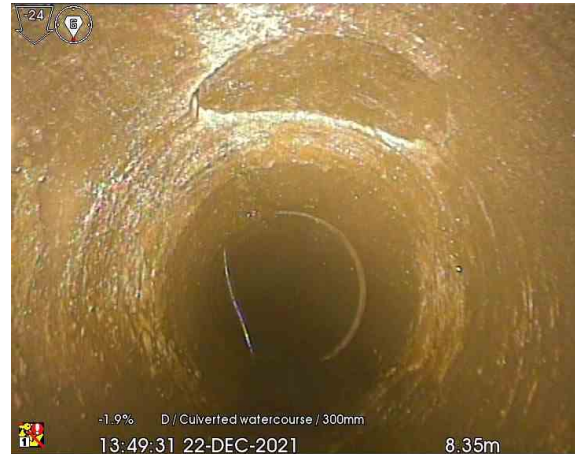
MH6X_8-35m_134931.jpg, 00:00:59, 8.35 m
 Connection other than junction, closed, at 12 o'clock, diameter: 150 mm

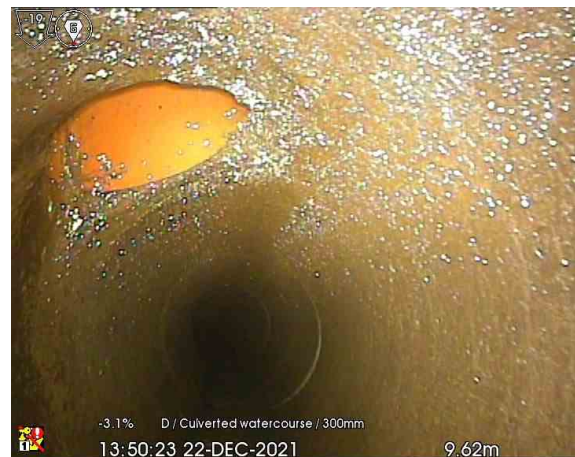
MH6X_9-62m_135023.jpg, 00:01:19, 9.62 m
 Connection other than junction, at 11 o'clock, diameter: 150 mm

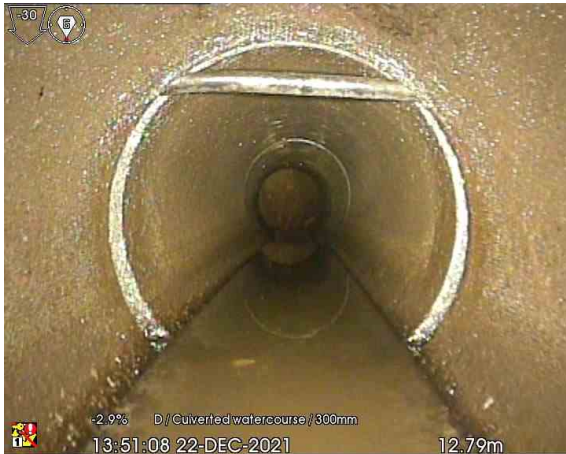
MH6X_12-79m_135108.jpg, 00:01:44, 12.79 m
 Sealing ring intruding, intruding but not hanging, from 10 to 02 o'clock

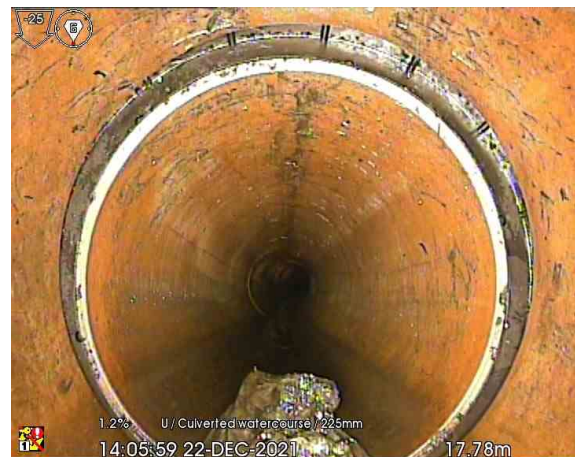
MH3X_17-77m_140559.jpg, 00:02:26, 17.77 m
 Open joint, medium

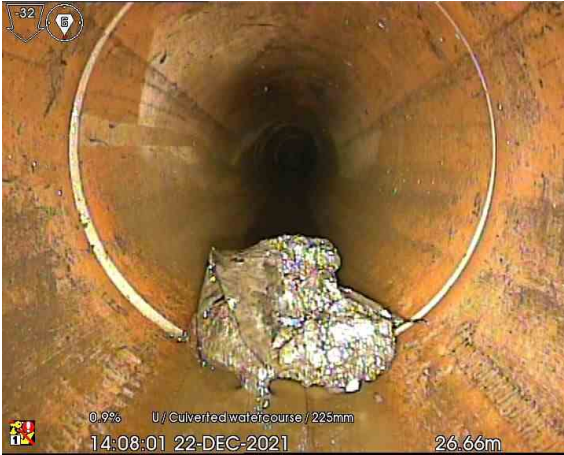
MH3X_26-66m_140801.jpg, 00:04:09, 26.66 m
 Survey abandoned, Can no longer push rock any further. The rock is getting stuck on the joint.

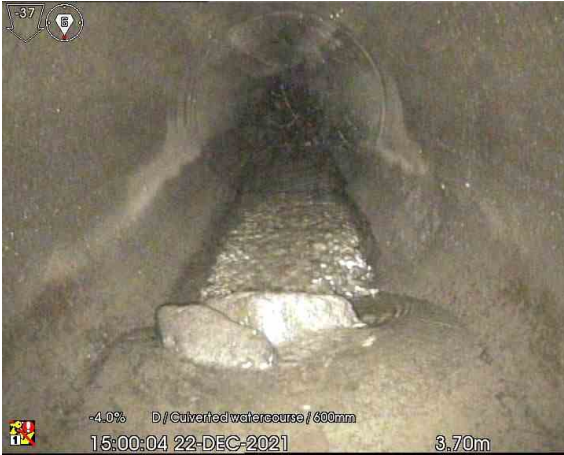
MH109X_3-70m_150004.jpg, 00:00:20, 3.70 m
 Other obstacles in invert, from 05 to 07 o'clock, 10% %
 cross-sectional area loss, Rock

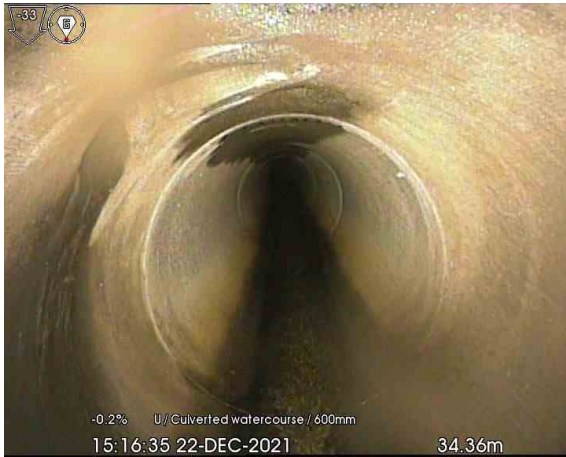
MH09X_34-36m_151635.jpg, 00:02:13, 34.36 m
 Connection other than junction, at 10 o'clock, diameter: 150 mm

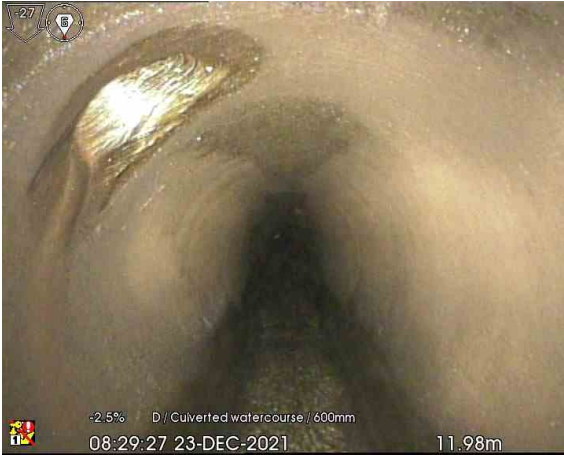
MH110X_11-98m_082927.jpg, 00:01:09, 11.98 m
 Connection other than junction, at 10 o'clock, diameter: 150 mm

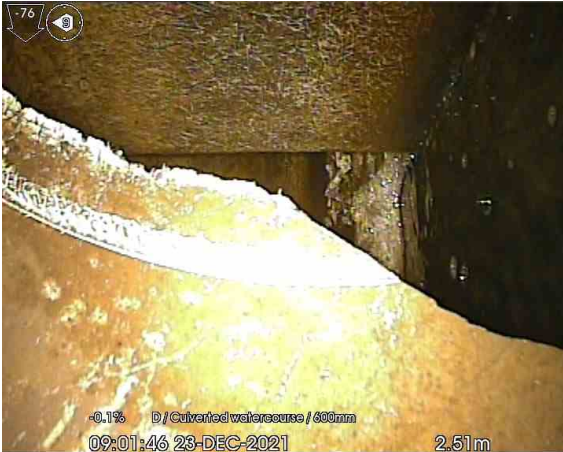
MH112X_2-51m_090146.jpg, 00:01:21, 2.51 m
Finish node type, outfall, reference number: OUTFALL,
Syphon

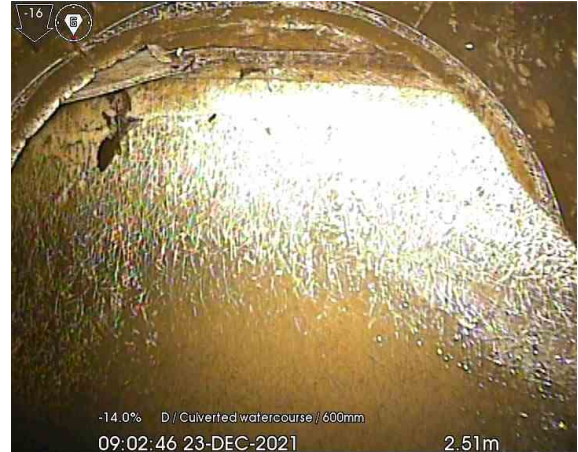
MH112X_2-51m_090246.jpg, 00:01:41, 2.51 m
General photograph taken at this point, Possibly a syphon
before reducing down into the outfall in the River Lostock. Dye
tested to prove the connectivity.

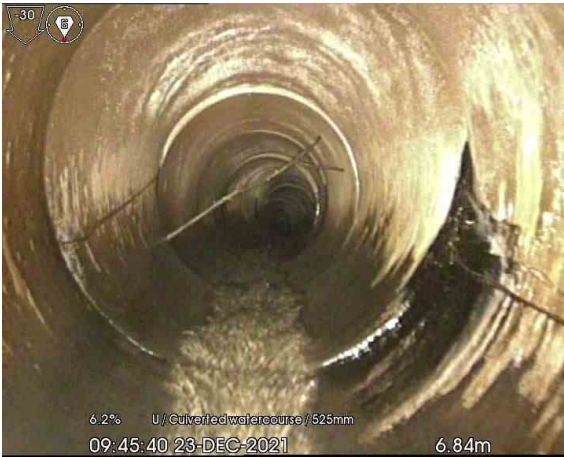
MH105X_6-84m_094540.jpg, 00:00:43, 6.84 m
 Roots, fine at joint

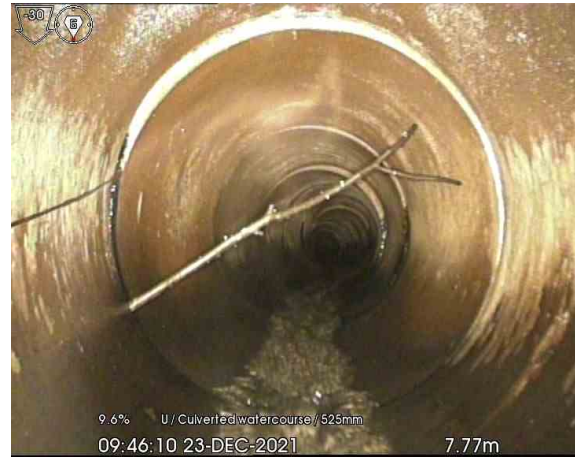
MH105X_7-77m_094610.jpg, 00:00:53, 7.77 m
 Roots, tap at joint

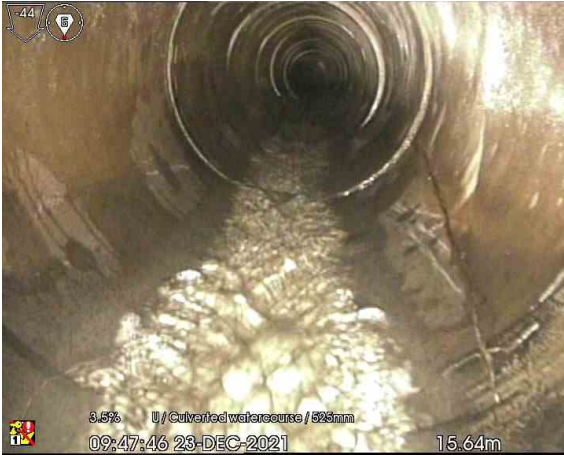
MH105X_15-64m_094746.jpg, 00:01:50, 15.64 m
 Roots, fine at joint

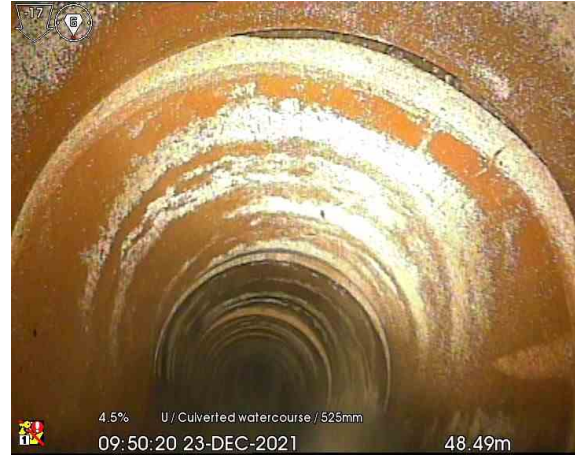
MH105X_48-49m_095020.jpg, 00:04:16, 48.49 m
 Open joint, medium

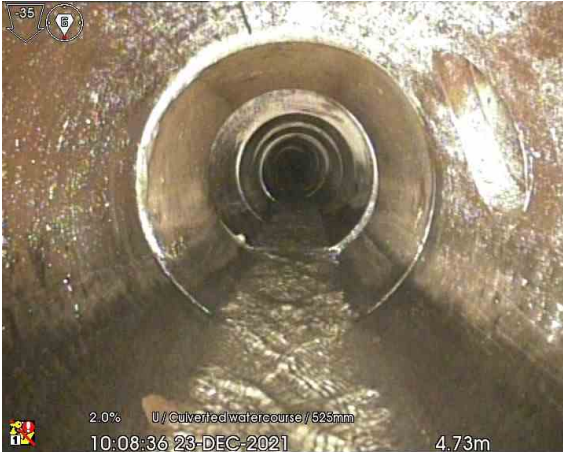
MH104X_4-73m_100836.jpg, 00:00:26, 4.73 m
 Connection other than junction, closed at 3 o'clock, diameter:
 150mm

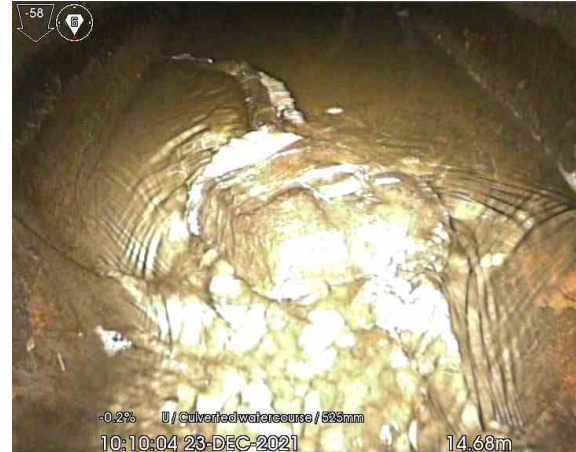
MH104X_14-68m_101004.jpg, 00:01:30, 14.68 m
 Other obstacles in invert, from 05 to 07 o'clock, 10% %
 cross-sectional area loss, Rock

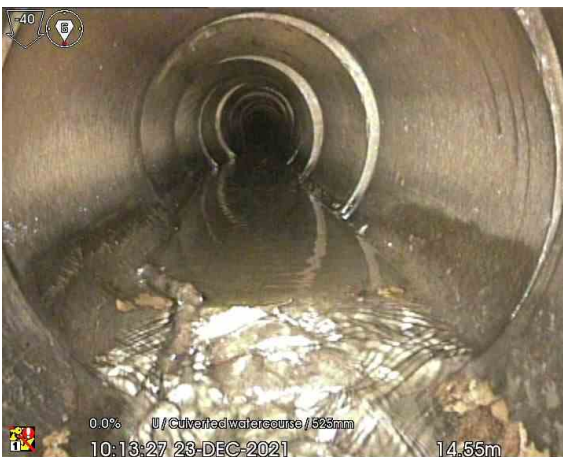
MH104X_14-55m_101327.jpg, 00:04:38, 14.55 m
 Survey abandoned, Unable to drive over rocks stuck on the
 joint. Line needs jetting. TM needed.

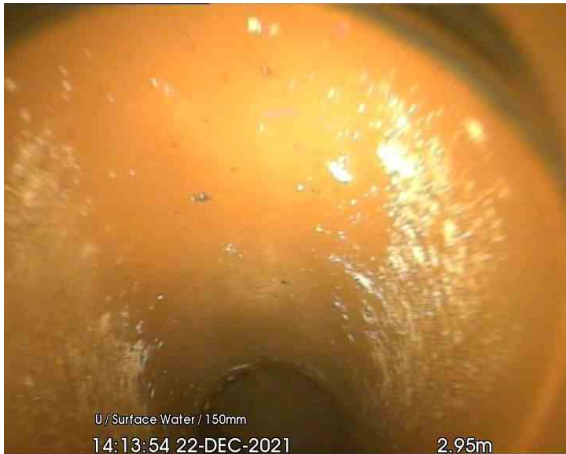
CP3X_2-95m_141354.jpg, 00:00:18, 2.95 m
 Joint displaced, medium

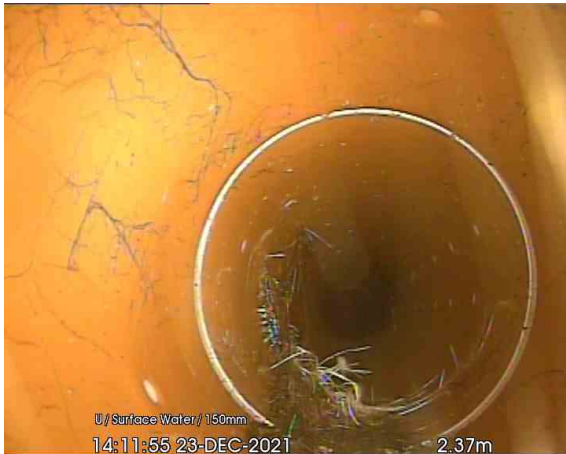
CP3 PIPE A_2-37m_141155.jpg, 00:00:22, 2.37 m
 Roots, fine

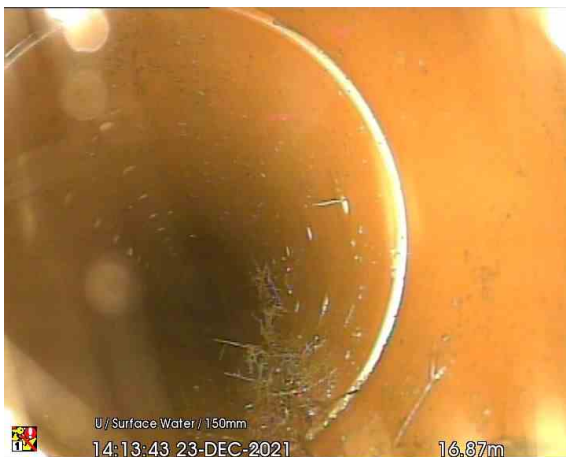
CP3 PIPE A_16-87m_141343.jpg, 00:01:39, 16.87 m
 Roots, fine

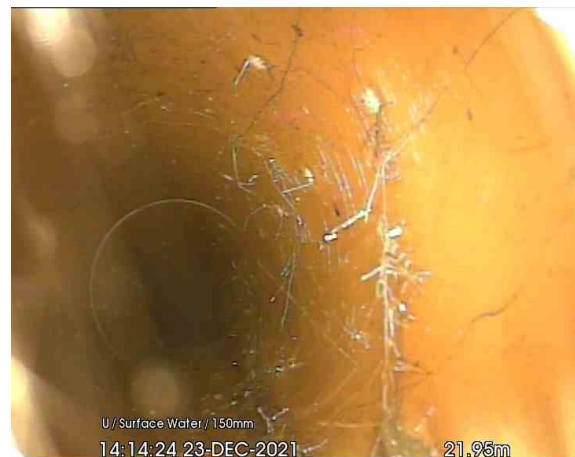
CP3 PIPE A_21-95m_141424.jpg, 00:02:14, 21.95 m
 Roots, fine

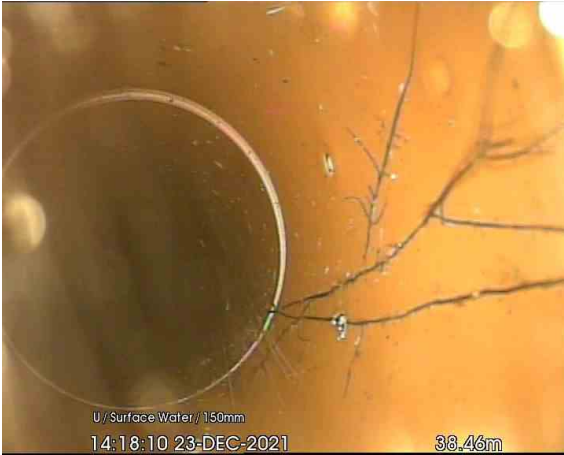
CP3 PIPE A_38-46m_141810.jpg, 00:05:32, 38.46 m
 Survey abandoned, Unable to push any further

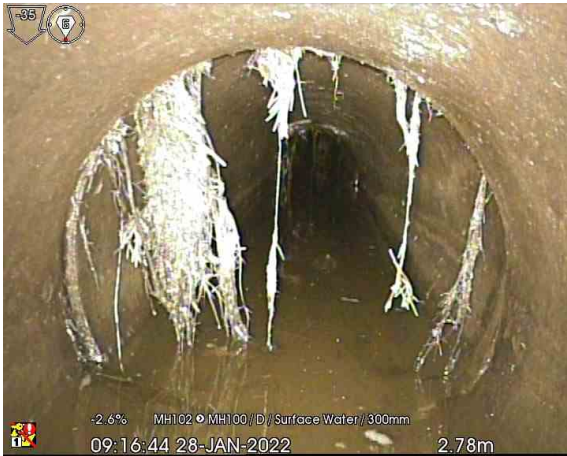
MH102X_2-78m_091644.jpg, 00:00:23, 2.78 m
 Roots, mass at joint, 20% % cross-sectional area loss

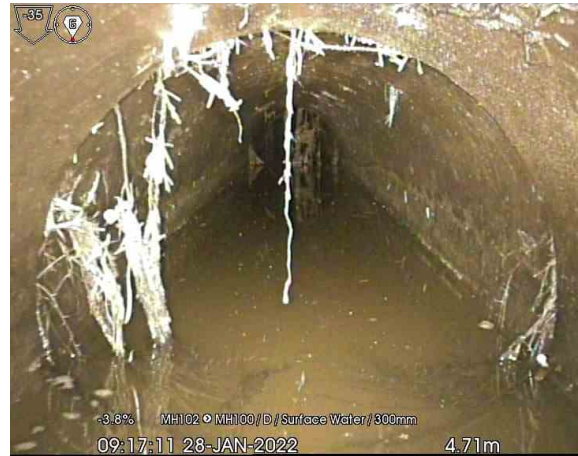
MH102X_4-71m_091711.jpg, 00:00:38, 4.71 m
 Roots, fine at joint

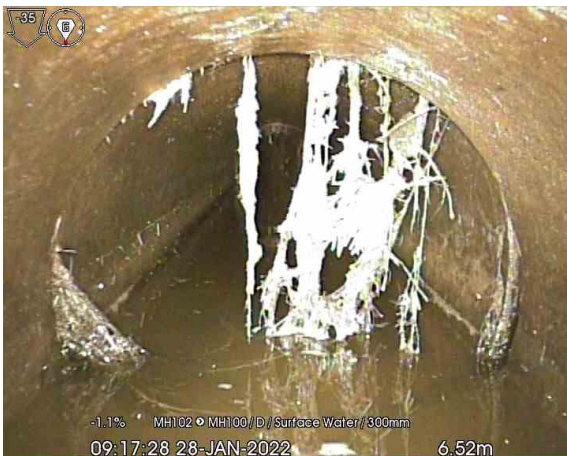
MH102X_6-52m_091728.jpg, 00:00:47, 6.52 m
 Roots, mass at joint, 20% % cross-sectional area loss

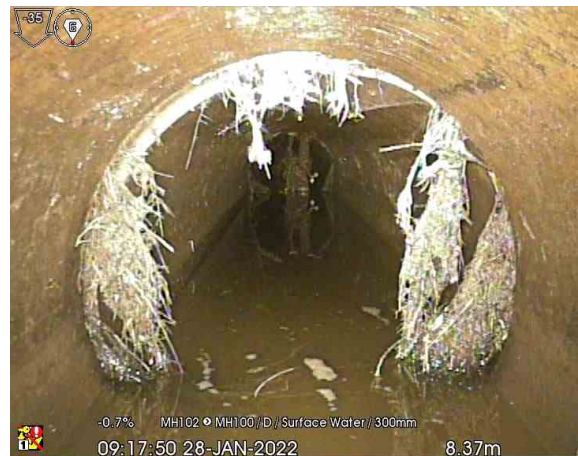
MH102X_8-37m_091750.jpg, 00:00:55, 8.37 m
 Roots, mass at joint, 30% % cross-sectional area loss

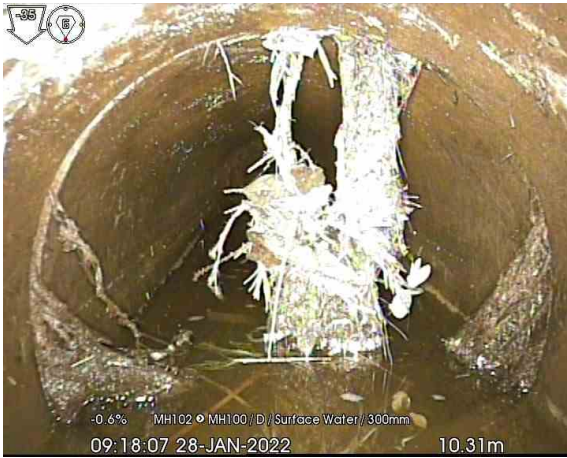
MH102X_10-31m_091807.jpg, 00:01:05, 10.31 m
 Roots, mass at joint, 30% % cross-sectional area loss

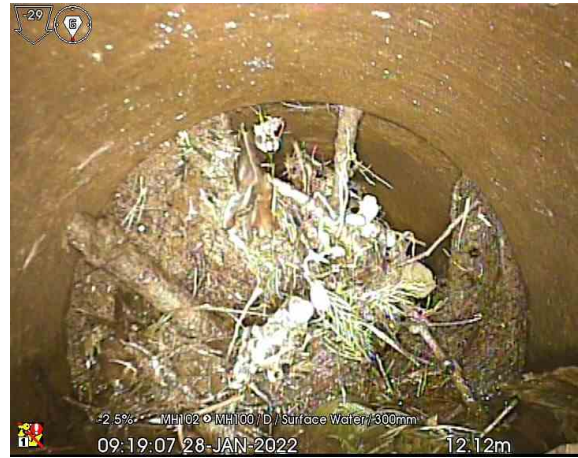
MH102X_12-12m_091907.jpg, 00:01:54, 12.12 m
 Roots, mass at joint, 70% % cross-sectional area loss

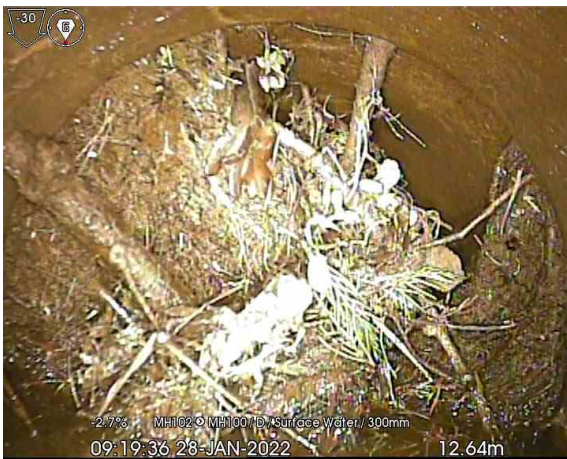
MH102X_12-64m_091936.jpg, 00:02:11, 12.64 m
 Survey abandoned, Unable to pass mass roots

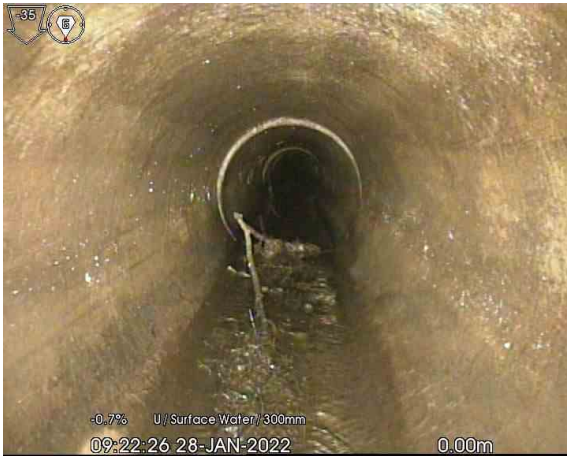
MH102 Upstream_0-00m_092226.jpg, 00:00:05, 0.00 m
 Roots, tap

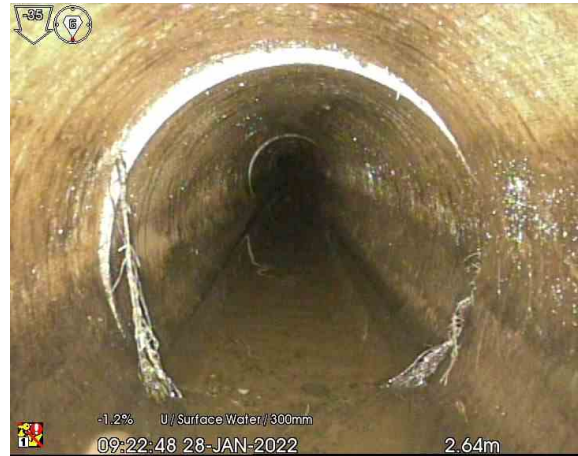
MH102 Upstream_2-64m_092248.jpg, 00:00:20, 2.64 m
 Roots, fine at joint

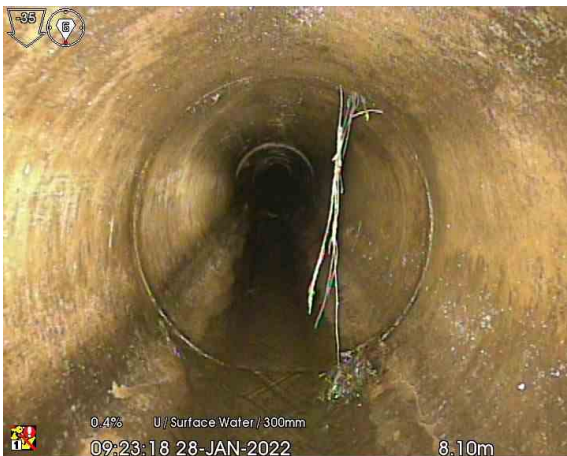
MH102 Upstream_8-10m_092318.jpg, 00:00:44, 8.10 m
 Roots, fine at joint

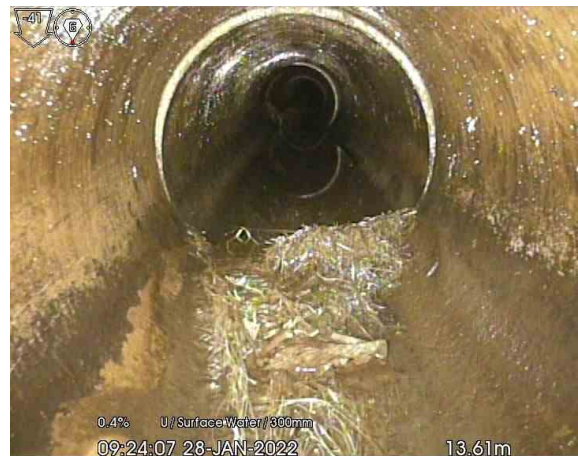
MH102 Upstream_13-61m_092407.jpg, 00:01:23, 13.61 m
 Roots, mass at joint, 20% % cross-sectional area loss

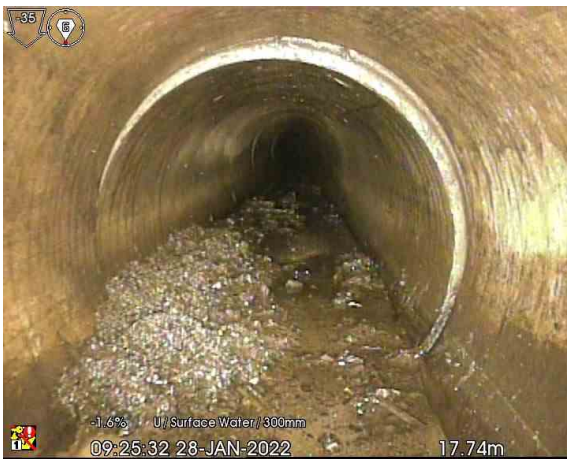
MH102 Upstream_17-74m_092532.jpg, 00:02:09, 17.74 m
 Settled deposits, fine, 25% % cross-sectional area loss

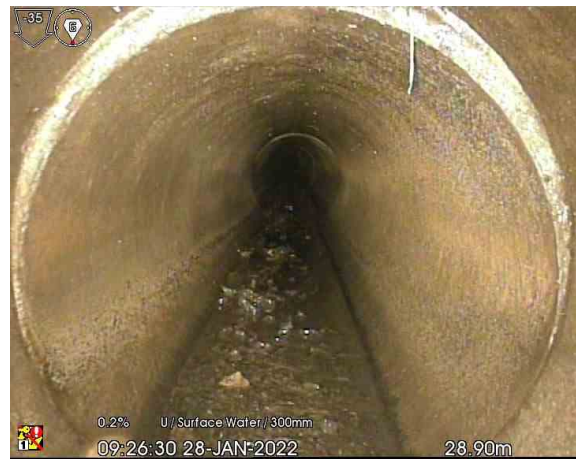
MH102 Upstream_28-90m_092630.jpg, 00:03:00, 28.90 m
 Settled deposits, fine, 10% % cross-sectional area loss

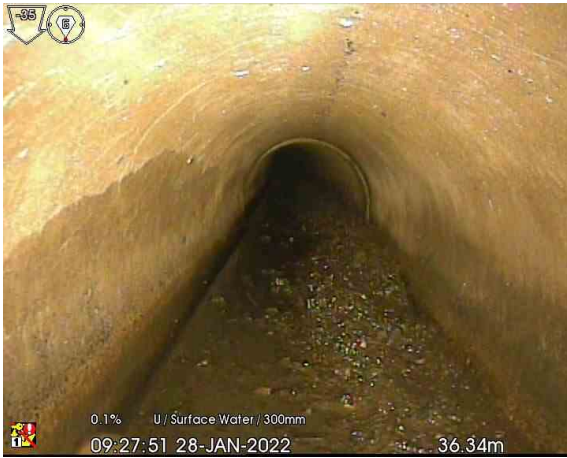
MH102 Upstream_36-34m_092751.jpg, 00:03:55, 36.34 m
 Settled deposits, fine, 20% % cross-sectional area loss

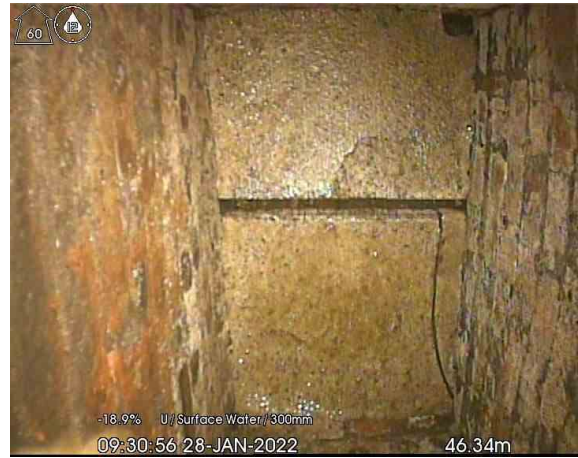
MH102 Upstream_46-34m_093056.jpg, 00:05:30, 46.34 m
 Finish node type, catchpit, reference number: Buried Catchpit,
 Buried Catchpit. Unable to continue survey as the crawler is
 dropping into a deeper section of the catchpit which will stop
 us from getting the crawler back.
