Project  
**LANCASHIRE CENTRAL, PRESTON**

Title  
**DRAINAGE SURVEY REQUIREMENTS**

Client  
**MAPLE GROVE DEVELOPMENTS**

WIE DR 92 0503-01 P02

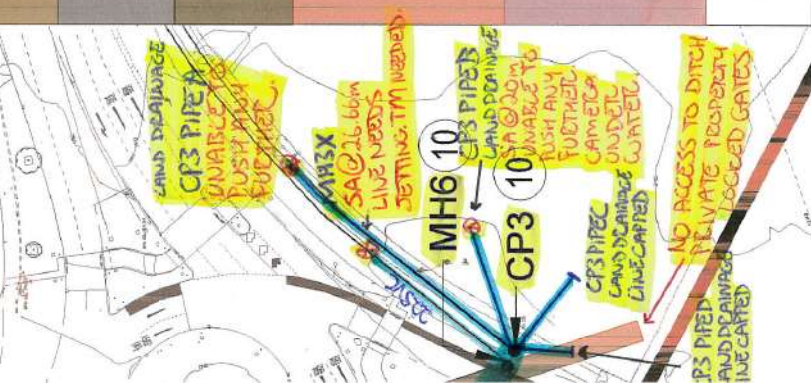
KEY AREA 3  
SURVEY AREA 4

- 2 the River Lostock, located approximately 77m north of the onsite headwall. Verify if culvert is a twin pipe culvert and if verified, survey both culverts.

- 3 CCTV of 600mm pipe flowing in northerly direction along Stanifield Lane, under the Stanifield Lane / Watkin Lane / Lostock Lane roundabout and presumably outfall to the River Lostock. Confirmation pipe discharges to the River Lostock, located approximately 80m northwest of the roundabout. Verify extents of pipe upstream of the roundabout - what is the upstream start point of this pipe run.

- 4 CCTV of 525mm pipe flowing from field to the southwest of the roundabout to the north edge of the roundabout. Is there connectivity of the field to the southwest of the roundabout (identified as FUTURE PHASE). Verify route of pipe downstream of roundabout - does it discharge to the River Lostock?

- 5 CCTV of highway gullies on Stanifield Lane - where do these gullies drain to? CCTV of manhole in footway on east side of Stanifield Lane to confirm upstream and downstream connections, verifying where the manhole ultimately discharges to.

- 6 CCTV survey of Manhole Ref MH6 (located in footpath adjacent Stanifield Lane / Watkin Lane / Lostock Lane roundabout) confirm upstream and downstream connectivity.

- 7 CCTV survey of culverts upstream and downstream of M65 Roundabout that links M65 to Lostock Lane. Confirmation of number of culvert inlets onsite, and corresponding outlets.

- 8 Existing ditch on south side of Stoney Lane is culverted under Stoney Lane. CCTV survey required upstream and downstream of culvert. Confirm downstream route of culvert / ditch beyond Stoney Lane.

- 9 CCTV all incoming and outgoing connections to United Utilities public foul sewer located in splitter island on Craven Drive / Lostock Lane Junction. Public sewer records indicate one incoming pipe from the south and one outgoing pipe heading in a northerly direction up Craven Drive.

- 10 Geo positioning of chamber / headwall required to confirm cover level, invert level and exact position of incoming and outgoing drainage lines.

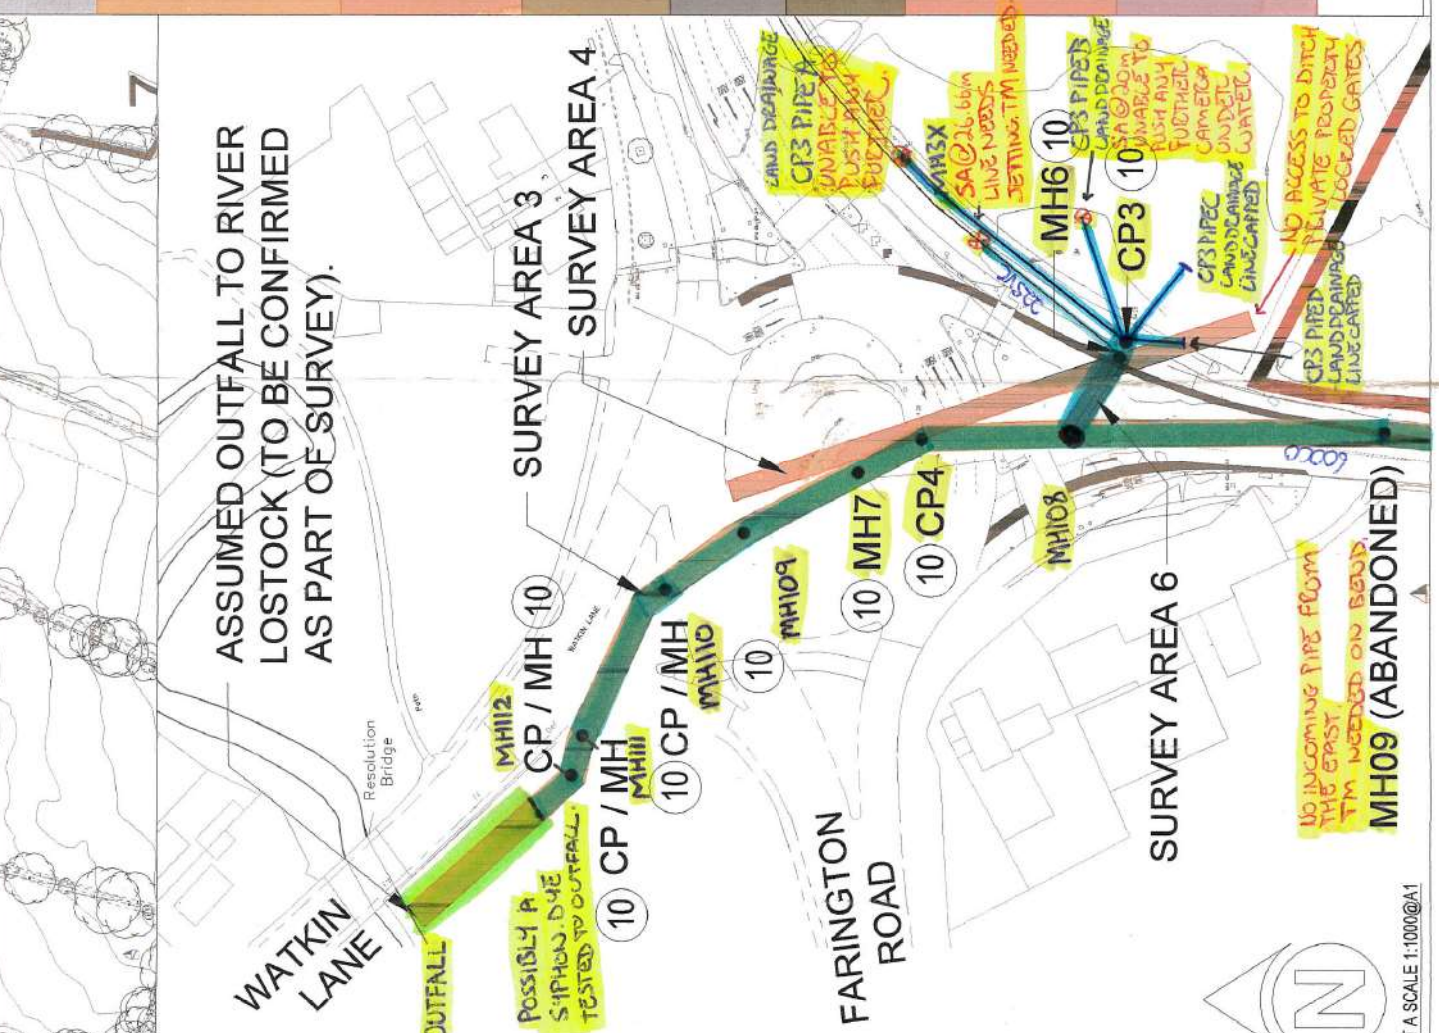
NET A SCALE 1:1000@A1

- 2 the River Lostock, located approximately 77m north of the onsite headwall. Verify if culvert is a twin pipe culvert and if verified, survey both culverts. CCTV of 600mm pipe flowing in northerly direction along Stanfield Lane, under the Stanfield Lane / Watkin Lane / Lostock Lane roundabout and presumably outfall to the River Lostock. Confirmation pipe discharges to the River Lostock, located approximately 80m northwest of the roundabout. Verify extents of pipe upstream of the roundabout - what is the upstream start point of this pipe run. CCTV of 525mm pipe flowing from field to the southwest of the roundabout to the north edge of the roundabout. Is there connectivity of the field to the southwest of the roundabout (identified as FUTURE PHASE). Verify route of pipe downstream of roundabout - does it discharge to the River Lostock? CCTV of highway gullies on Stanfield Lane - where do these gullies drain to? CCTV of manhole in footway on east side of Stanfield Lane to confirm upstream and downstream connections, verifying where the manhole ultimately discharges to.

however only one culvert inlet was observed during site visit in October 2021.  
*TWIN PIPE CULVERT*  
Route of survey is shown based on previous surveys and as built drawing CLM02-H201-500-001 Stanfield Lane Junction Improvements, Drainage. Drawing produced by Lancashire County Council. CCTV survey required upstream of Manhole Ref MH09 - this manhole is identified as being abandoned. CCTV survey up a downstream of this manhole to confirm if there are any upstream flows entering the manhole, and confirmation as to if there are any connections to this manhole from the east. *SURVEY COMPLETE*  
Historic survey data shows a headwall and heavily silted ditch located in the FUTURE PHASE field. Access to this field will not be possible. Historic data states that a survey of this pipe downstream of the roundabout was not possible due to a concrete flag blocking the end of the pipe from a ditch. *NO ACCESS TO DITCH. NO 525mm PIPE ON BOUNDARY*
