Drainage Ditch Survey

Land Drainage Survey

Woodcock Estate

Doc No: LCCC-BDP-RPT-C-001

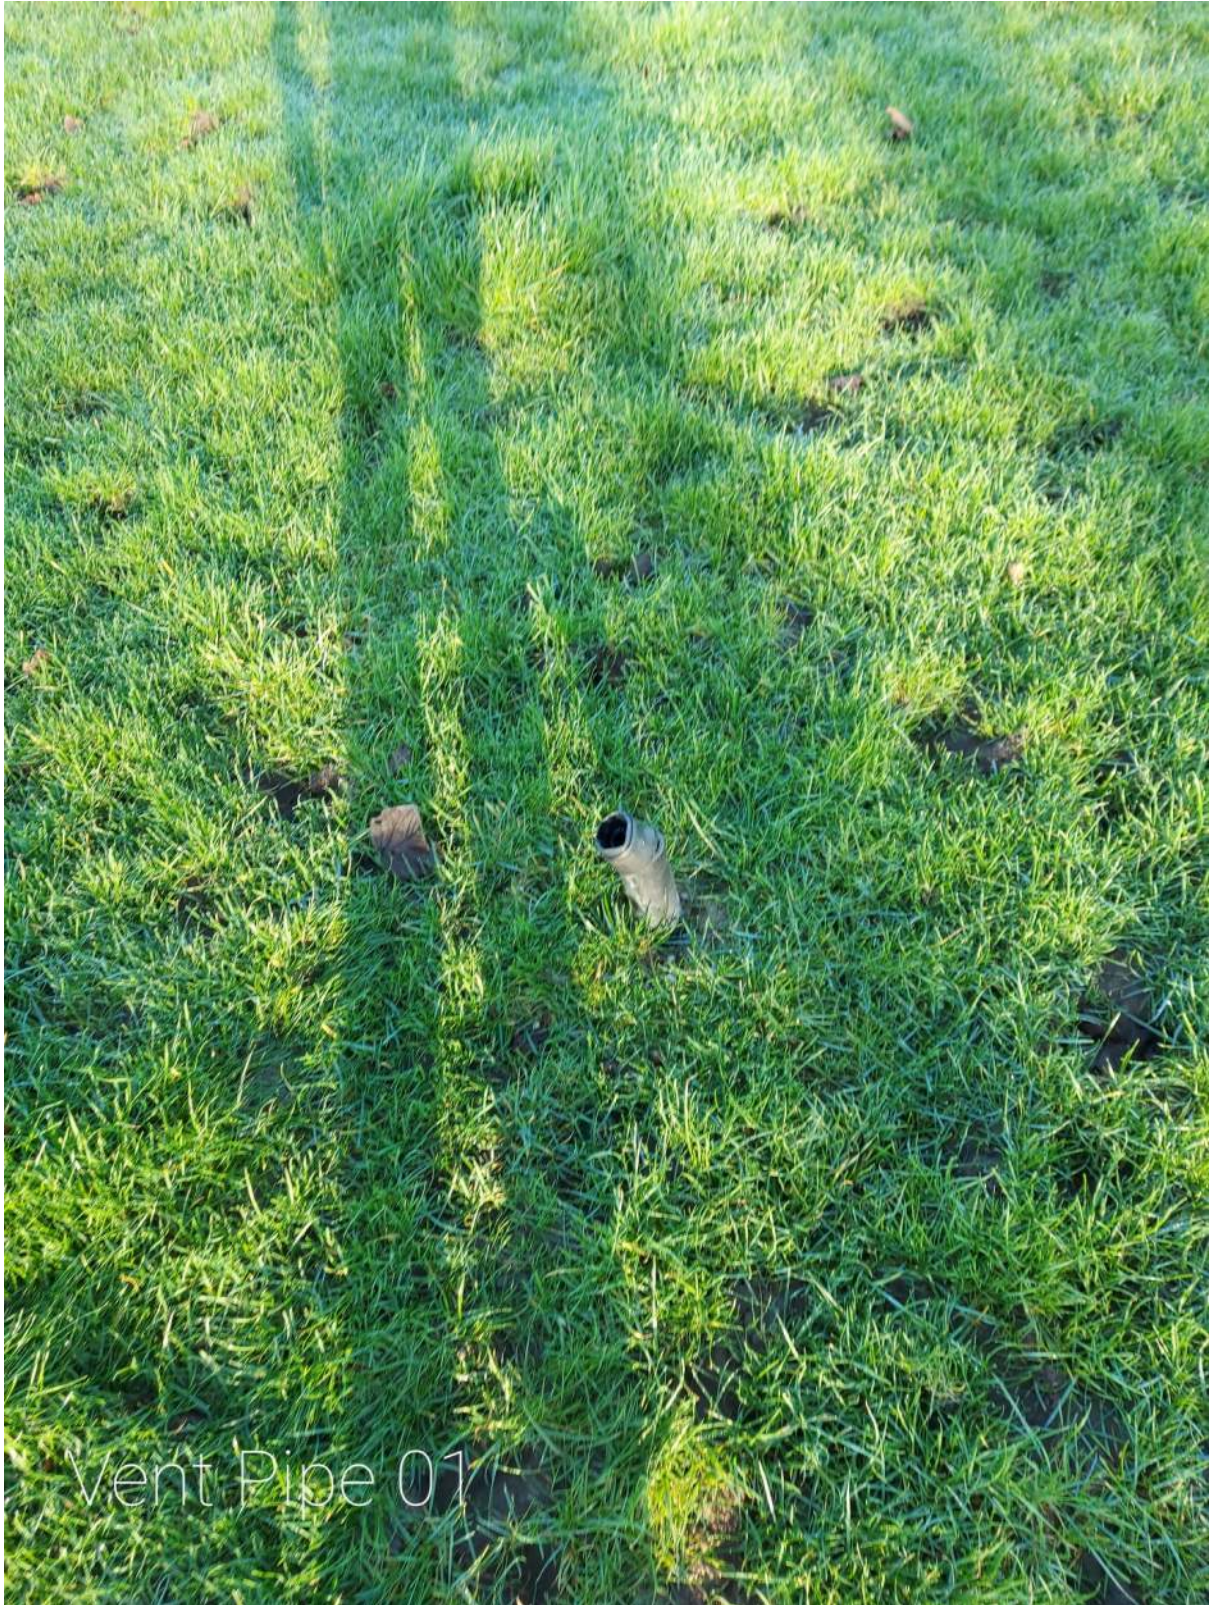
VENT PIPE 01

Unknown pipe found out falling into SP 08 ditch. The pipe carried constant flow with the head of the pipe unfound. Assumed to be land drainage. Exposed vertical open pipe found in the field upstream of discovered pipe (See vent pipe 02 image and General arrangement for location).
