**Preston and South Ribble FRMS**

**Updated Otter Survey**

ENV0000009C-JAC-ZZ-00-MO-BD-0002  
01

October 2020

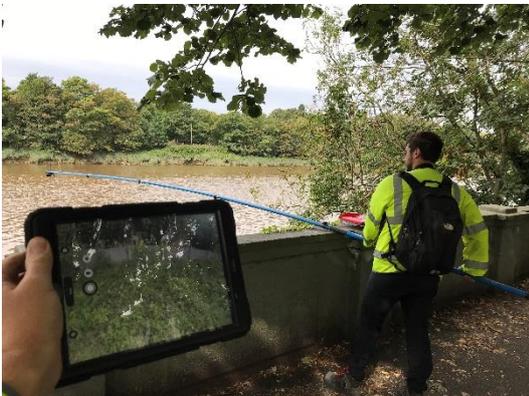
**Plate 4.1 – GoPro setup on site.**

All suitable bankside features were visually surveyed using a GoPro camera (model: GoPro HERO5) attached to a 7.3m telescopic pole. The GoPro camera was connected to an iPad which enabled footage to be recorded and viewed in real time in the field. All footage was also reviewed via desk-top means upon the completion of the survey. The GoPro could be positioned to give a close-up view of the bank, which enabled surveyors to pick up potential signs of otter, such as footprints or spraints. It could also be positioned to give a birds-eye view to pick out mammal pathways through the vegetation, depressions in the vegetation or otter slides on the bank. Evidence of otter was recorded where present.

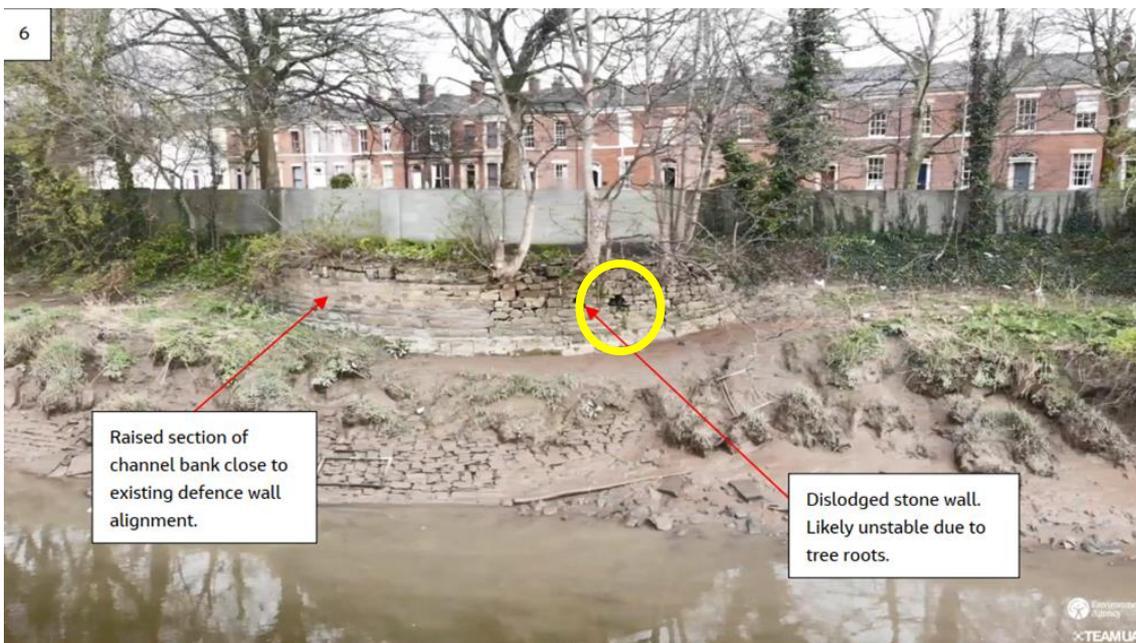
Plate 5.1 - TN1 viewed from drone (highlighted by yellow circle)

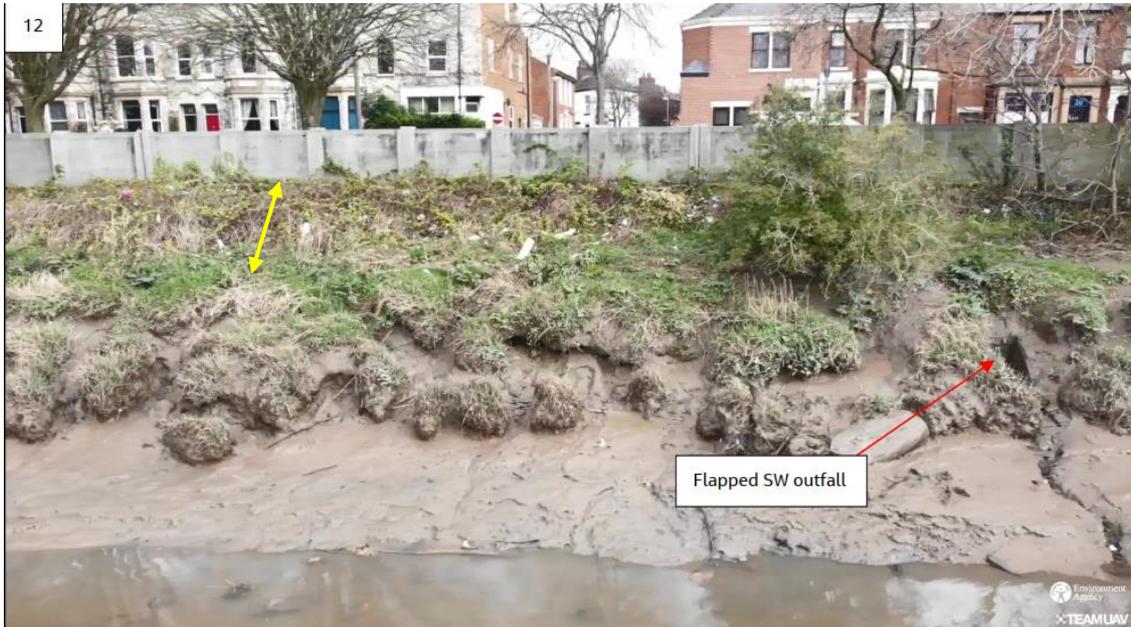
Plate 5.2 - TN 4 viewed from drone in winter. Narrow band of scrub between high tide mark and wall.

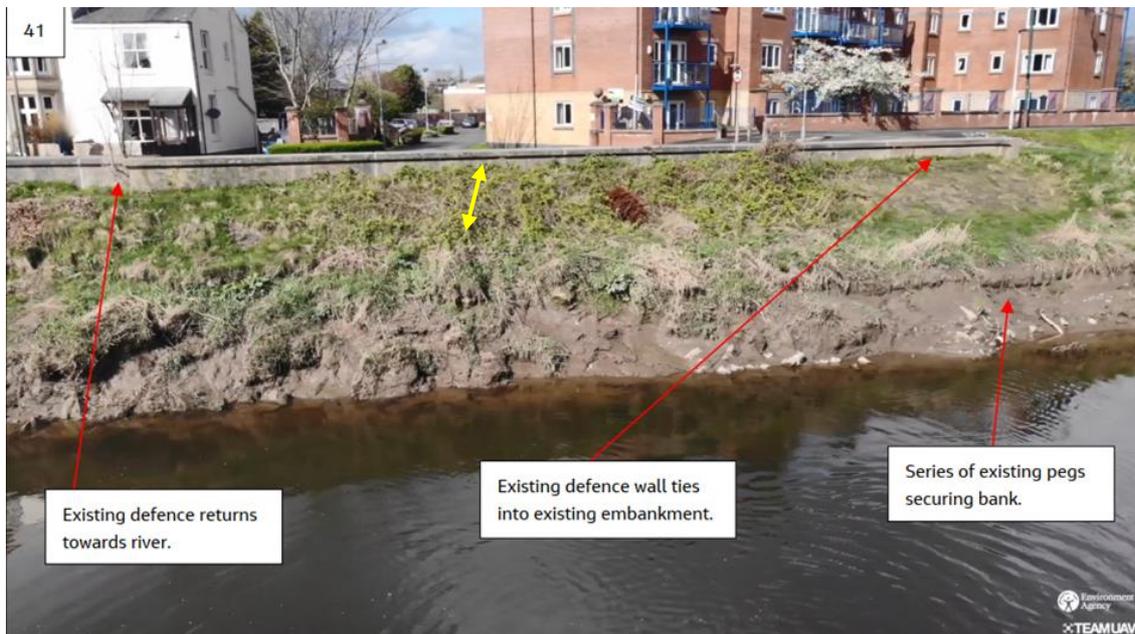
Plate 5.3 - TN 5 viewed from drone in winter. Narrow band of scrub between high tide mark and wall.

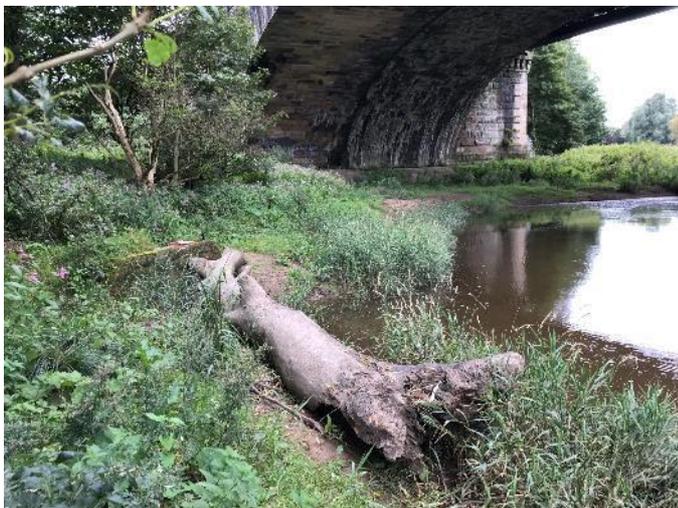
Two well used spraint sites were recorded during this inspection. These were located on small outfall and on log immediately adjacent to outfall next to the Ribble Viaduct (SD 53557 28329).

Plate 5.4 – Spraint site on log near Ribble Viaduct
