Lancashire Cricket, Lancashire County Council and Eric Wright Construction

FARINGTON CRICKET FACILITY

Transport Assessment

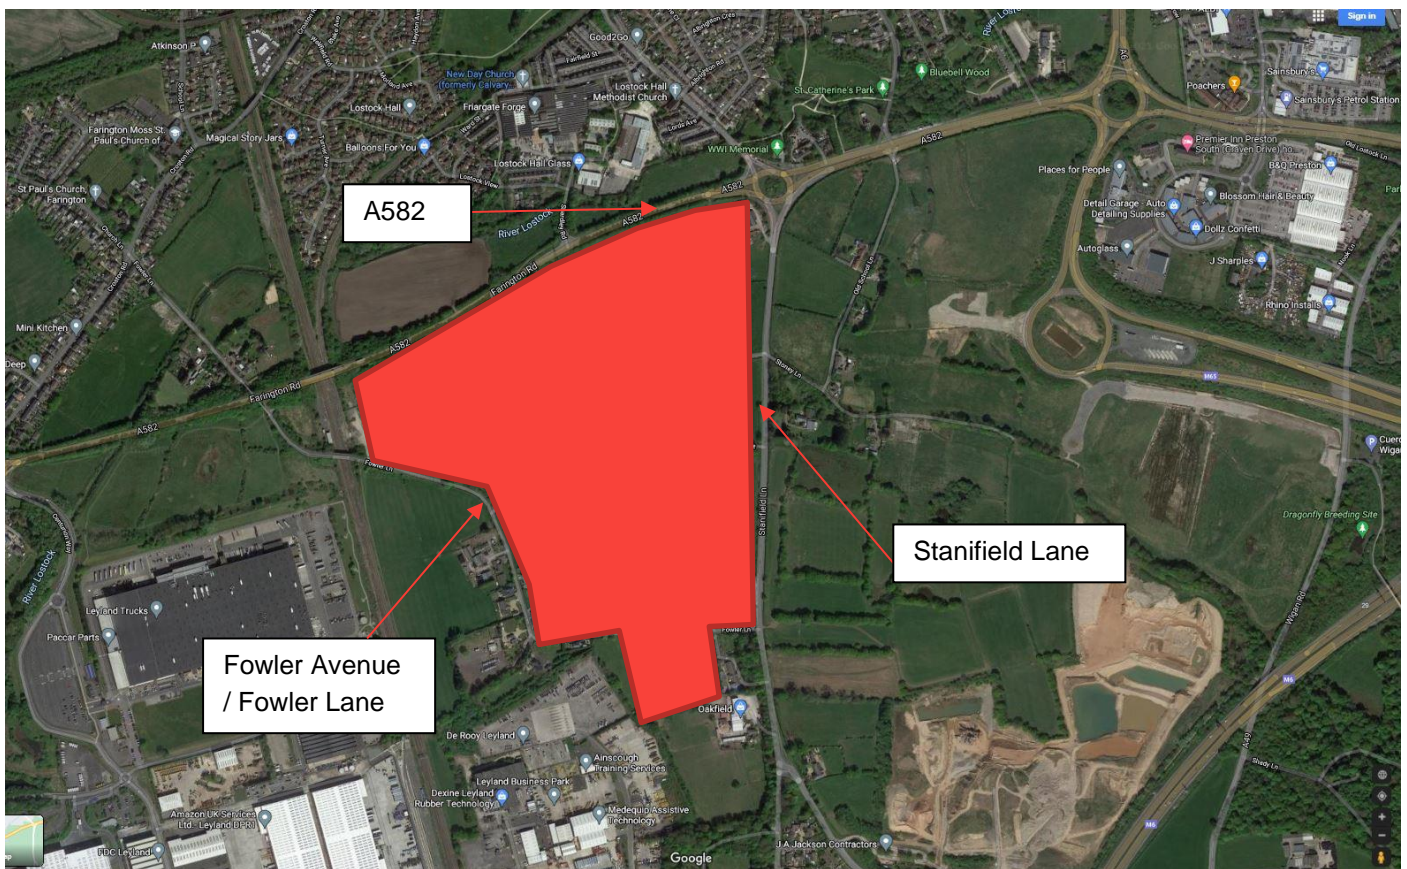
Figure 1 Site Location Plan

The proposed site is located in existing fields within the Woodcock Estate, north of Farington in South Ribble. The site is bordered by Stanfield Lane on its eastern edge, the A582 on the northern boundary, and Fowler Avenue / Fowler Lane to the south and west.

Lostock Hall station is located approximately 0.5km north of the site, and Leyland station some 1.3km south of the site. Local bus services currently run along Stanfield Lane and could serve the site in future.

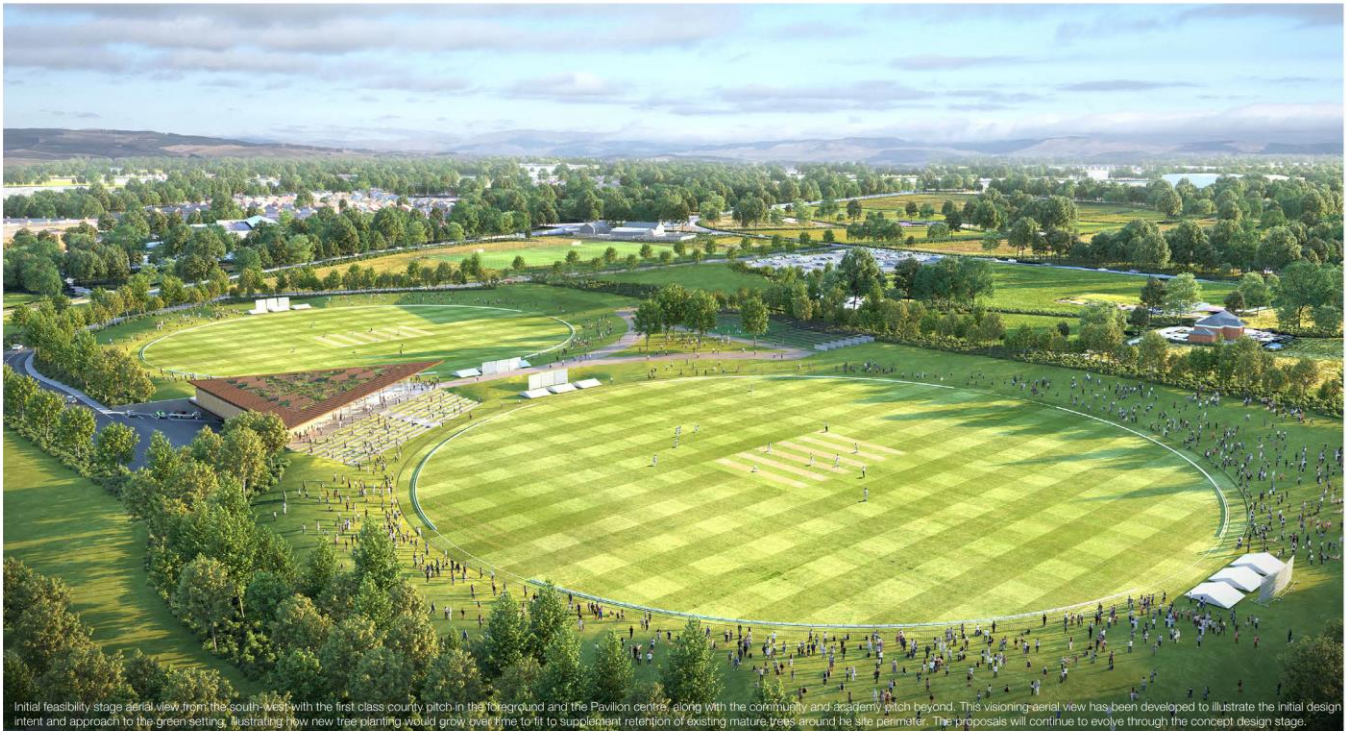
Figure 2 - CGI Impression of the Farington Cricket Amenity (BDP)

Farington Cricket includes two cricket ovals, one featuring a square/pitches designed to a standard capable of hosting first class fixtures. The facility will be used by Lancashire County Cricket Club (LCCC), and will be used for first class matches, second XI fixtures, Women's cricket and Youth team / Academy matches, as well as for training sessions.

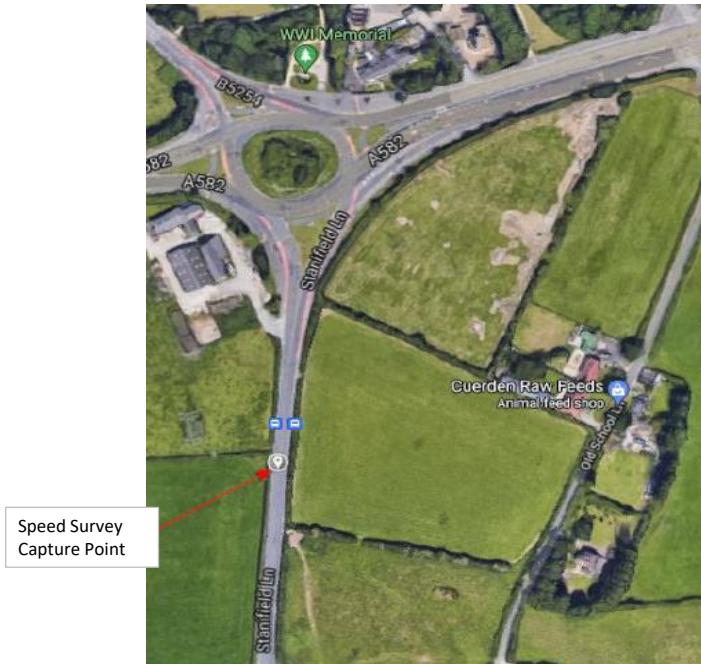
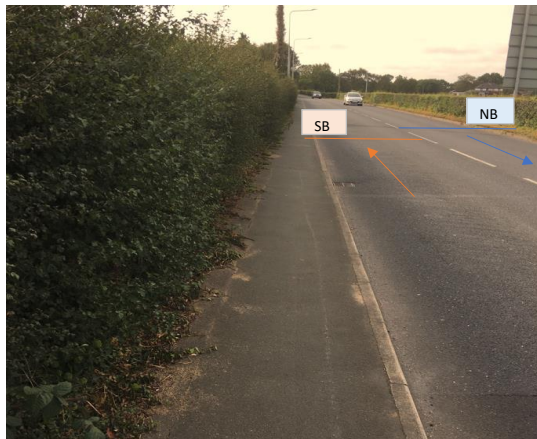
Site 1

Job Number: MHC-245-21 Stanifield Lane, Farington
Speed limit: 60mph
Weather: Dry, Clear
Date: Tuesday 21st September 2021
Time period: 10:00-12:00, 14:00-16:00
Incidents: None reported

Northbound	
85th Percentile	37.5
Average speed	32.5
Vehicles above limit	0
Vehicles 15mph above limit	0

Southbound	
85th Percentile	43.0
Average speed	37.3
Vehicles above limit	1
Vehicles 15mph above limit	1
