B. Drainage Survey Details

Project Name: B5254 Lostock Hall 2021_12_06
Project Description: WinCan Import in Miraculix WRc4 Standard
Project Date: 07/12/2021
Inspection Standard: MSCC4 Sewers & Drainage GB (SRM4 Scoring)

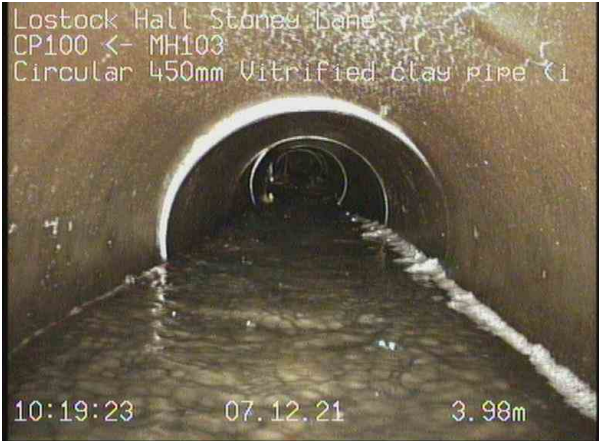
CP100X_2fba9b8d-ee7a-4bca-b569-5b92df62eada_20211207_092310_652.jpg, 00:00:29, 3.98 m
 Water level, 40% of the vertical dimension

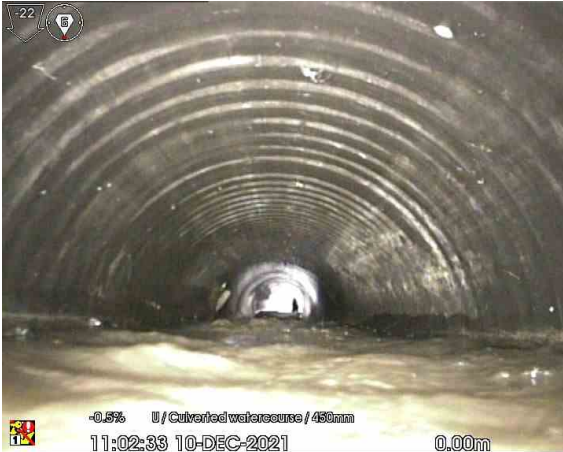
POND1X_0-00m_110233.jpg, 00:00:03, 0.00 m
 Water level, 50% % of the vertical dimension

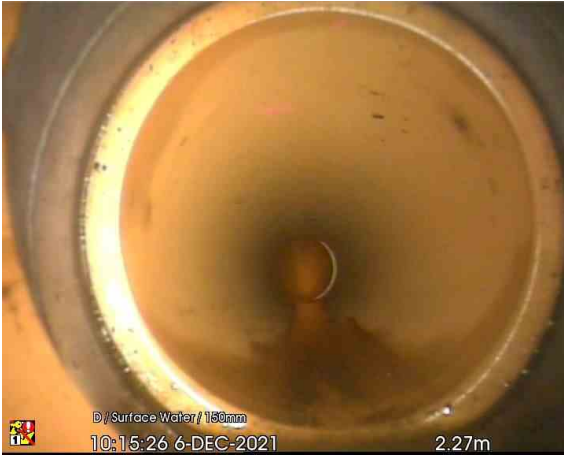
GY2X_2-27m_101526.jpg, 00:00:20, 2.27 m
 Open joint, large

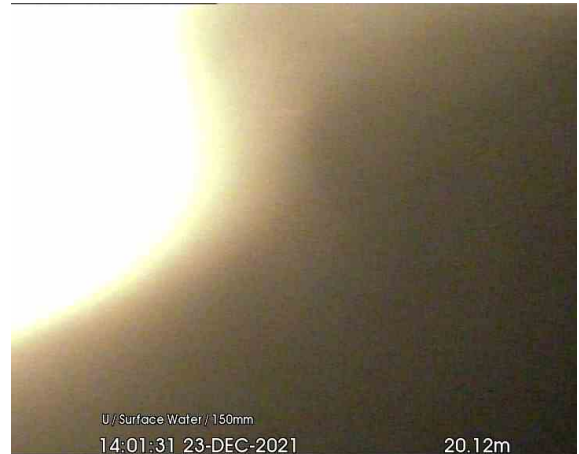
U / Surface Water / 150mm
 14:01:31 23-DEC-2021 20.12m
 CP3 PIPE B_20-12m_140131.jpg, 00:03:21, 20.12 m
 Survey abandoned, Unable to push any further
